Honouliuli POW and Internment Camp

Archaeological Investigations at *Jigoku-Dani*
2006-2017

Mary M. Farrell

December 2017

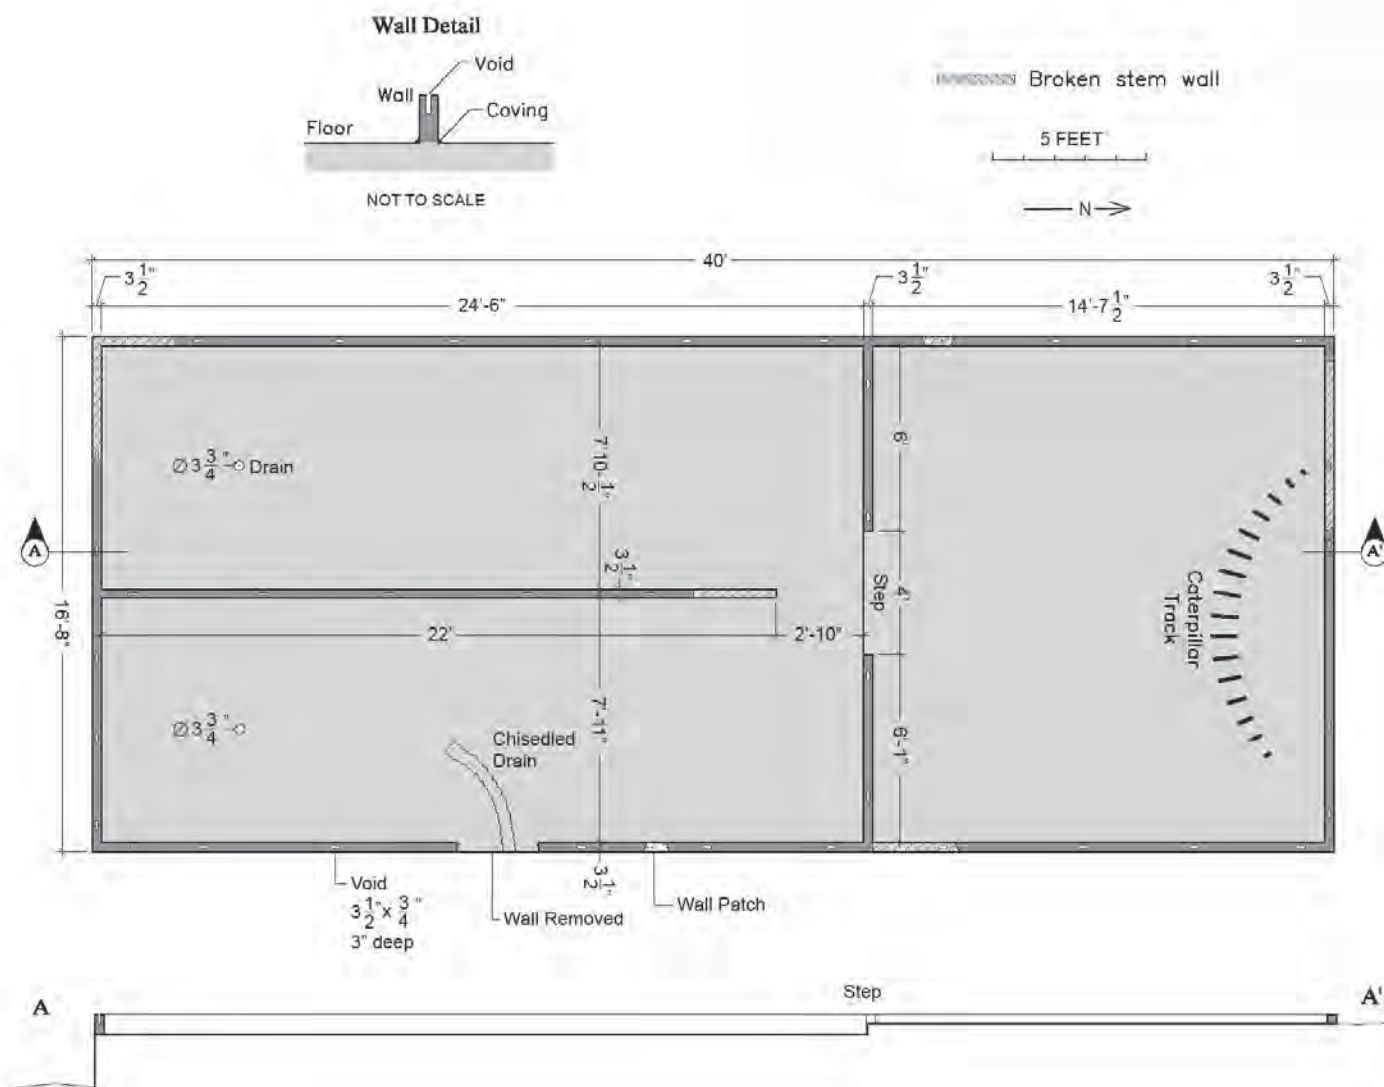
Figure 5.38. Feature II-2, track marks on shower foundation (2011).

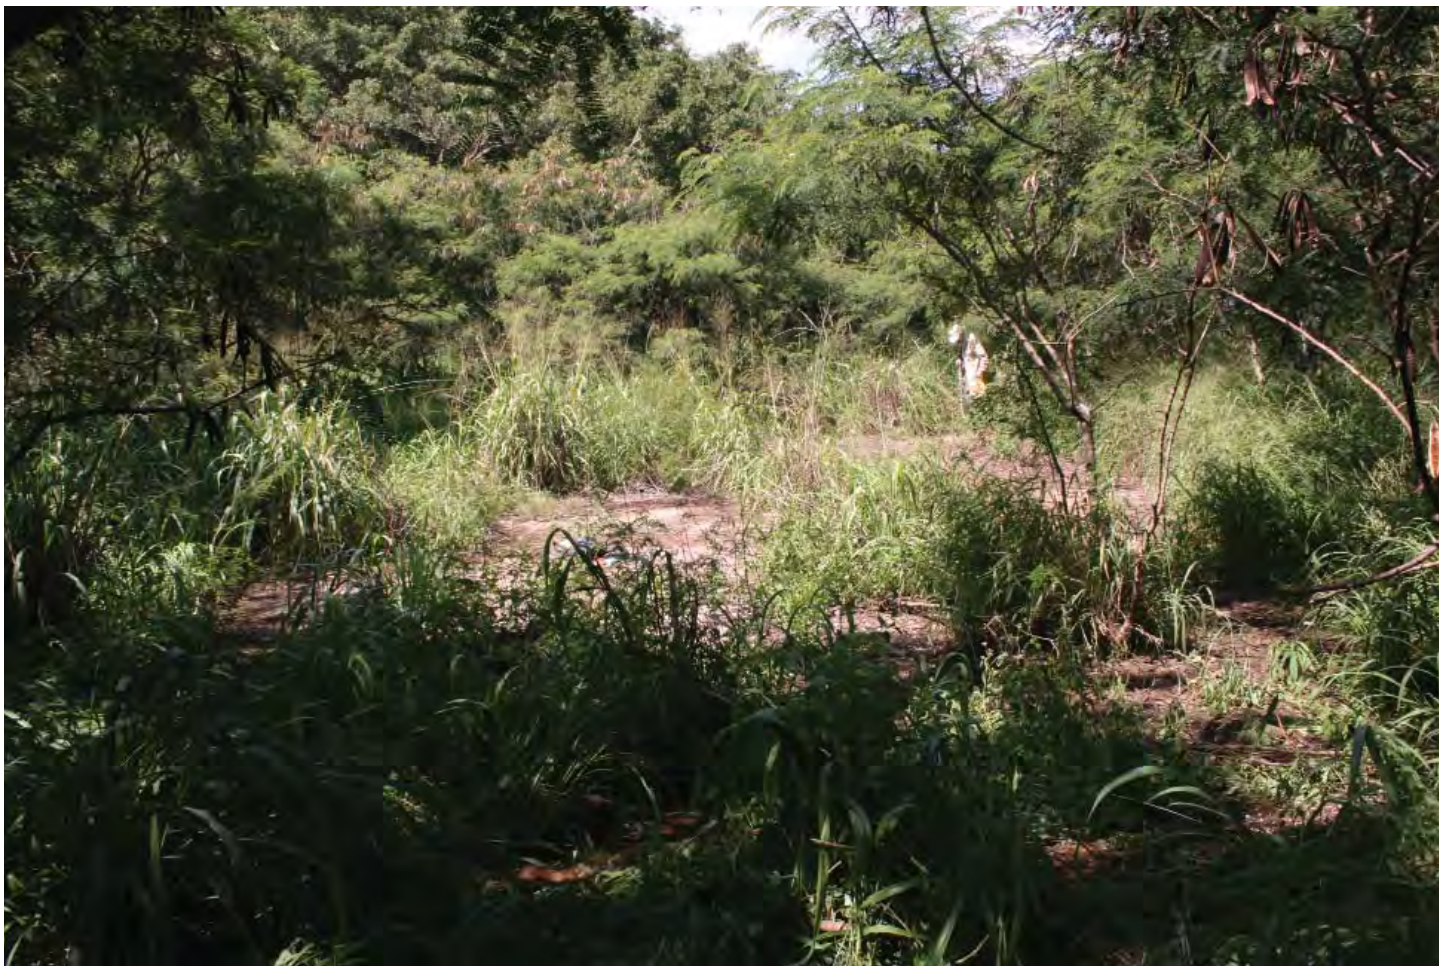
Figure 5.144. Feature V-1, internee mess hall foundation prior to cleaning (2008).

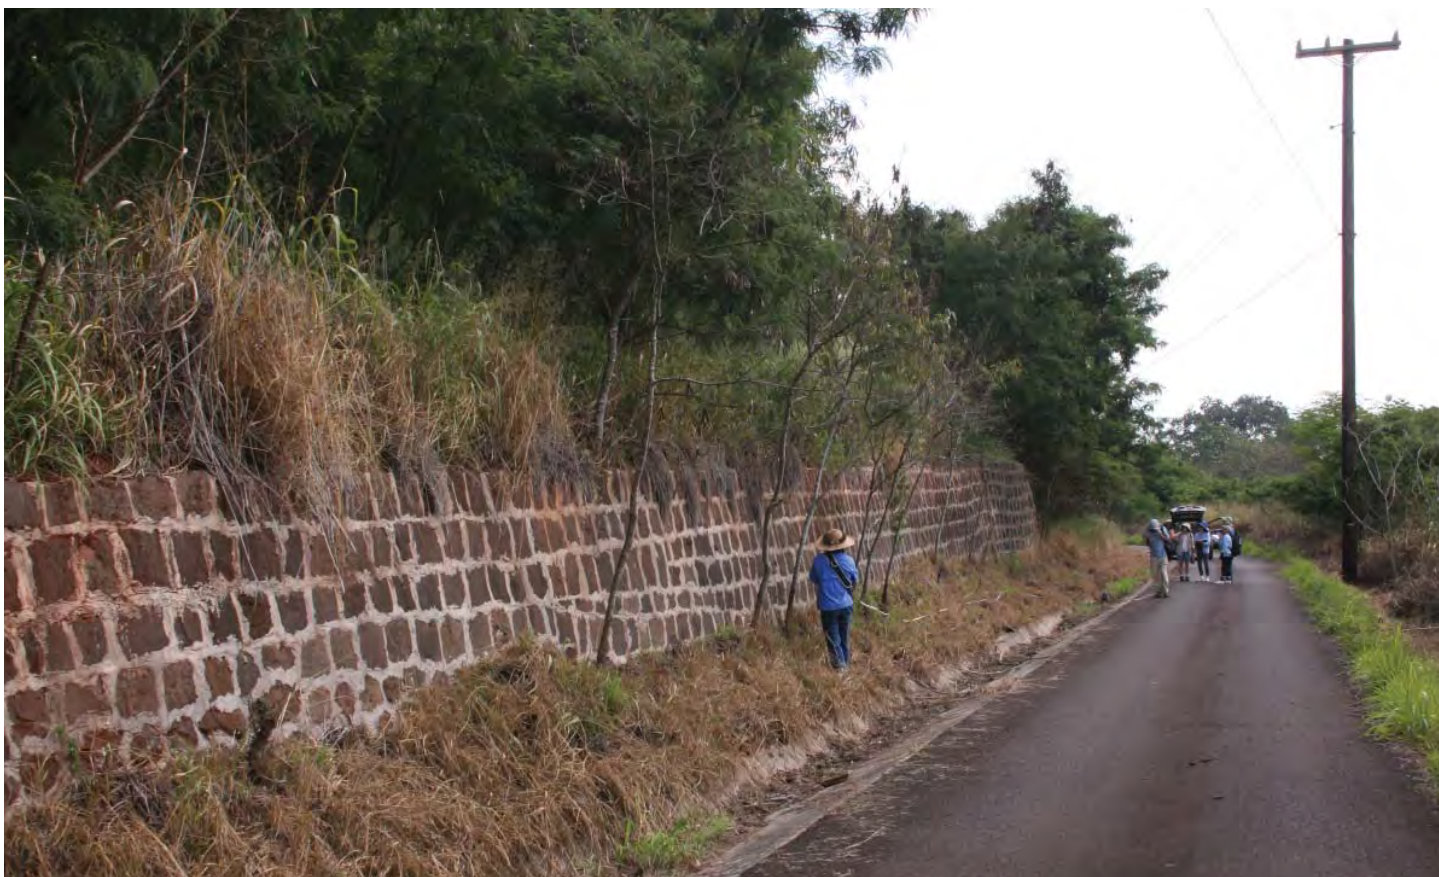
Figure 5.196. Feature V-15, rock retaining wall (2008).
