ARCHEOLOGICAL FEATURE ASSESSMENT AT HONOULIULI NATIONAL HISTORIC
SITE: APPENDIX B – THE 2018 UNIVERSITY OF HAWAI‘I WEST O‘AHU
ARCHEOLOGICAL FIELD SCHOOL

WILLIAM R. BELCHER

15 JULY 2019

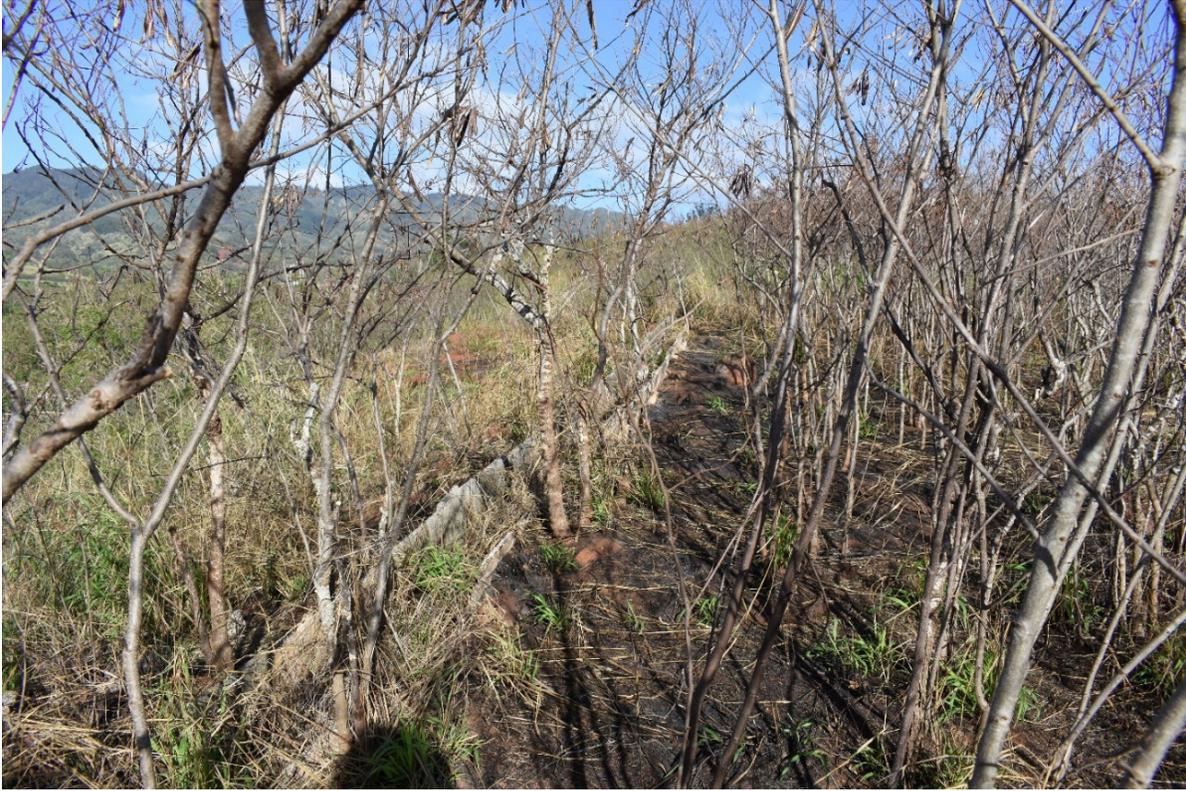
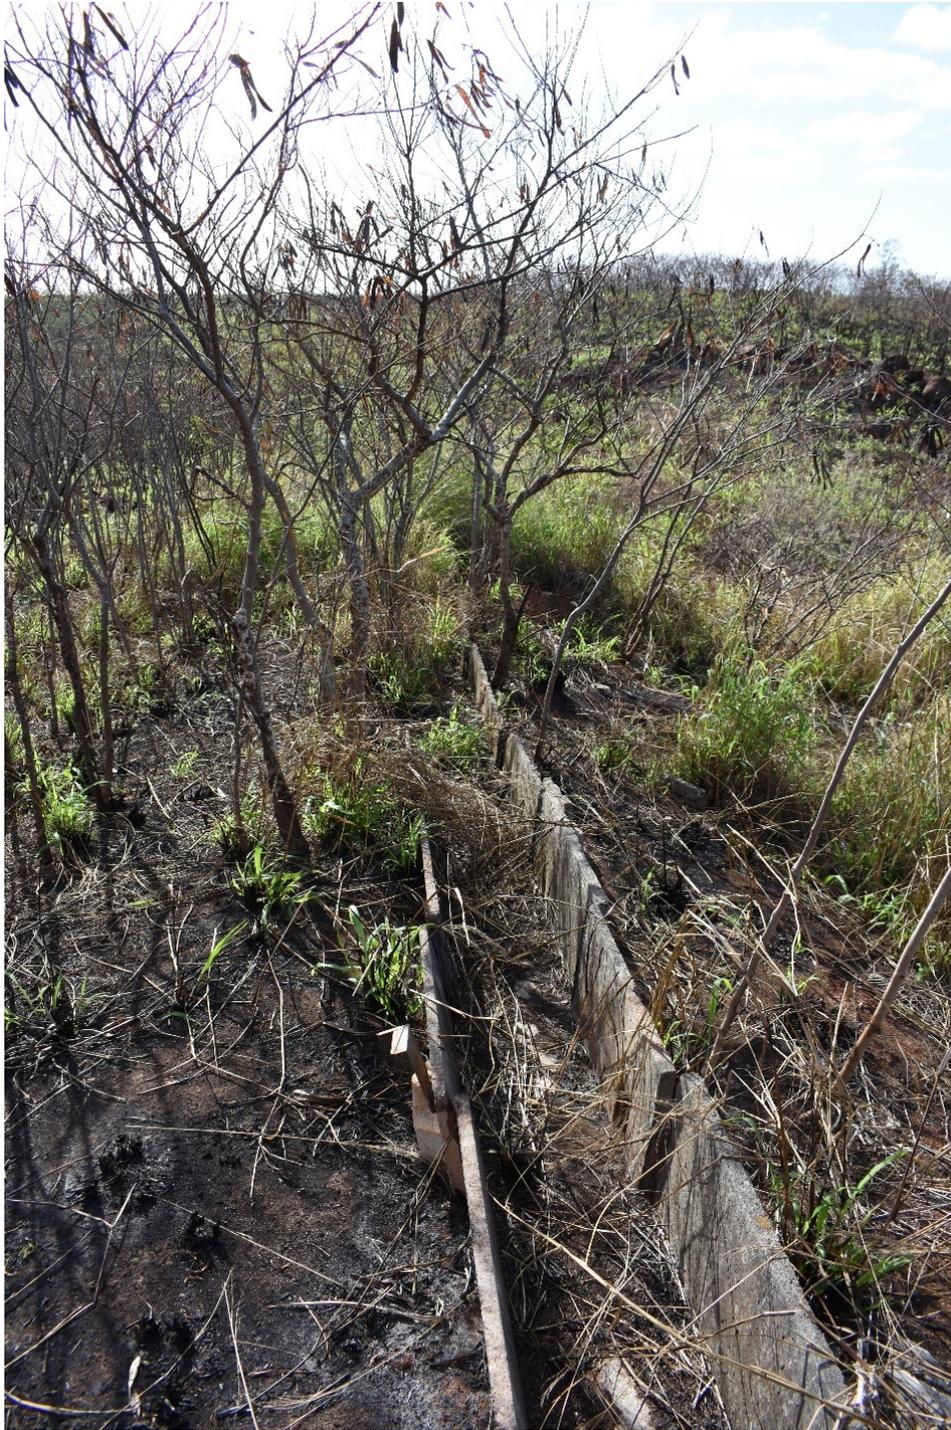
Feature I-6: Flume System (Figures 11 and 12). This is an “areal” feature that expands much of the northern portion of Compound I as well as along the ridgeline. This system is composed of an earthen ditch system, augmented with pre-fabricated concrete flumes, and several concrete and basalt control points to direct water to different areas of the fields. Detailed descriptions, drawings, and photographs of this feature complex can be found in Belcher (2018a). However, an additional 200 to 300 feet of *in situ* concrete flumes were documented on 10 February 2018, a few weeks after a large, estimated 11-acre brush fire. This brush fire did minimal damage (some thermal cracking and spalling of the concrete) to the feature, but did increase the archeological visibility of this feature complex (Belcher 2018b).

Figure 11. Exposed continuation of Feature I-6; view is south. Photograph is after fire in February 2018.

Figure 12. Exposed continuation of Feature I-6; view is east. Photograph is after fire in February 2018.

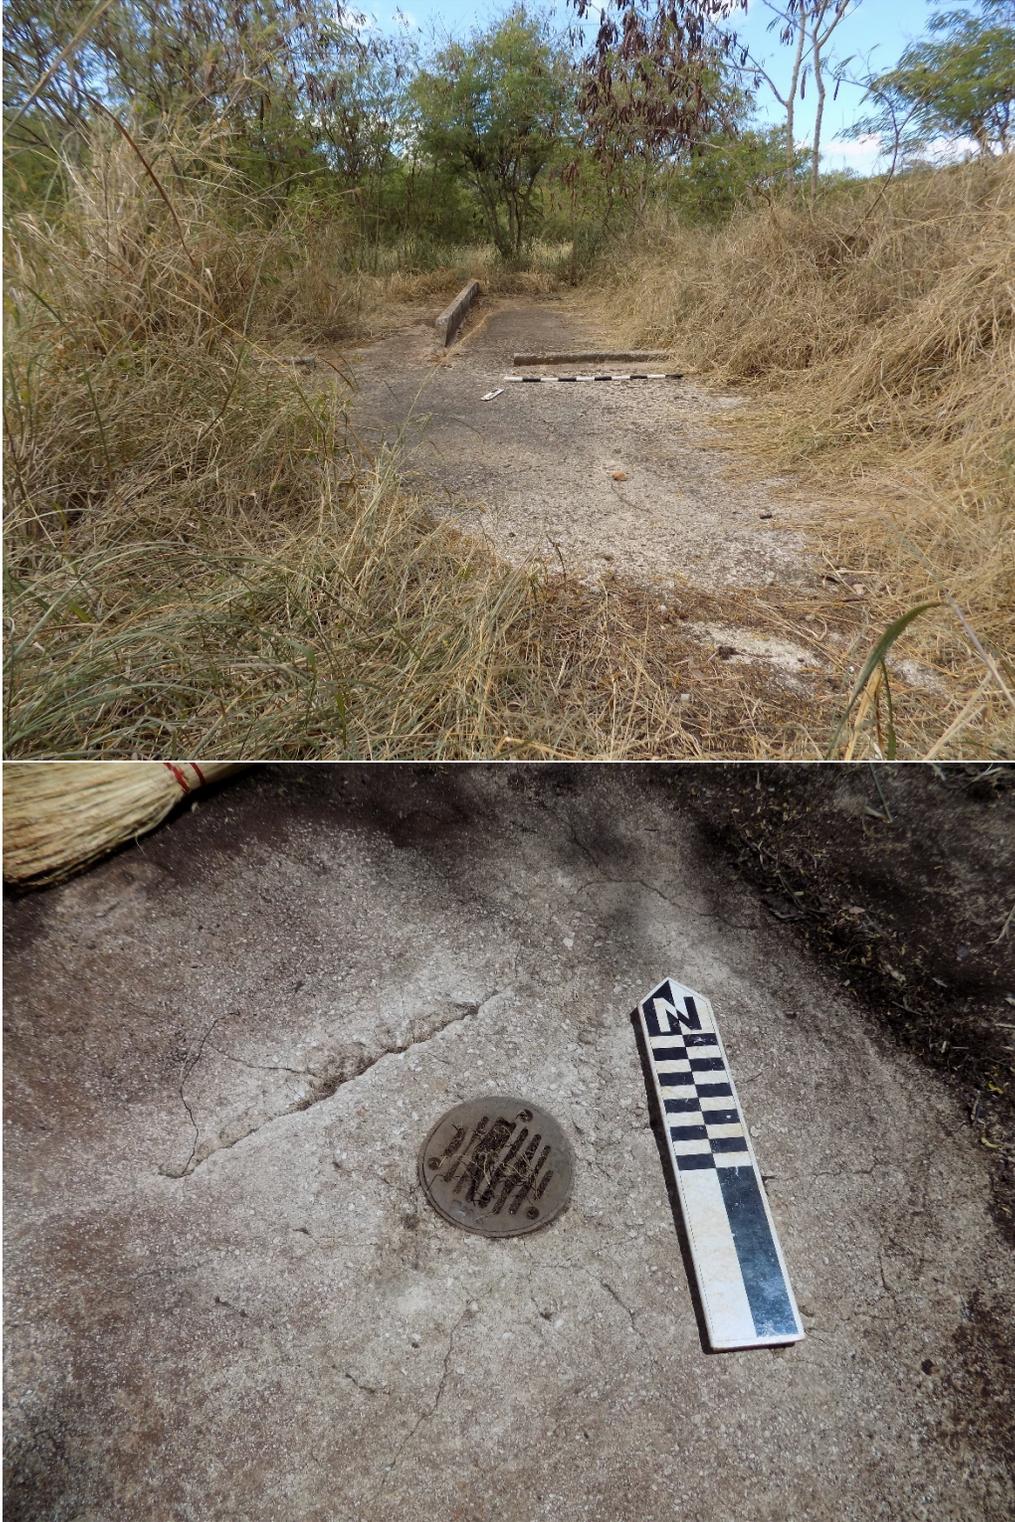
Feature II-2: Shower Building Foundation (Figure 19). This feature was identified as a shower building in the 2012 nomination based on the locations on the U.S. Army Corps of Engineer maps. The north end of the foundation/platform remains buried (so complete measurements were not possible), but it measures approximately 16 feet, 8 inches wide by 35 feet, 3 inches in length. Other shower platforms are 40 feet in length, so Feature II-2 is thought to be similar in dimensions. There is a 4 inch wide raised perimeter; a raised concrete stem wall appears to define at least three rooms, two of which are approximately 8 feet wide by 25 feet long. Interestingly, a concrete repair patch appears just north of the doorway located in the center of the eastern room.

This feature appears in relatively good condition and stable when compared to the 2012 description.

Figure 19. Feature II-2, Shower Building Foundation (top, facing north; bottom, detail of shower drain).

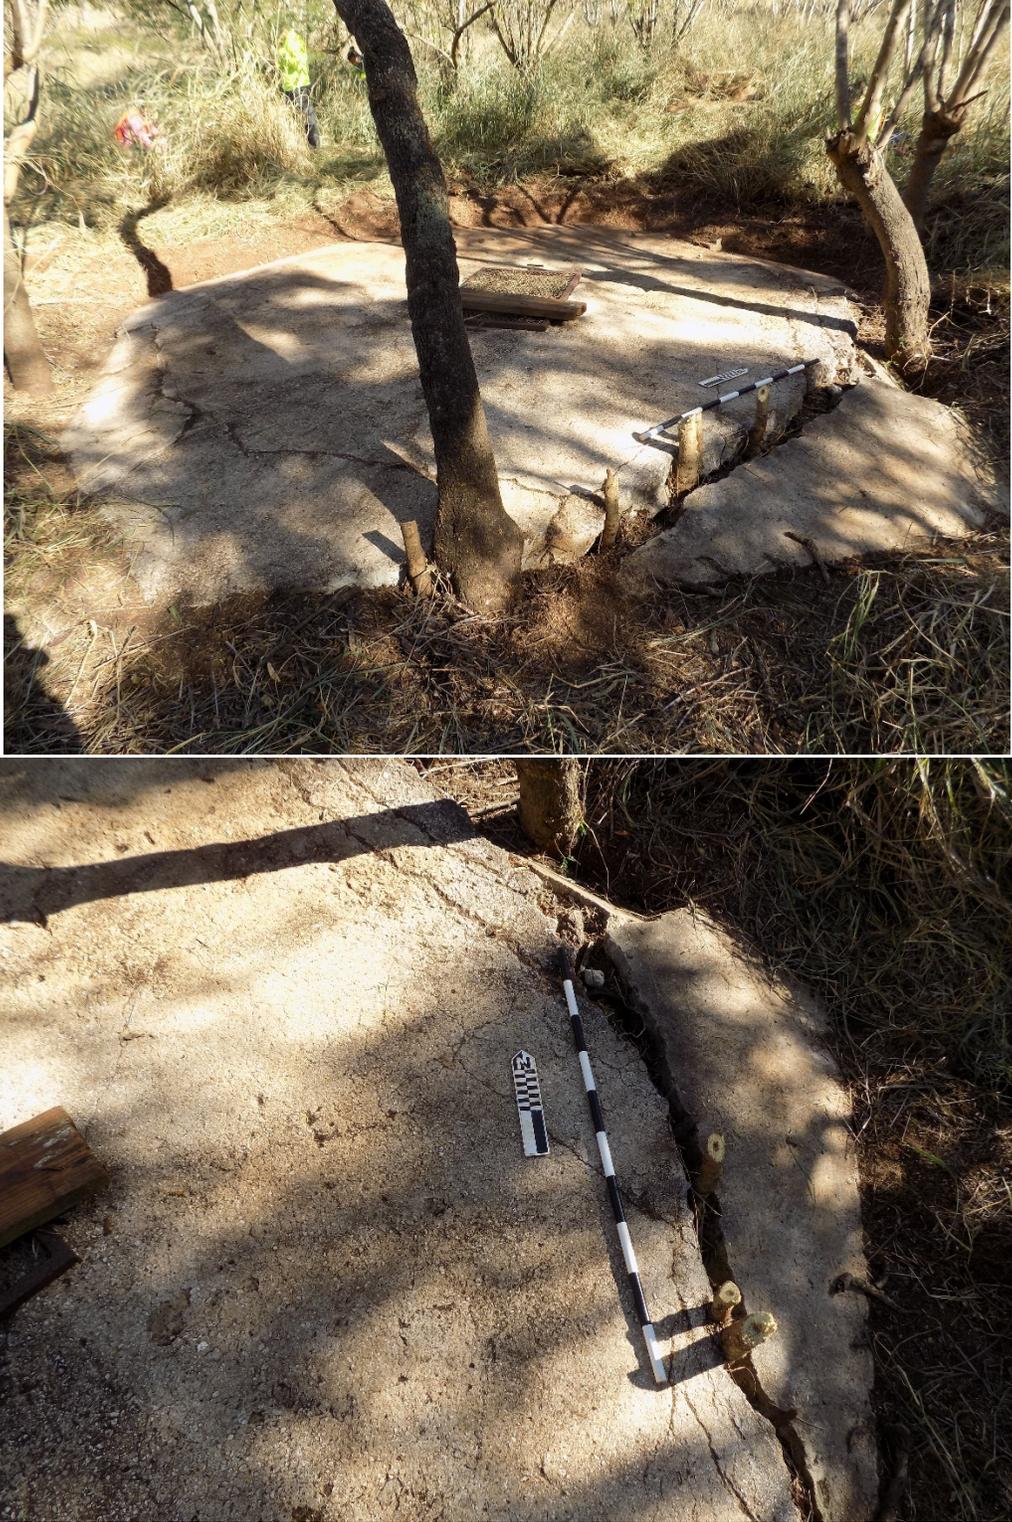
cover. The cesspool is in relatively good condition but still partially buried by sediments and obscured by heavy vegetation. The eastern edge of the octagonal lid has been fractured by *koa haole* growth. The UH West O‘ahu field school attempted to clear the entire area, but did not have sufficient time towards the end of the field school.

Figure 20. Feature II-3, Cesspool (top, general view, facing northwest; bottom, damage from *koa haole* growth).

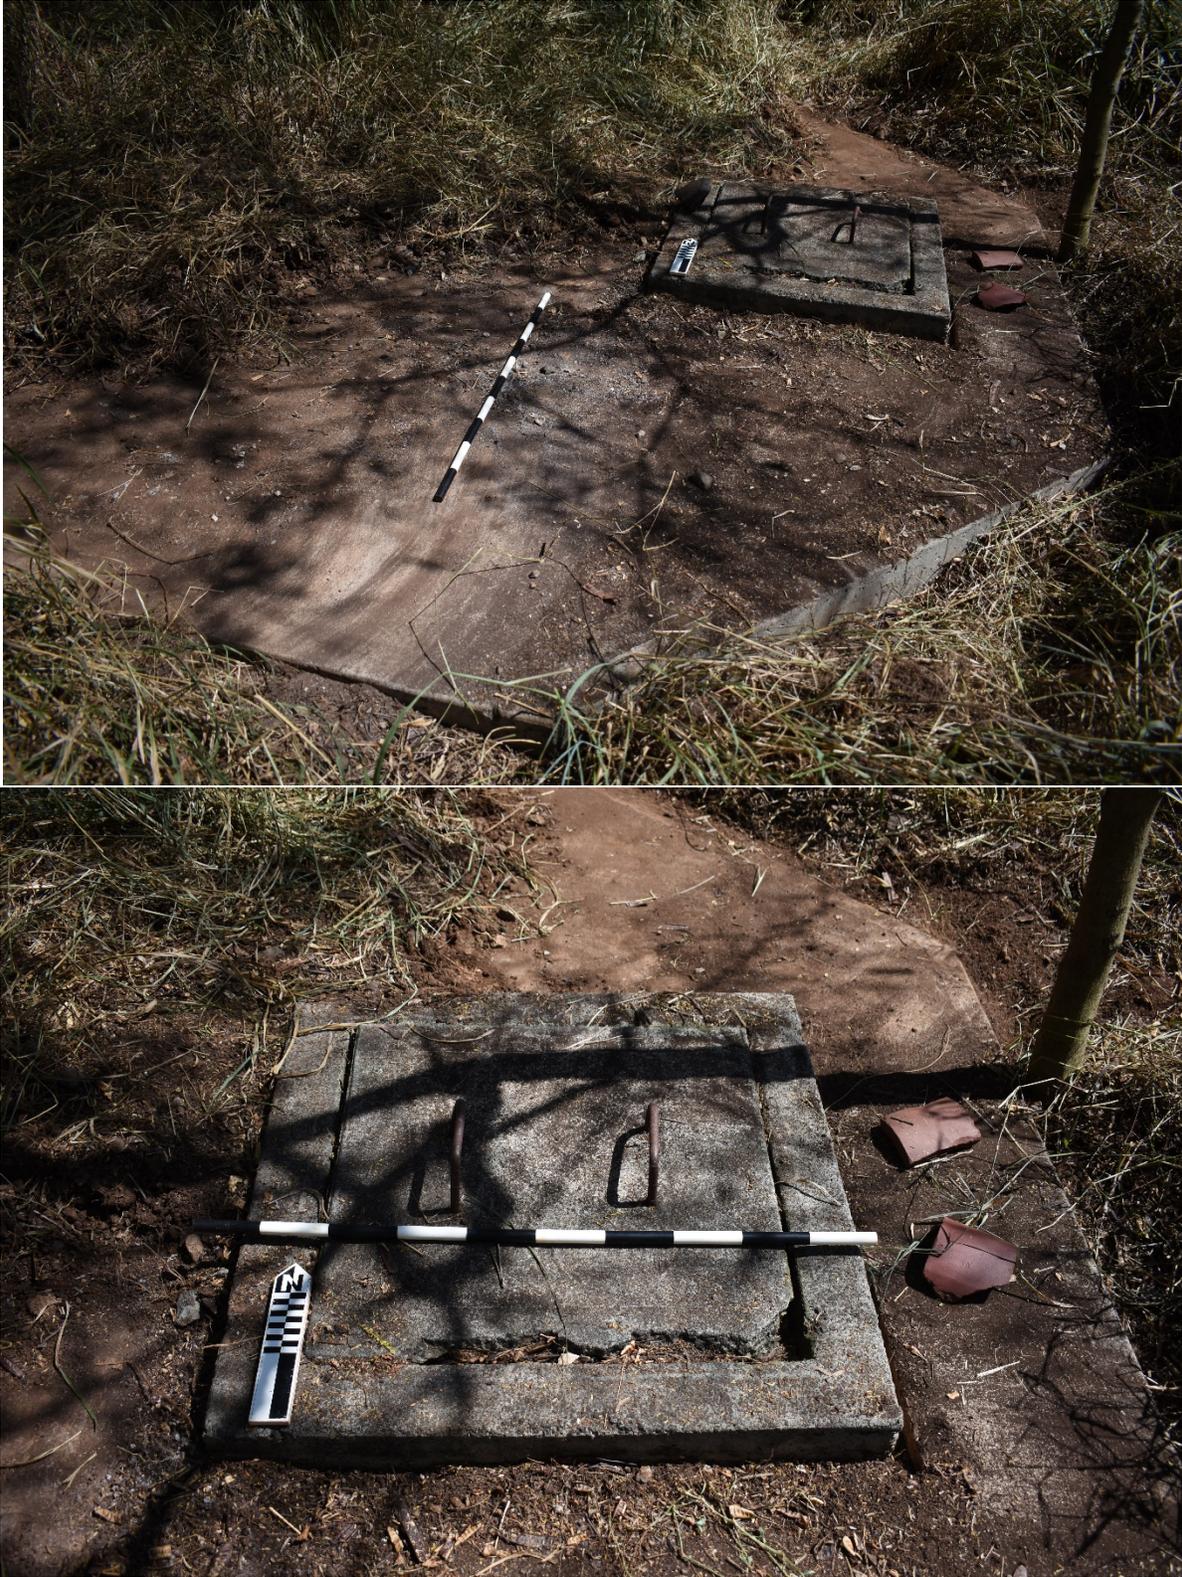
Feature II-4 Cesspool (Figure 21). This feature can be found on the USCOE blueprints and has an octagonal slab on the ground surface, measuring approximately 13 feet across; each side measures 5 feet, 4 inches in length and has a 3-inch rim along the edge. There is a 2-foot square access panel that has an elevated” flange around the panel. When removing the panel, there is a typical block-lined pit below, which is over 15 feet deep. An iron outlet tee pipe (6-inch interior diameter, 10-inch exterior diameter) extends from the southwest wall of the pit. This feature was not completely uncovered during the previous surveys, but the UH West O‘ahu team uncovered most of the octagonal cover. Two fragments of unglazed red ceramic pipe were encountered (but not collected) near this feature.

Figure 21. Feature II-4, Cesspool, partially uncovered, facing north (top overview; bottom hatch detail).

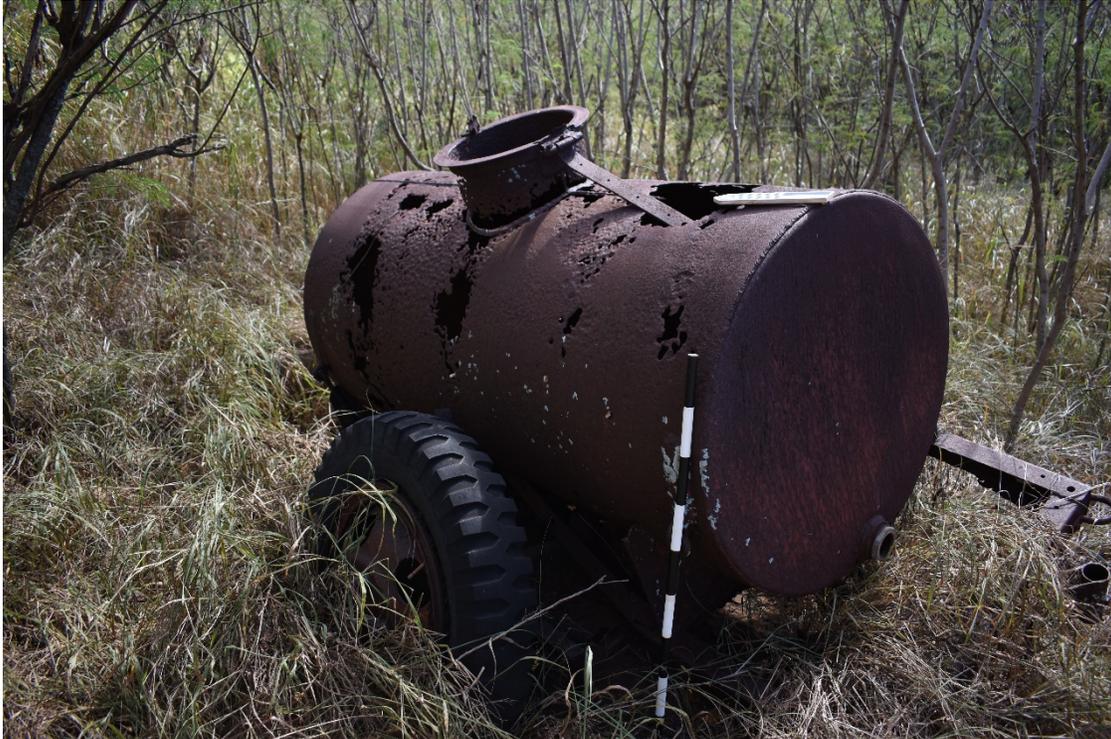
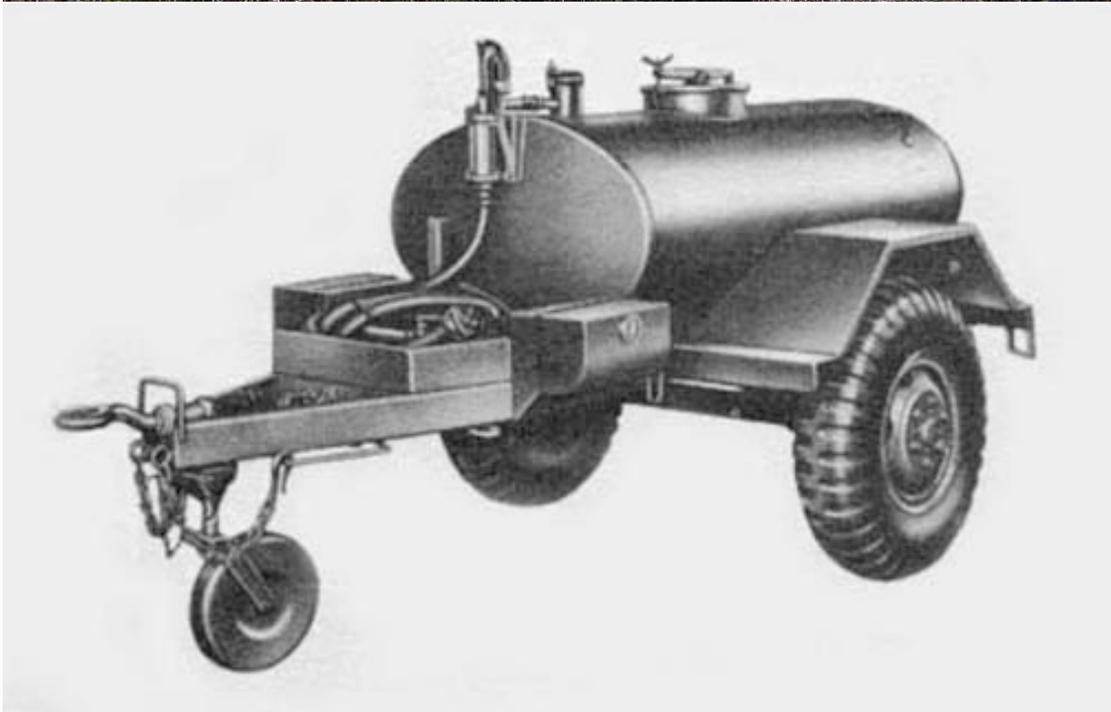
Feature II-24: Water Trailer (“Donkey”) (Figure 29): This item is a cylindrical water tank with central hatch on the upper surface. It is on a welded trailer mount with wheels. Very little of the surface is intact with rust holes and dry-rot damage to the rubber wheels. This consistent with a military water tank, a 1 ½ ton, M106 Trailer with a 400-gallon capacity tank.

Figure 29. Feature II-24, M106 Trailer with Water Tank (top, current condition of feature; M106 Trailer with Water Tank, https://olive-drab.com/images/id_m106_trailer_700_01.jpg).

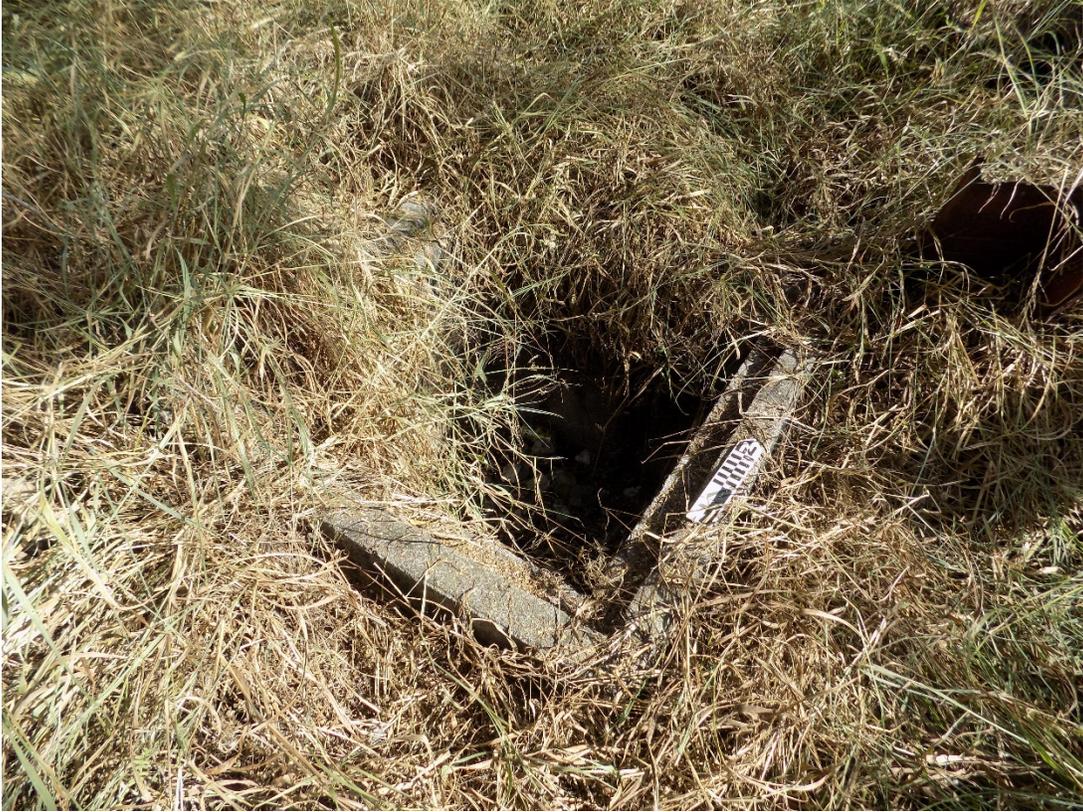
Feature III-2: Concrete Structure (Figure 31). This feature appears as a concrete “box” that is at least 3 feet deep. Two pipes, both with an exterior diameter of 2-inches, enter in the interior, northeastern corner of the feature (the unthreaded pipe enters in the north wall, while the threaded pipe enters the eastern wall). While its function is currently unknown, Burton and Farrell (2012:16) believe it may have housed a water pump. Miscellaneous trash, such as a Kenmore three-burner propane metal stove, window screening, etc. have been dumped into the feature. It appears relatively intact based on previous photographs and descriptions from the 2012 NRHP nomination packet.

Figure 31. Feature III-2, Concrete Structure.

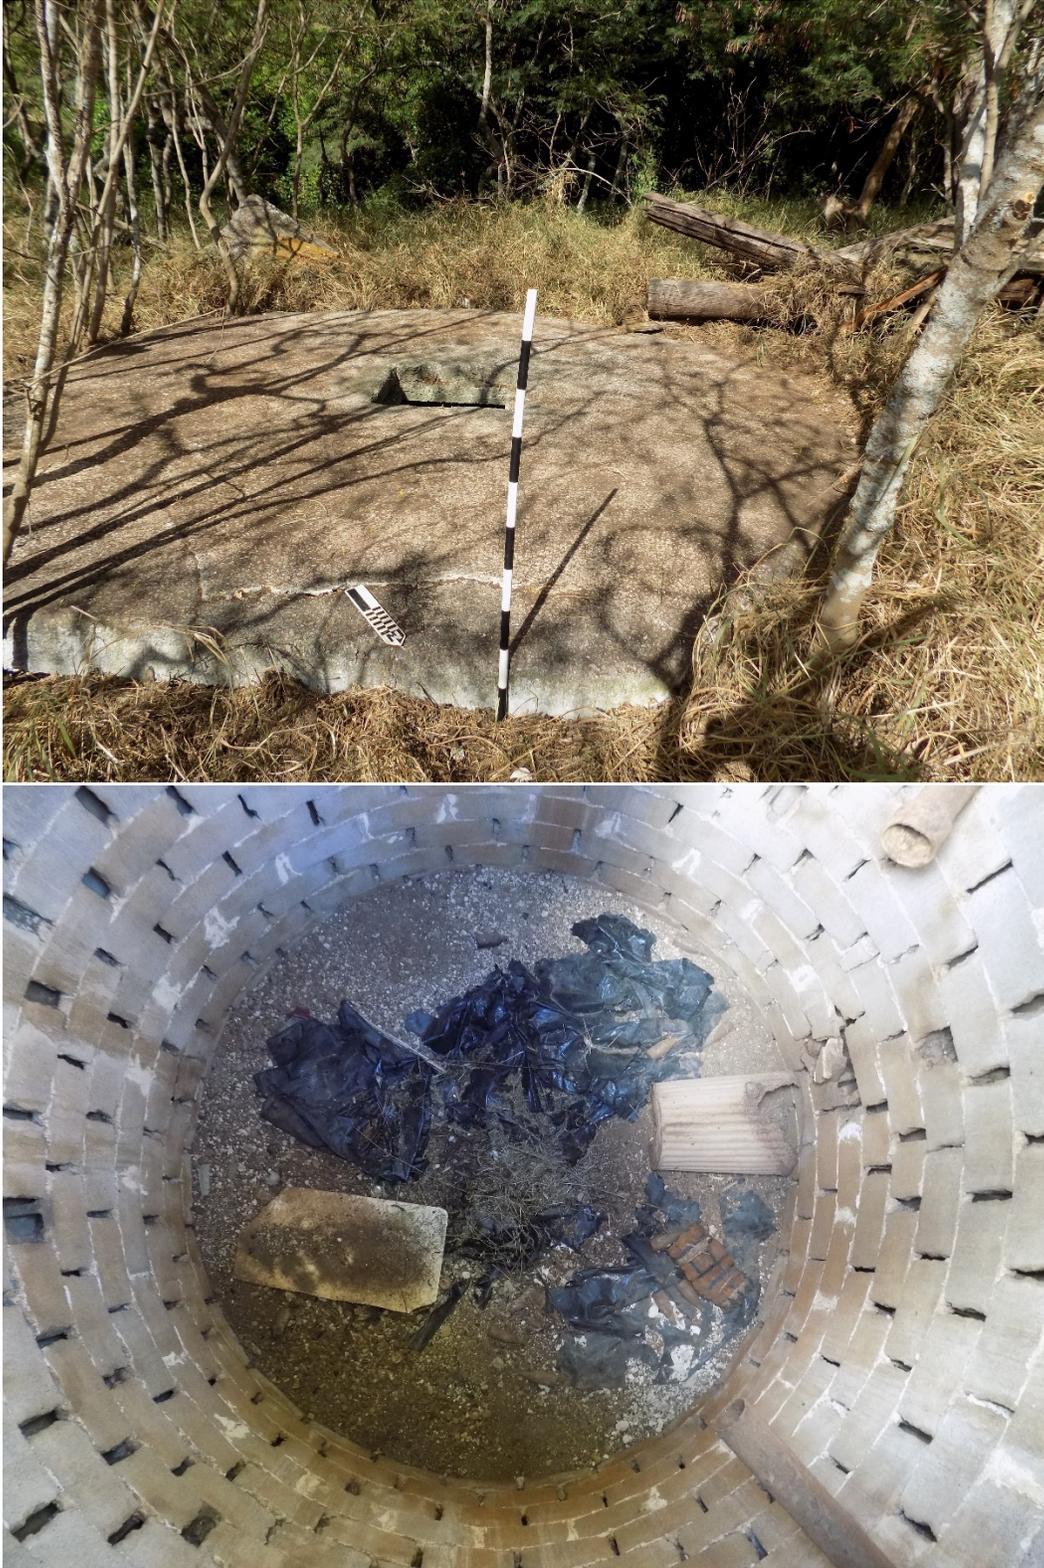
Feature III-3: Cesspool (Figure 32). This cesspool is similar in appearance to previously described cesspools, except the cover is seven-sided and not octagonal. The access hatch is slightly less than 2 feet square and appears closer to the center of the cover. Three pipes enter the side of the cesspool, which is at least 10 feet deep. Trash, such as scrap lumber and a trash can have been thrown inside the feature. The cesspool appears to be in relatively stable condition, although it appears to be filling slowly with sediment through cracks between the cover and the lower stacked blocks that form the cesspool catchment.

Figure 32. Feature III-3, Cesspool (top, general view of cesspool, facing southwest; bottom, interior).

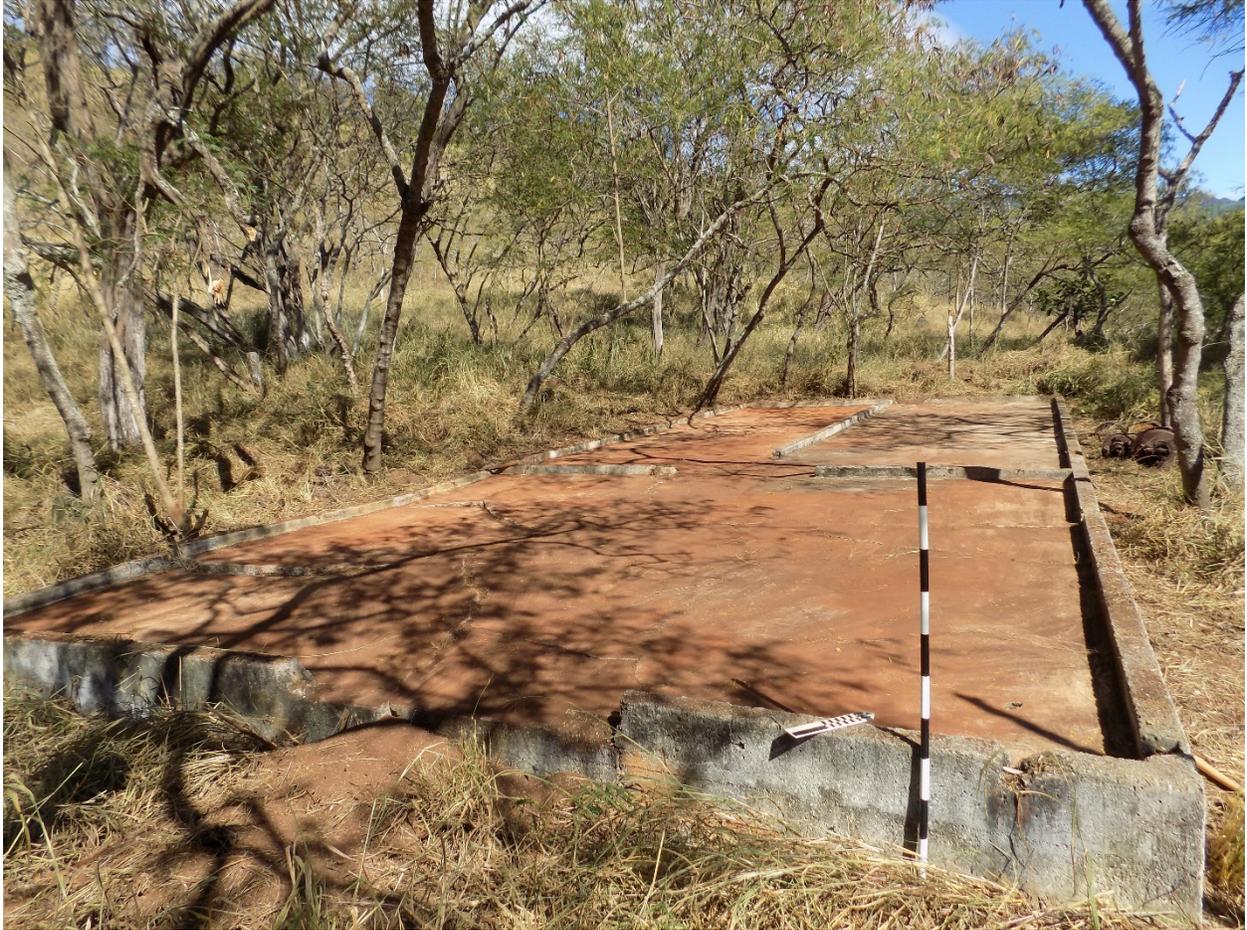
Feature III-4: Shower Building Foundation (Figure 33). This feature is a shower building that is approximately 40 feet long by 6 feet, 9 inches wide. This foundation appears to have been divided into three rooms by concrete stem walls that are 3 to 3 ½ inches above the floor. Various vehicle parts are located near the concrete foundation. The descriptions from the 2012 NHRP nomination form suggest little change to the feature since its discovery in 2008.

Figure 33. Feature III-4 Shower Building Foundation, facing northwest.

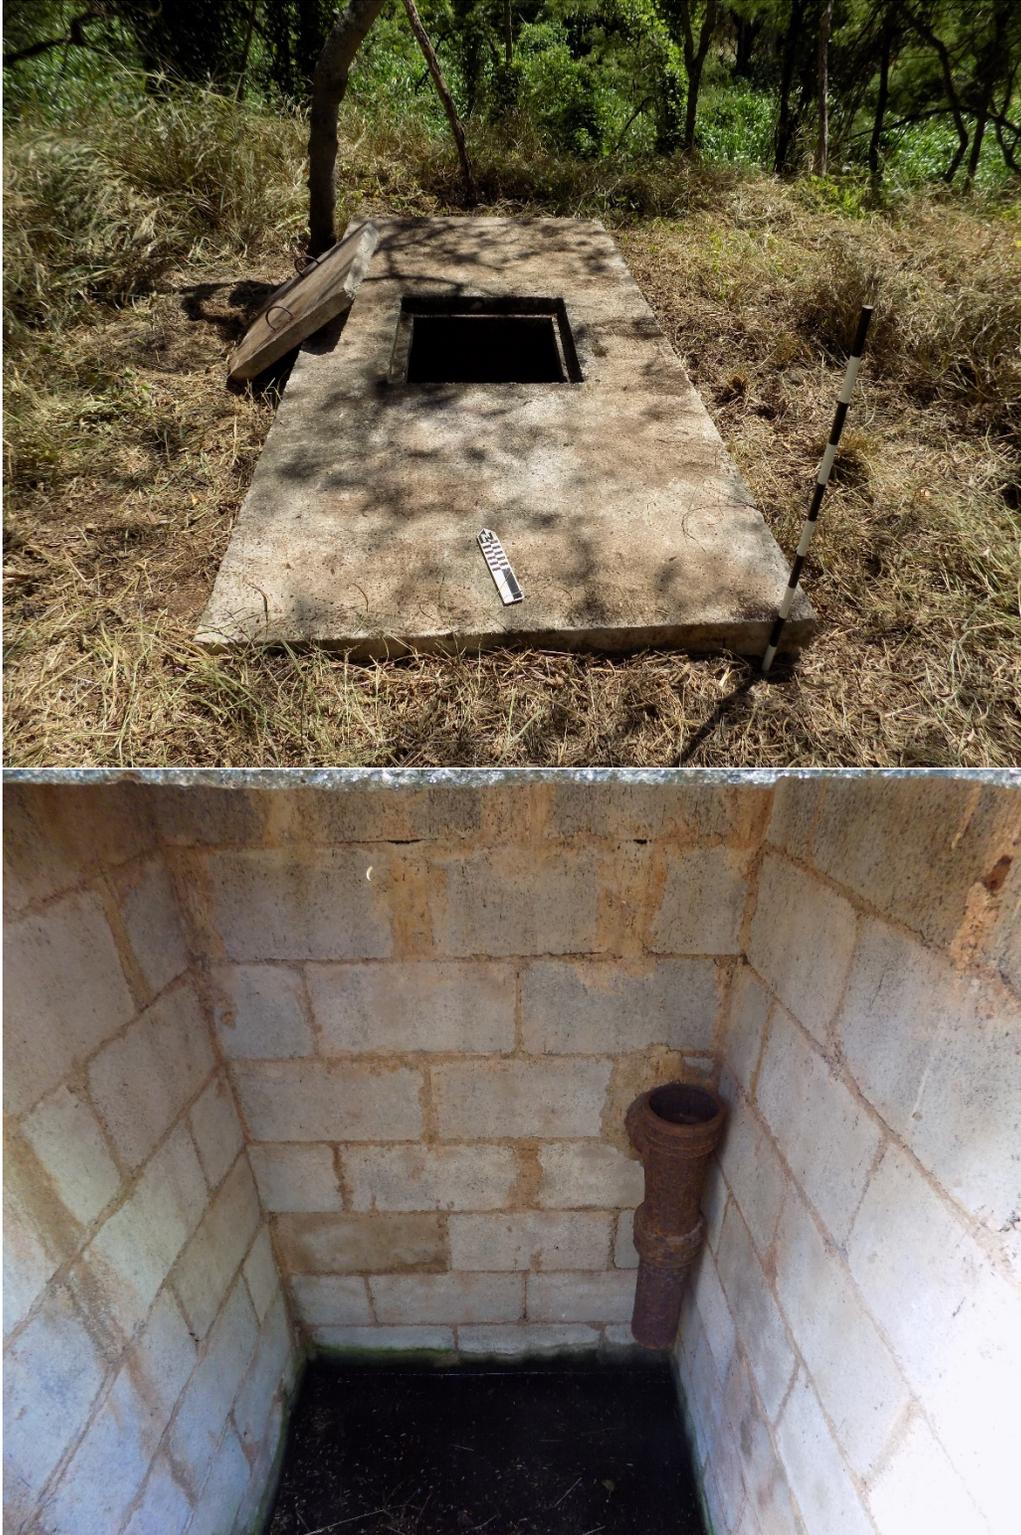
Feature III-5: Septic Tank (Figure 34). This feature is located near (within 6 feet) Feature III-4 (Shower Building Foundation) and measures approximately 5 feet by 9 feet, 3.5 inches. There is a square (2 feet, 4 inches) access panel with a raised concrete flange, near the center of the surface slab. The interior is at least 6 feet deep with water present at the bottom. Two cast iron pipes enter the tank uphill and there is a cast iron outlet t-joint on the downhill wall. This feature appears to be in similar condition with the NHRP nomination form.

Figure 34. Feature III-5, Septic Tank (top, surface view, facing north; bottom, interior of tank).

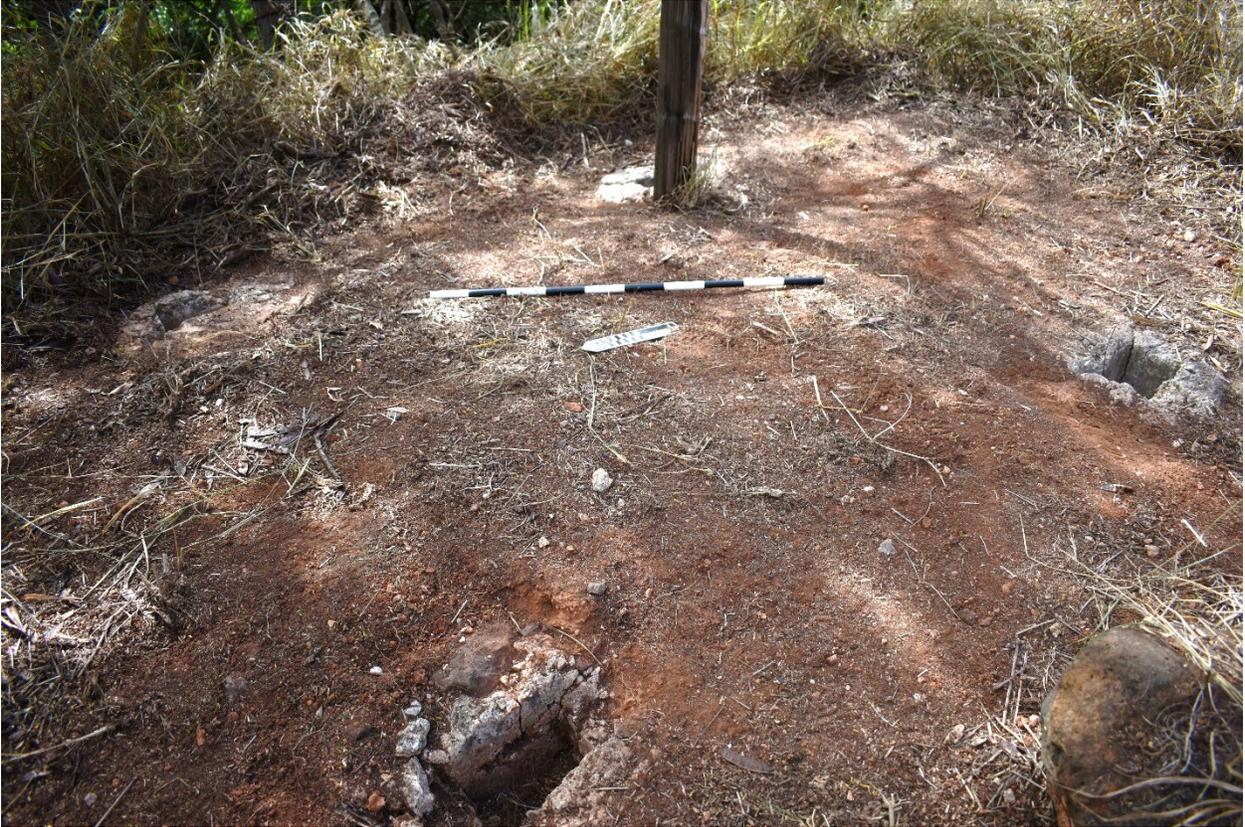
Feature IV-2: Guard Tower Footings (Figure 37). These guard tower footings were completely buried and had to be uncovered to be relocated and assessed. The guard tower footings are almost directly across from Feature L-2 siphon and footings on the east side of the road. Each footing was composed of concrete poured in a circular hole that held a rectangular post (now a post hole). The post holes are approximately 5-x-8-inches in size but vary slightly. The outline of these postholes forms a square that is approximately 6 feet on a side. A deteriorated fence post that measures 4.5-x-5-inches is set directly into the ground adjacent to the footings; however, based on the composition and similar fence posts, it is thought that this post is from the post-camp occupation of the site. This feature is in relatively good condition when compared to pre-2018 photographs and descriptions.

Figure 37. Feature IV-2 Guard Tower Footings, facing east.

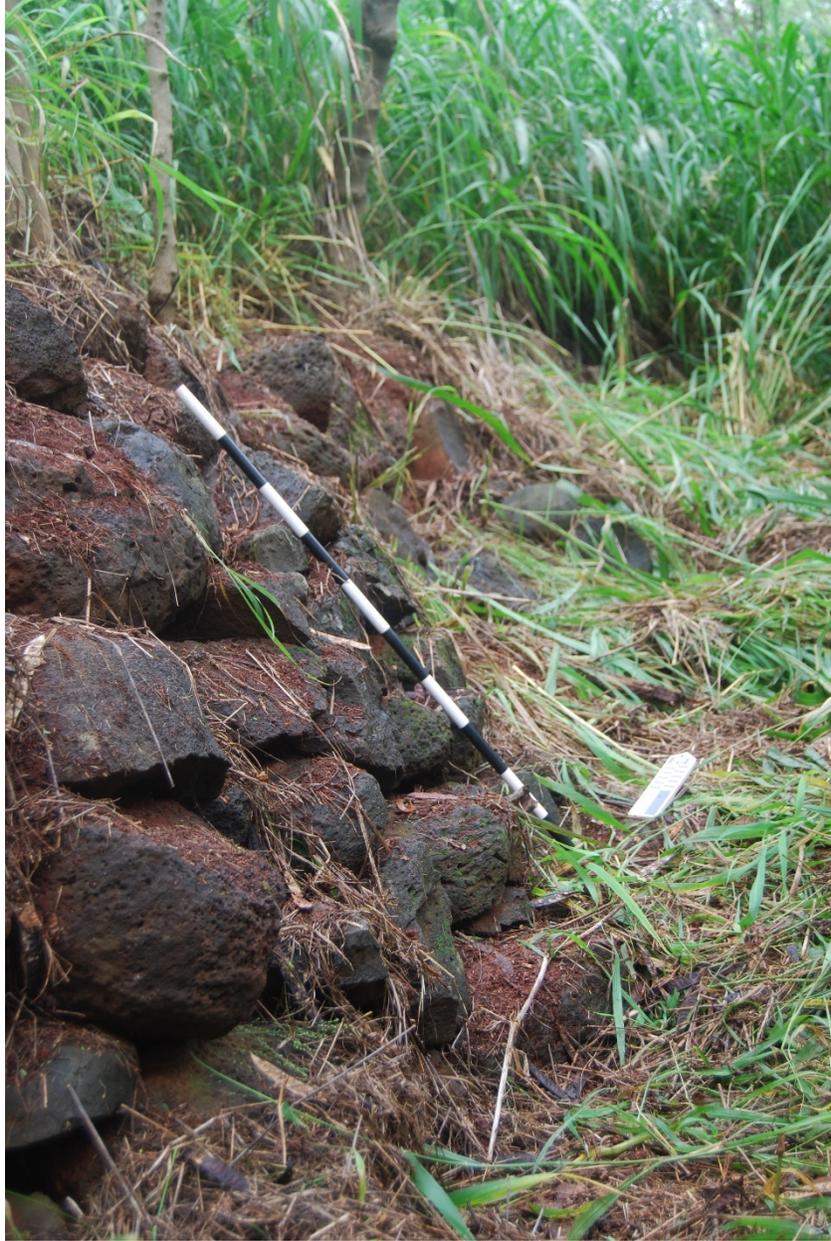
Feature V-11: Rock Wall (Figure 42). This feature is a dry-stack basalt rock wall composed of cobbles and boulders of various sizes. It is over 200 feet long with the northern 185-foot section well-constructed and intact; the southern portion has partially collapsed. The 2012 NRPH nomination form mentions tomato plants, mock orange, and togan (winter squash) present; these were not observed during the 2018 field season. The condition appears similar and it appears stable. Currently, no GPS coordinates were recorded for this feature.

Figure 42. Feature V-11, Rock Wall.

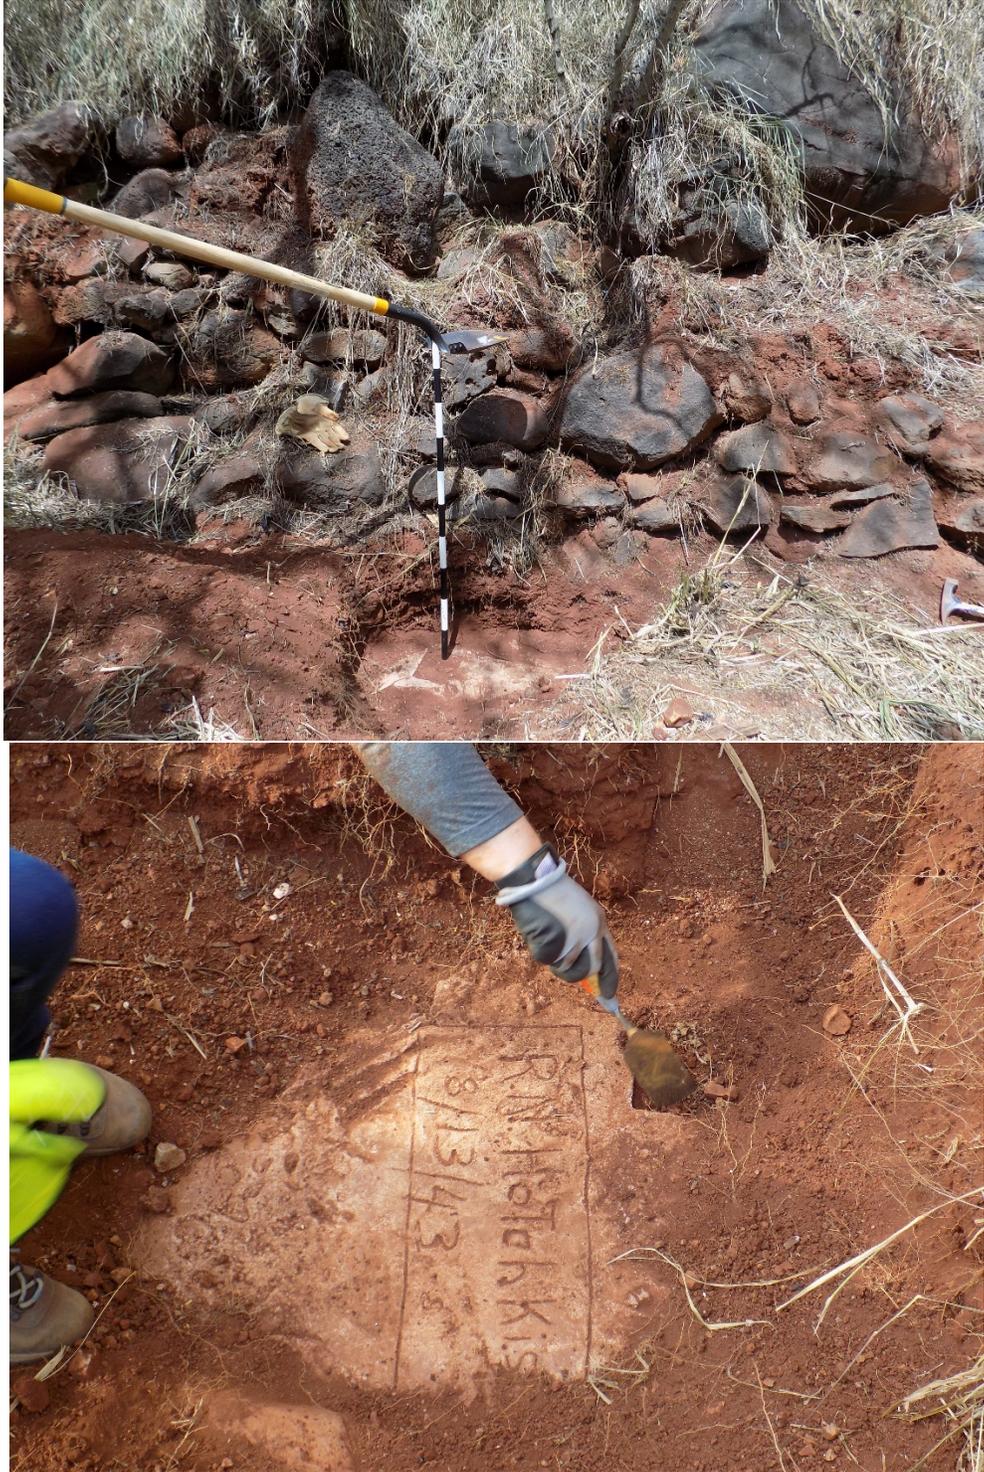
Feature V-13: Posthole (Figure 43). This feature is a concrete posthole. This concrete-lined post anchor appears set in the ground (the post is now missing) and measures 4-x-6-inches. Burton and Farrell (2012:20) suggest that this fence post may have been used to subdivide the various sections of Compound V. This posthole appears stable. Nearby this posthole is a thin veneer of concrete with the inscription “R.N. HoTchkiss 8/13/43”. The veneer of concrete is actively cracking along its edges and may eventually damage the actual inscription.

Figure 43. Feature V-13, Posthole (upper, detail of posthole; lower, check on buried inscription, “R.N. HoTchkiss 8/13/43”).

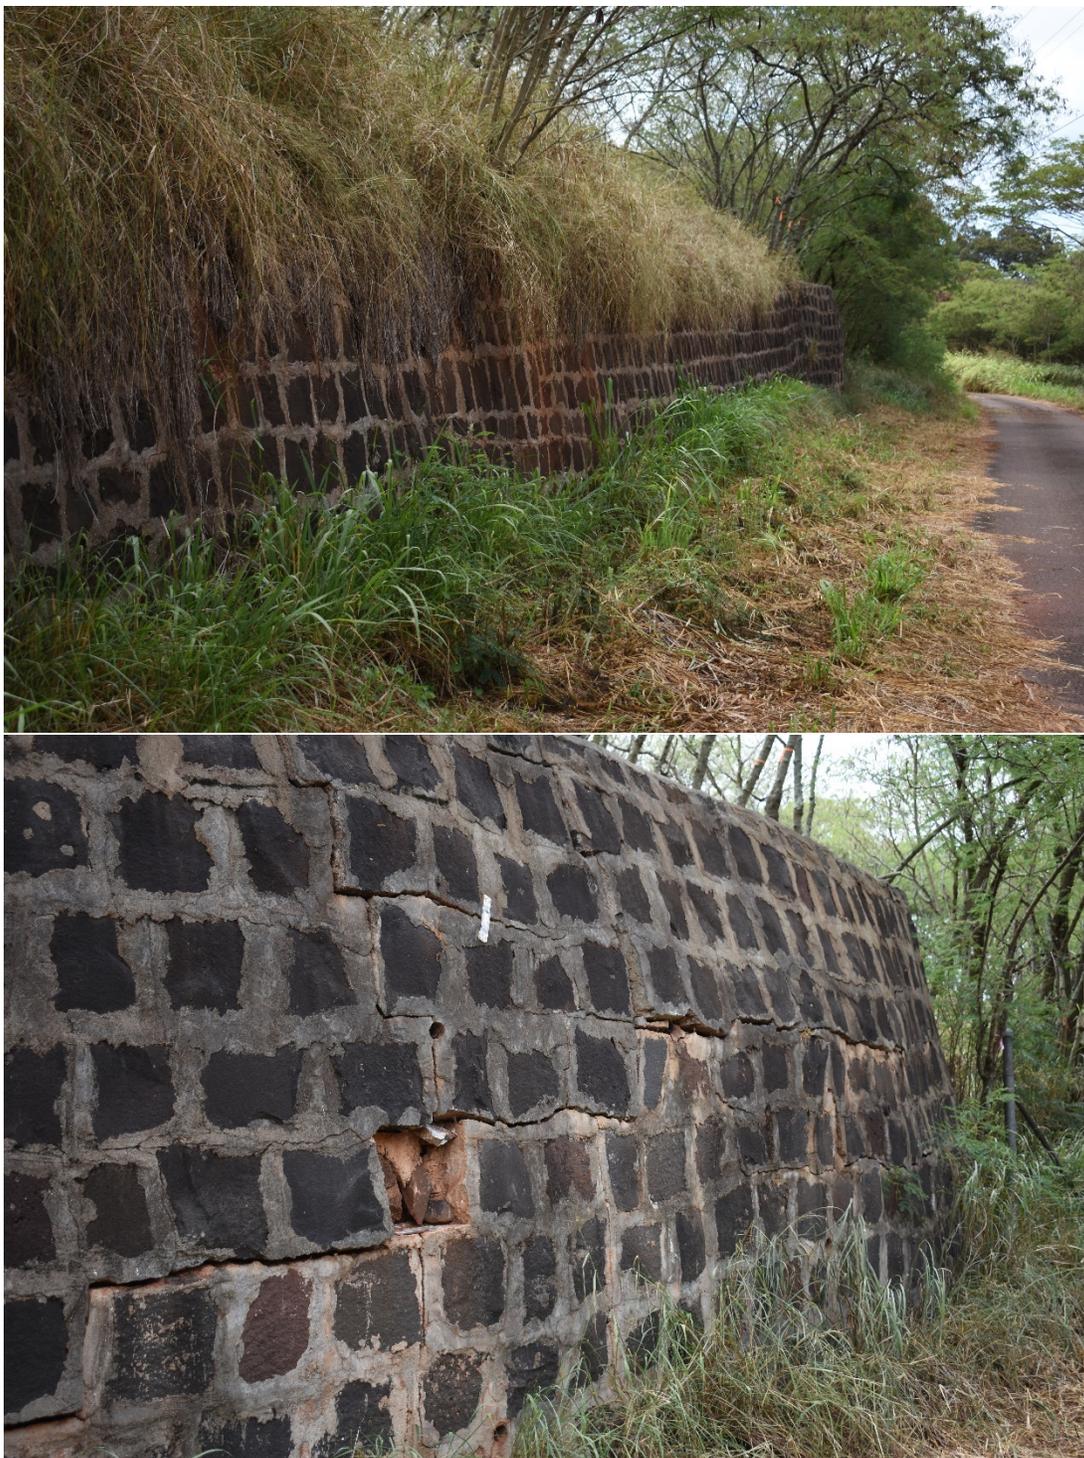
Figure 44. Feature V-15, Rock Wall (upper, southern portion of wall, facing south; lower, bowing and cracking of 1955 wall repair).

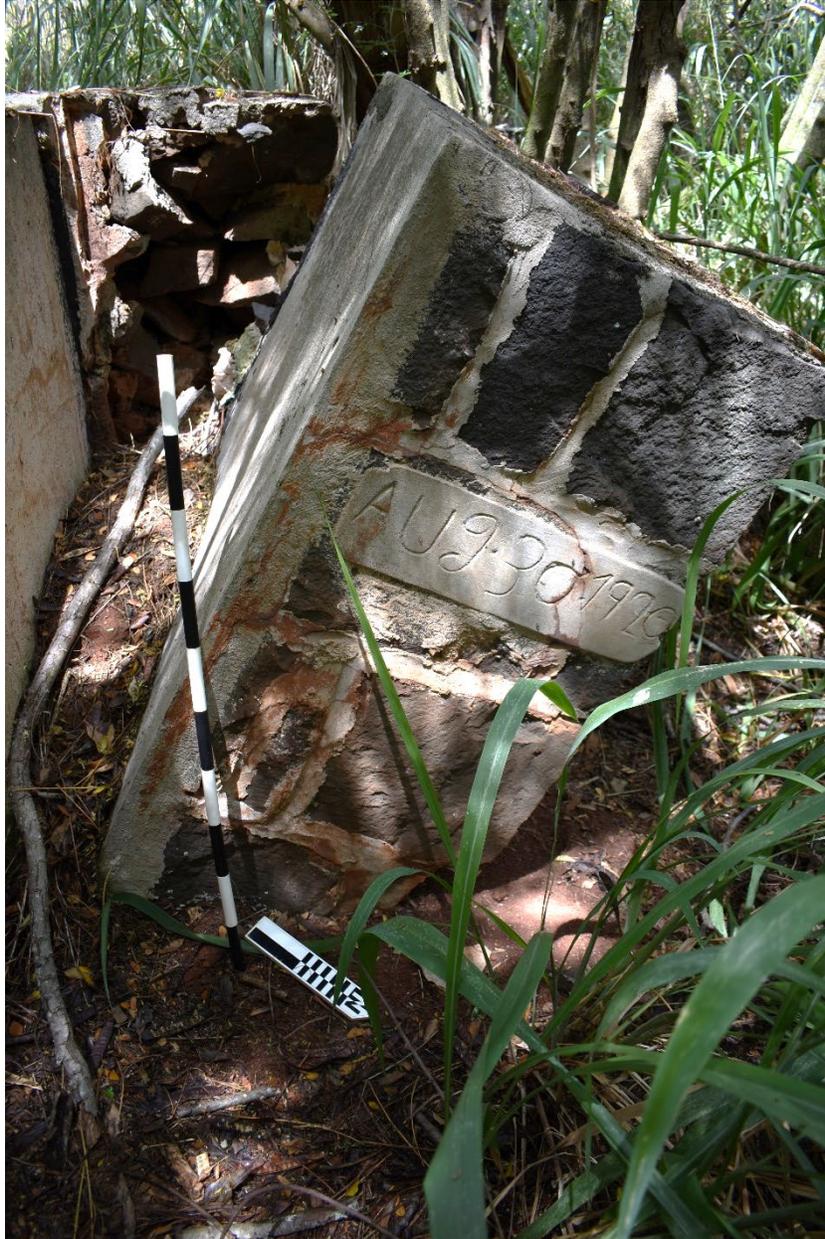
Feature L-1b Concrete Pier with date (Figure 67). On the western side of Honouliuli Stream, the northern pier has collapsed during flooding in spring 2016; this pier has a written inscription on it that dates the construction of the aqueduct to August 1920 (the inscription reads “08 30 1920”). It should be noted that these piers on this western side of the main aqueduct do not appear to be structural in nature and don’t support the rectangular aqueduct. This main pier is rectangular in cross-section and composed of dressed basalt blocks with concrete mortar. The area with the inscription on it is created using a small veneer of concrete. The pier appears stable in its current configuration, but the inscription veneer could be easily damaged.

Figure 67. Feature L-1b, Concrete Pier with Date.
