ARCHEOLOGICAL FEATURE ASSESSMENT AT HONOULIULI NATIONAL HISTORIC
SITE: APPENDIX B – THE 2018 UNIVERSITY OF HAWAI‘I WEST O‘AHU
ARCHEOLOGICAL FIELD SCHOOL

WILLIAM R. BELCHER

15 JULY 2019

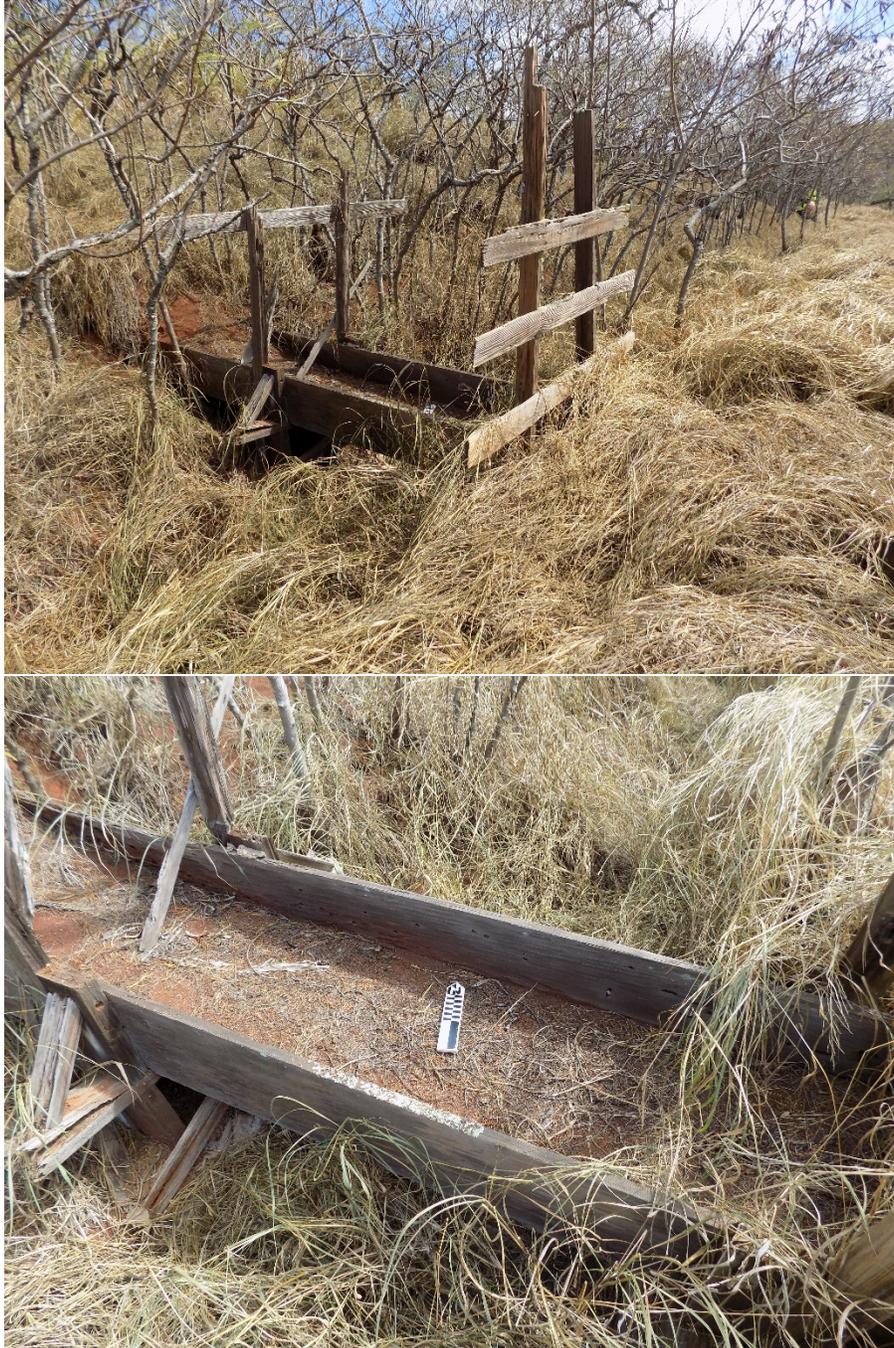
Feature L-1f Wooden Flume (Figure 71). This is a roughly constructed wooden flume built over the top of the irrigation ditch system in Guard Camp Area VI, but almost at the top of the ridgeline of the southwestern side of Honouliuli Gulch. It is relatively intact and due to its remoteness, it is relatively safe from any vandalism. However, it should be noted that it is exposed to the sun and is actively in the process of dry rotting.

Figure 71. Feature L-1f, Wooden Flume (top, general view, facing northwest; bottom, detail of flume tray, facing north).

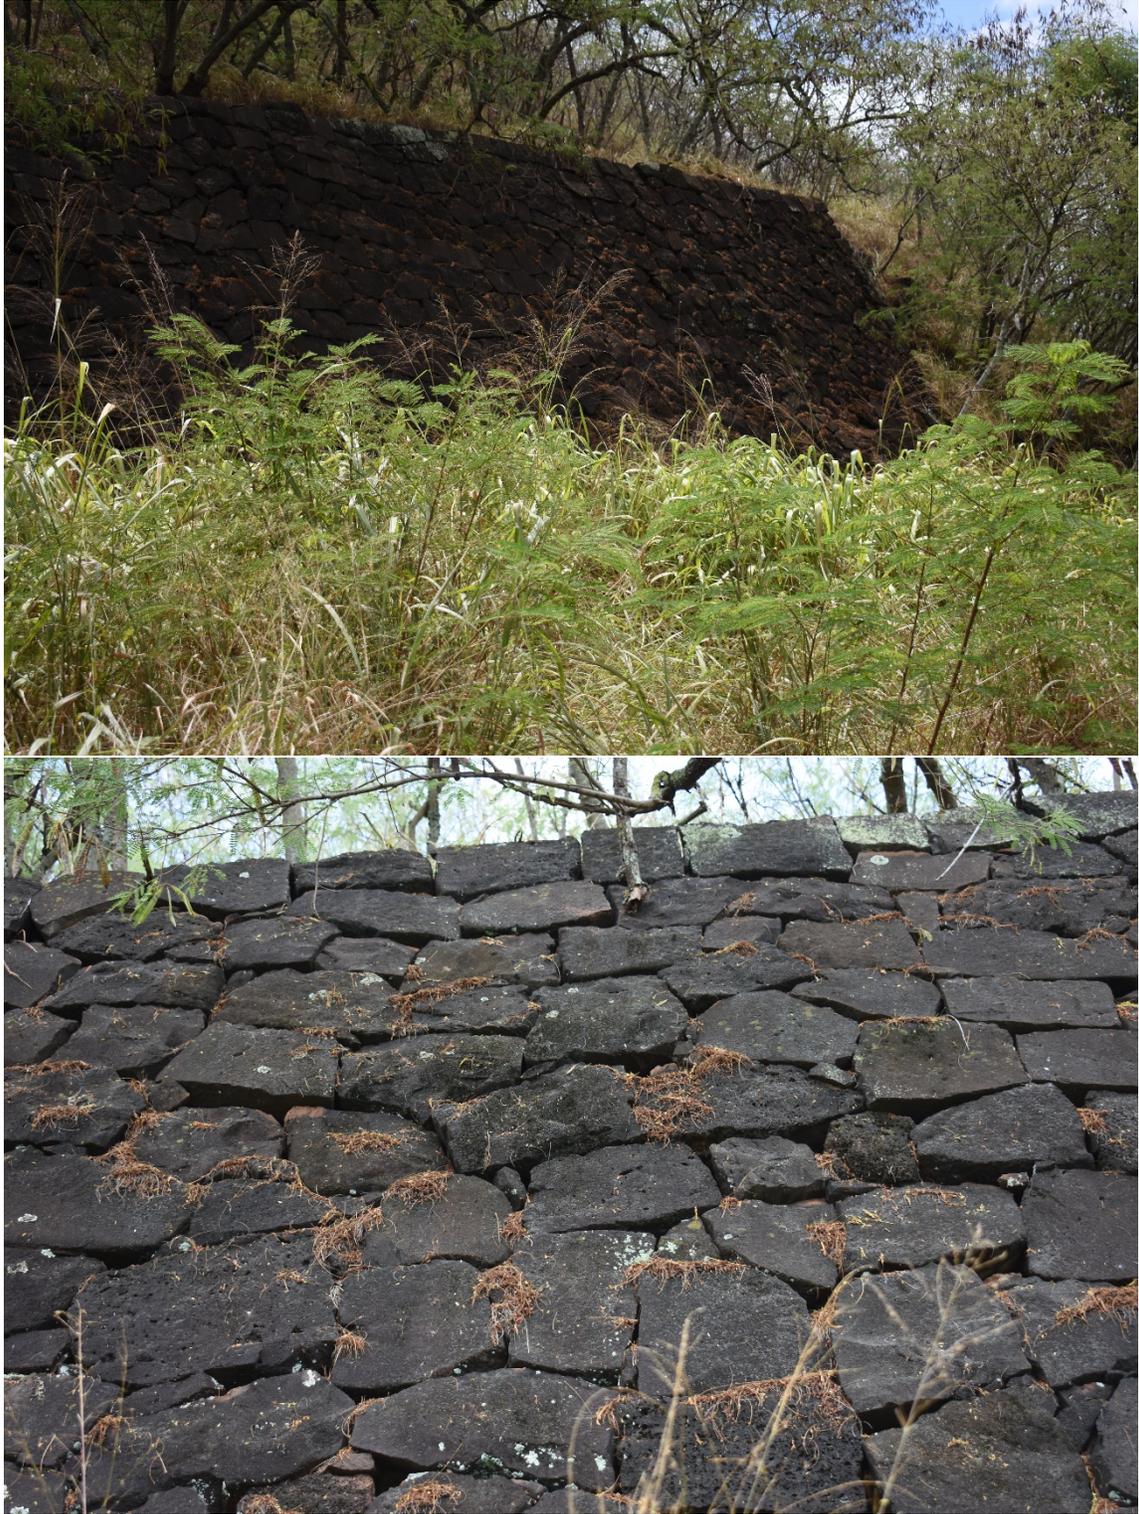
Feature L-1g Rock Wall (Figure 72). This feature is a dry stack retaining wall above the irrigation ditch along the east side of the main concrete aqueduct. This wall is approximately 220 feet and 1 to 2 feet wide; it ranges from the edge of the road to over 19 feet tall at the southern end. The wall decreases in height to the north and curves to meet the road and the siphon into the concrete aqueduct (Features L-1a). While this wall is in good shape, because it is a dry-stack wall, stones can be loosened, especially from the top portion of the wall, along the old road. Any construction or testing along this road should be done with caution as it may cause erosion and collapse of the wall.

Figure 72. Feature L-1g, Rock Wall (top – overview of wall facing south-southeast; bottom – detail of dry-stack technique).

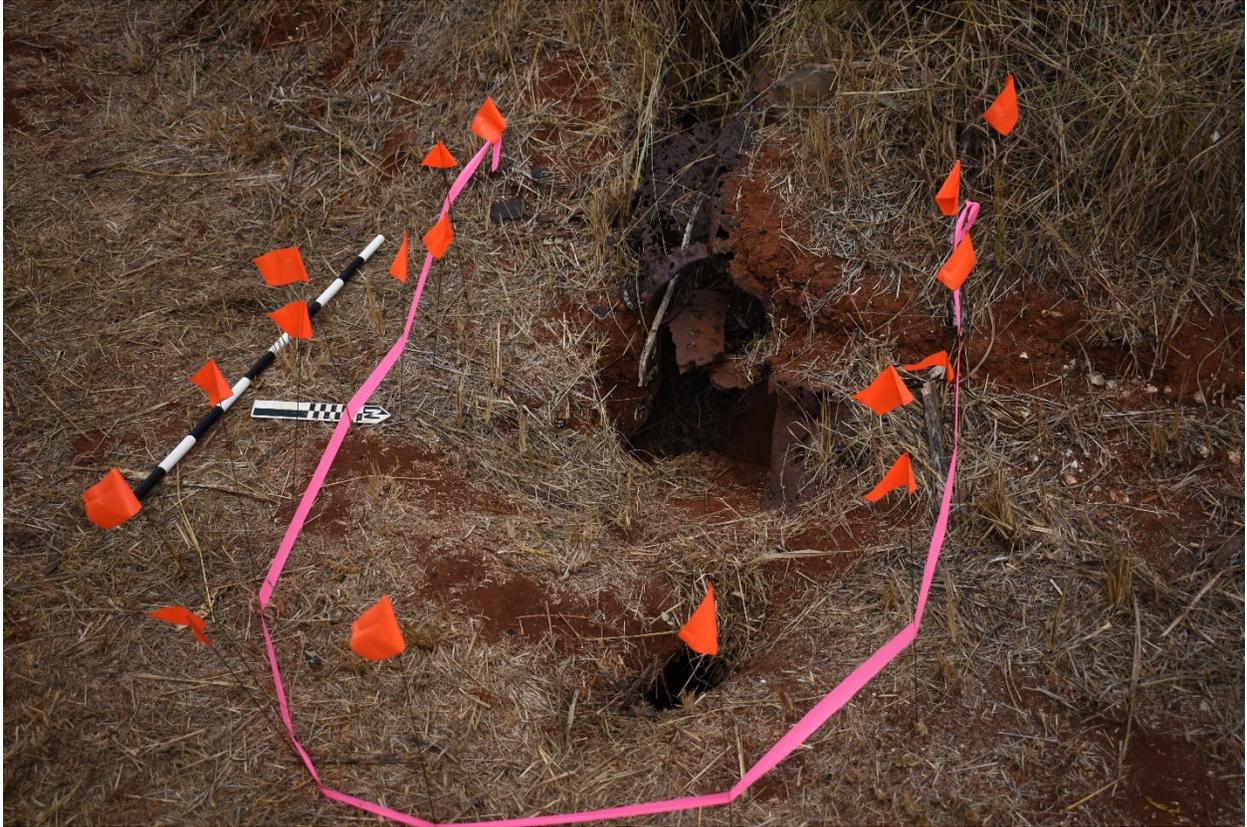
Figure 75. Feature L-2a, Metal Siphon. This portion of the feature is buried under the western road into the national historic site and is actively collapsing.
