ARCHEOLOGICAL FEATURE ASSESSMENT AT HONOULIULI NATIONAL HISTORIC
SITE: APPENDIX C – THE 2019 UNIVERSITY OF HAWAI‘I WEST O‘AHU
ARCHEOLOGICAL FIELD SCHOOL

WILLIAM R. BELCHER

HAWAI‘I-PACIFIC ISLANDS COOPERATIVE ECOSYSTEM STUDIES UNIT

21 NOVEMBER 2019

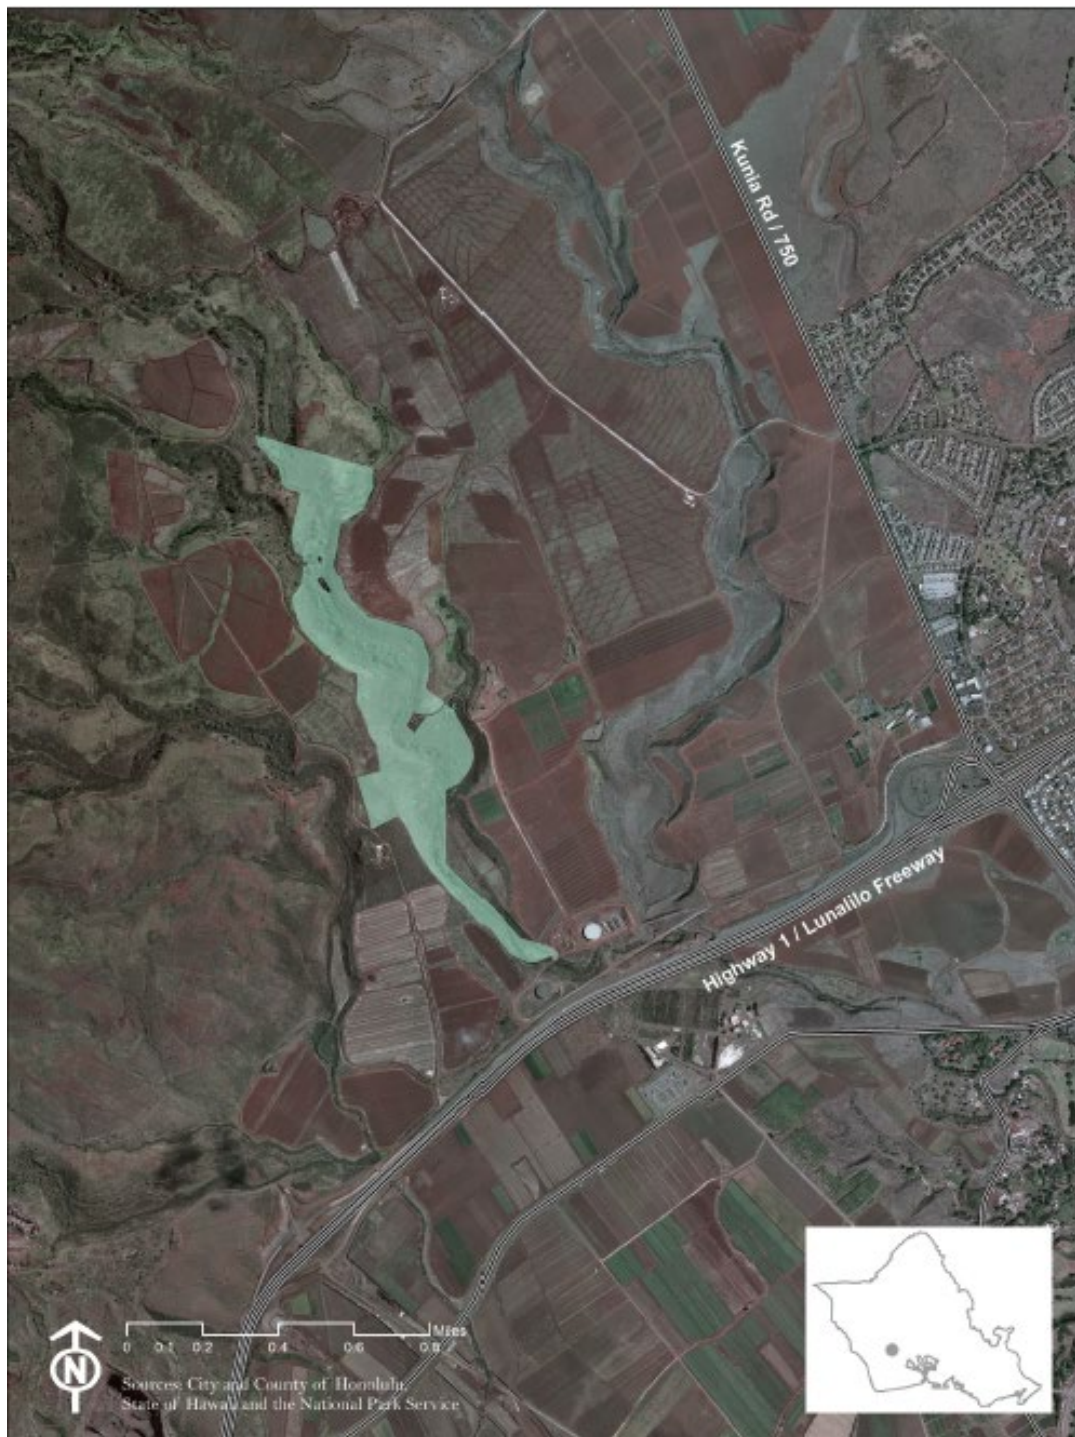
Figure 1. General outline of Honouliuli National Monument.

The Honouliuli National Historic Site is located on the island of O‘ahu, Hawai‘i about 15 miles northwest of Honolulu, north of Highway H1, and west of the Kunia Road. This site encompasses approximately 160 acres and is located within Honouliuli Gulch, roughly 6 miles *mauka* (inland) from the coast. The gulch varies from about 500 to 700 feet wide at the camp location, with steep slopes bounding the relatively flat floodplain, and is mostly surrounded by commercial agricultural land (Figures 1 to 6). Elevation ranges from 280 feet above mean sea level (AMSL) along the Honouliuli Stream at the southern end of the site to up to 520 feet AMSL on the slopes at the north end of the site (see Figures 5 and 6).

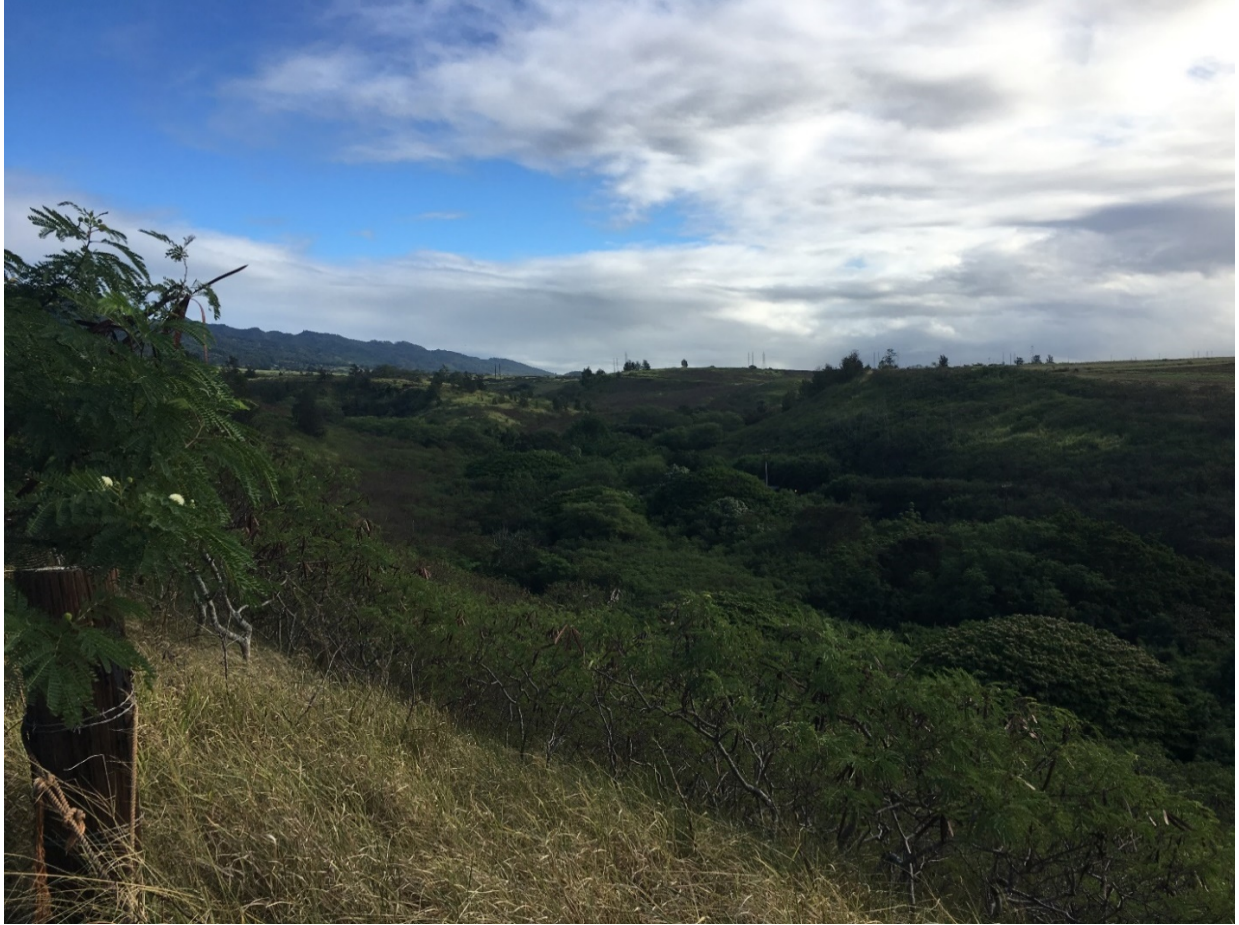
Figure 5. Overview of Honouliuli National Monument, view is northwest towards Compounds I, II, and III, from UH West O'ahu Access Road; view in foreground is Compounds V and VI. May 2017.

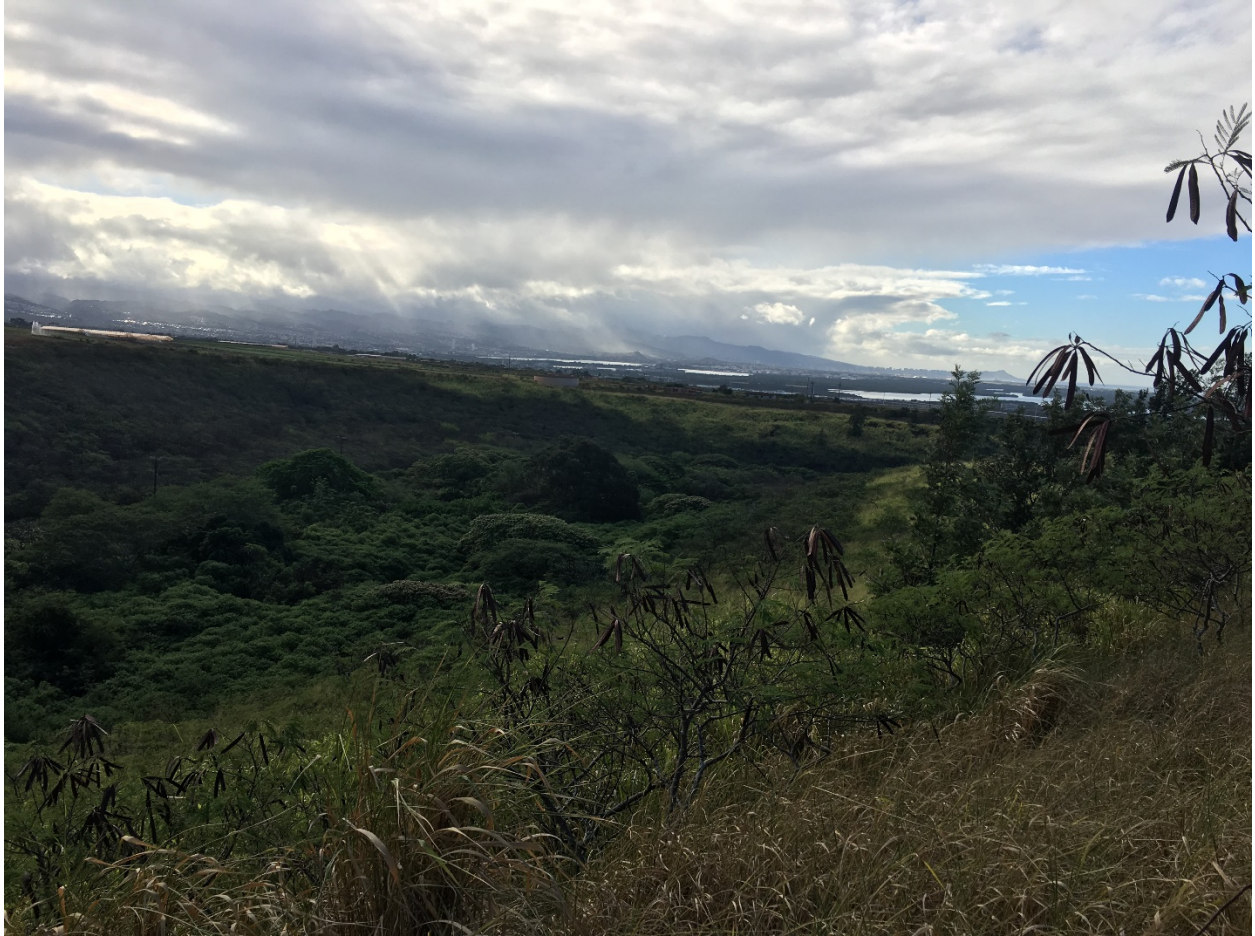
Figure 6. Overview of Honouliuli National Monument, view is southeast toward Compounds V, VI, and VII from UH West O’ahu Access Road. May 2017.

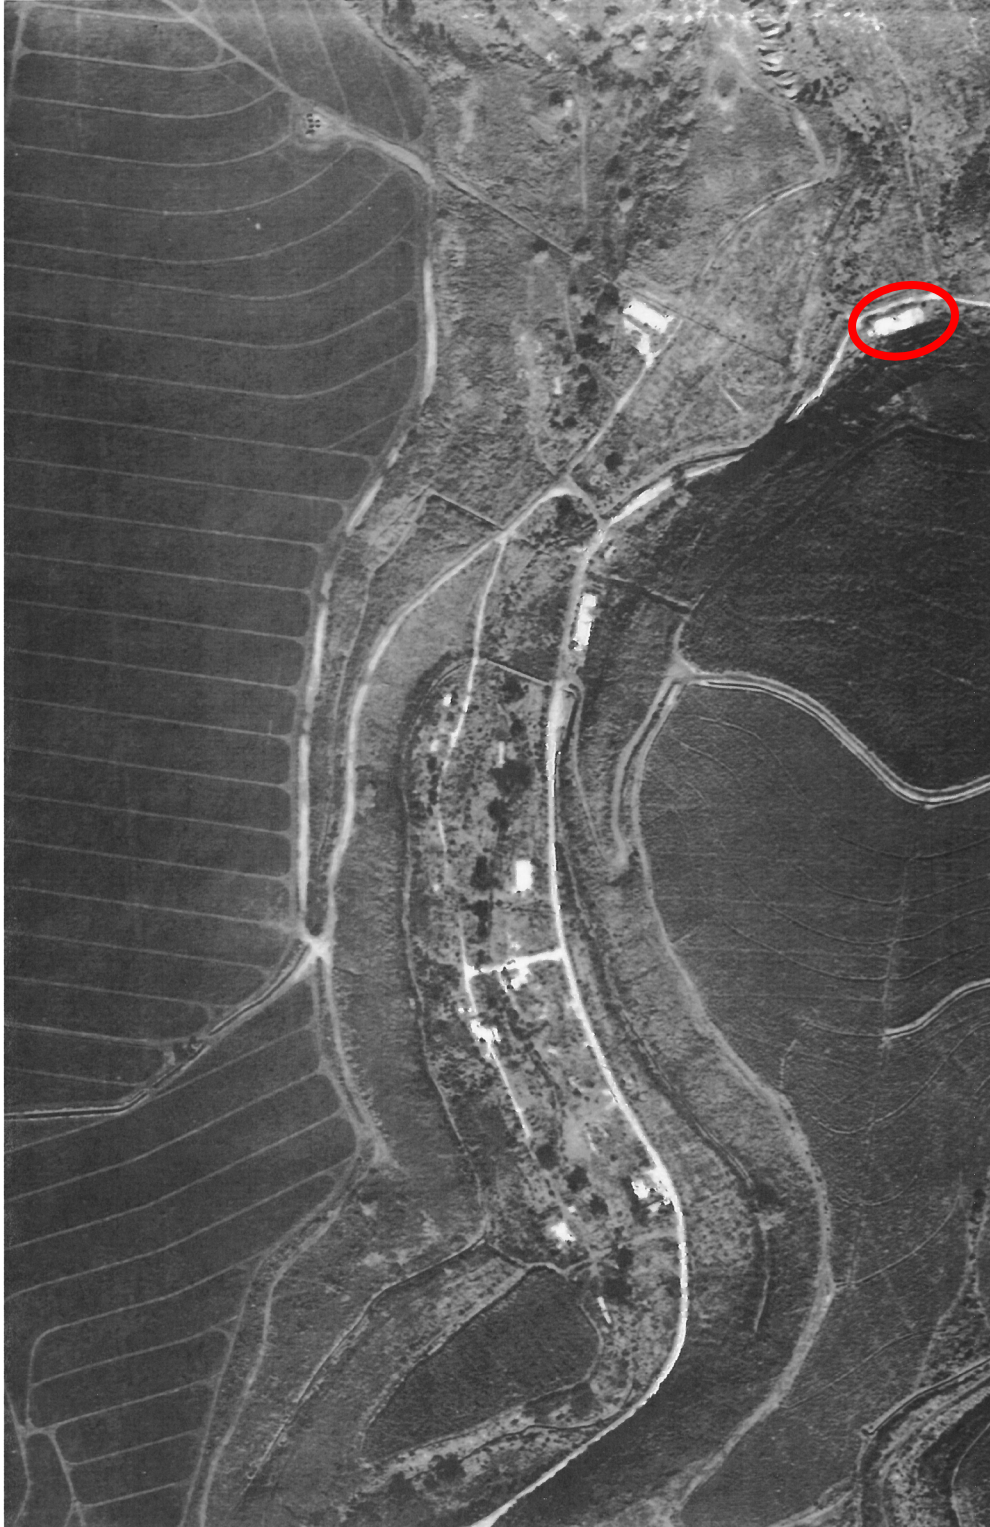
Figure 7. April 1948 Aerial Photograph (UM Mānoa Geospatial Map Collection). Feature I-7 is circled in red.

Feature I-7 is identified as a possible POW mess hall platform based on comparison with the U.S. Army blueprints and an aerial photograph dated 1948 (see Figures 7, 16 and 17). As stated above, based on these historical documents, the mess hall platform should be approximately 130 feet by 75 feet, oriented roughly northeast/southwest along a run that runs near Honouliuli Stream. One interesting observation was a “shadow” of a possible wall or other feature on the concrete platform when it was initially uncovered in TP-H (see Figure 24). The excavations did not uncover the entire shadow, but it is L-shaped with the long arm trending southeast/northwest and the short arm trending northeast/southwest. The long arm is approximately 3 inches wide and 24 inches long with the short base arm 8 inches in length and 3 inches wide. Overall, the concrete platform of Feature I-7 is level and is approximately 65 to 98 cm below the surface (see Figures 16 to 22).

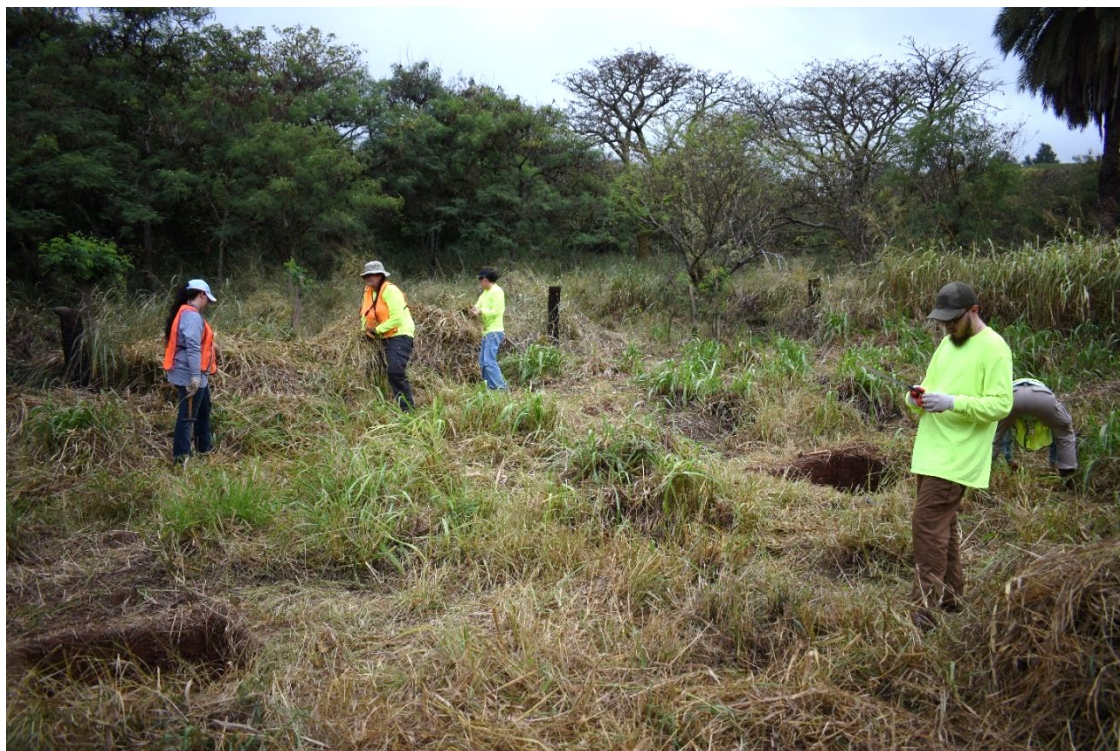
Figure 8. General overview (2018) of Compound I area where Feature I-7 is located. Facing northwest.

The primary goals of Task Agreement P16AC01702 (Modification 2; 2019 field season) were to conduct field work that focused on archeological assessment Feature I-7, in Compound I, through continued excavation. This feature is thought to be associated with the POW occupation of Compound I (Figures 7 and 8). Pedestrian survey was proposed for Compounds I and II during the 2019 field season; however, due to time constraints and weather delays, Dr. Belcher chose to focus on the excavations of Feature I-7.

Compound I is the northernmost compound of the Honouliuli National Historic Site and represents the large POW encampment. It is a relatively flat area covered with sparse *koa haole* trees and guinea grass (see Figures 8 and 14).

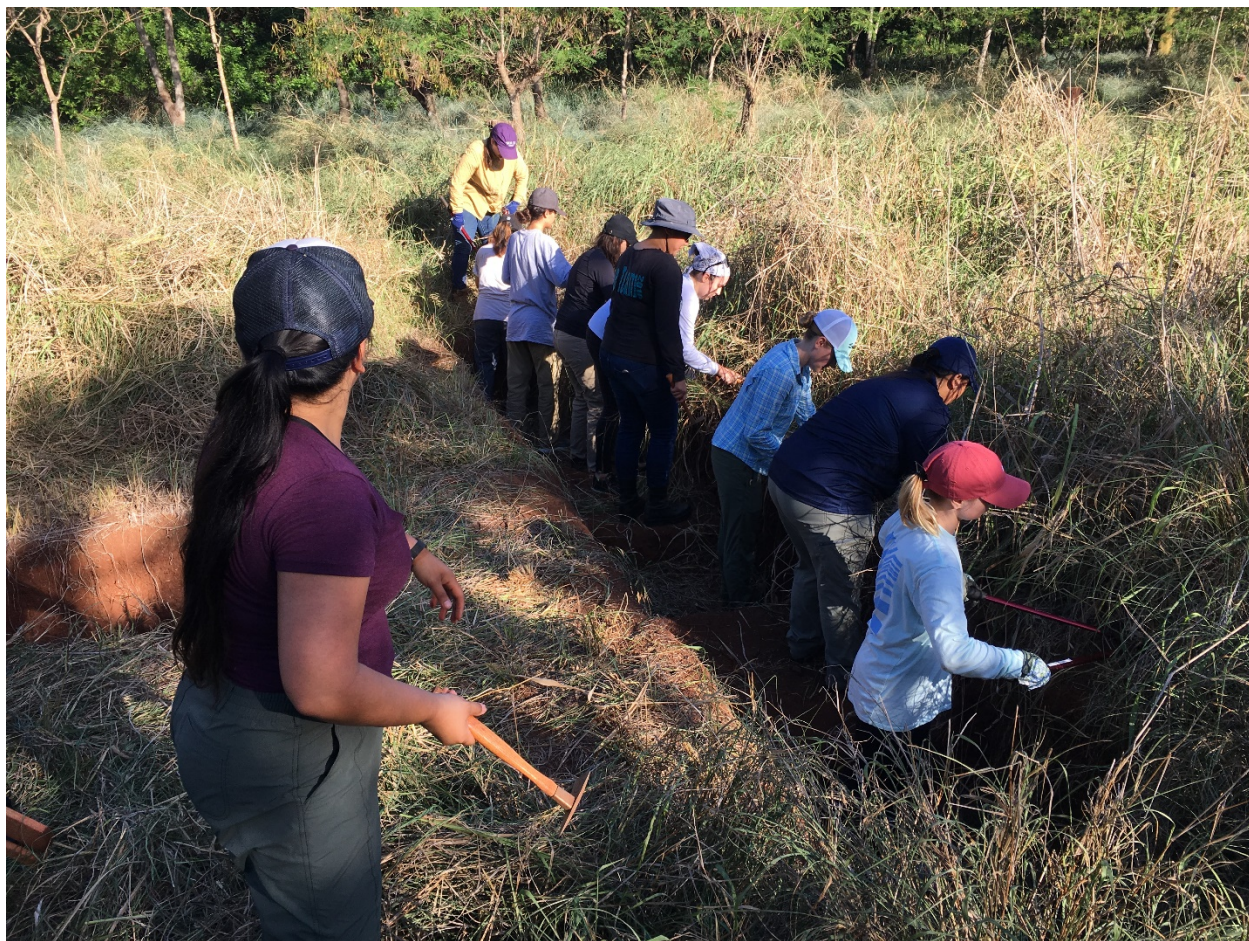
Figure 9. General overview of excavation area for Feature I-7 (2019), facing north-northwest.

The education goals of the UH West O‘ahu field school focused on introducing students to basic archeological methods, as well as expanding their knowledge of World War II incarcerations that included civilian internees and POWs as well as the social impacts in Hawai‘i of the civilian incarceration. The 2019 season included instruction on basic archeological techniques of survey/excavation and documentation through field notes, digital photography, GPS use, GIS data base use, historical artifacts, as well as drawing and mapping (Figures 9 to 13).

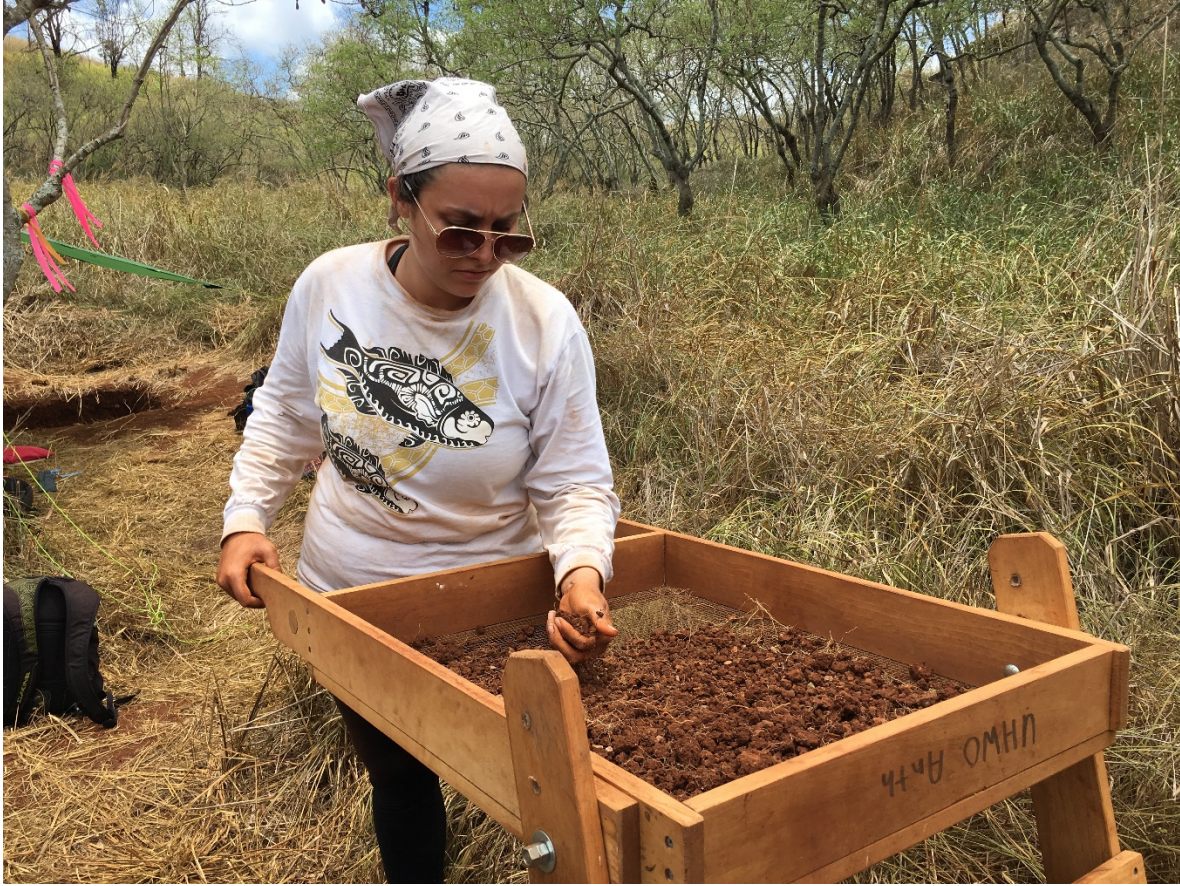
Figure 10. Marcela Bator screening sediment through 1/4-inch/6 mm mesh to search for small artifacts.

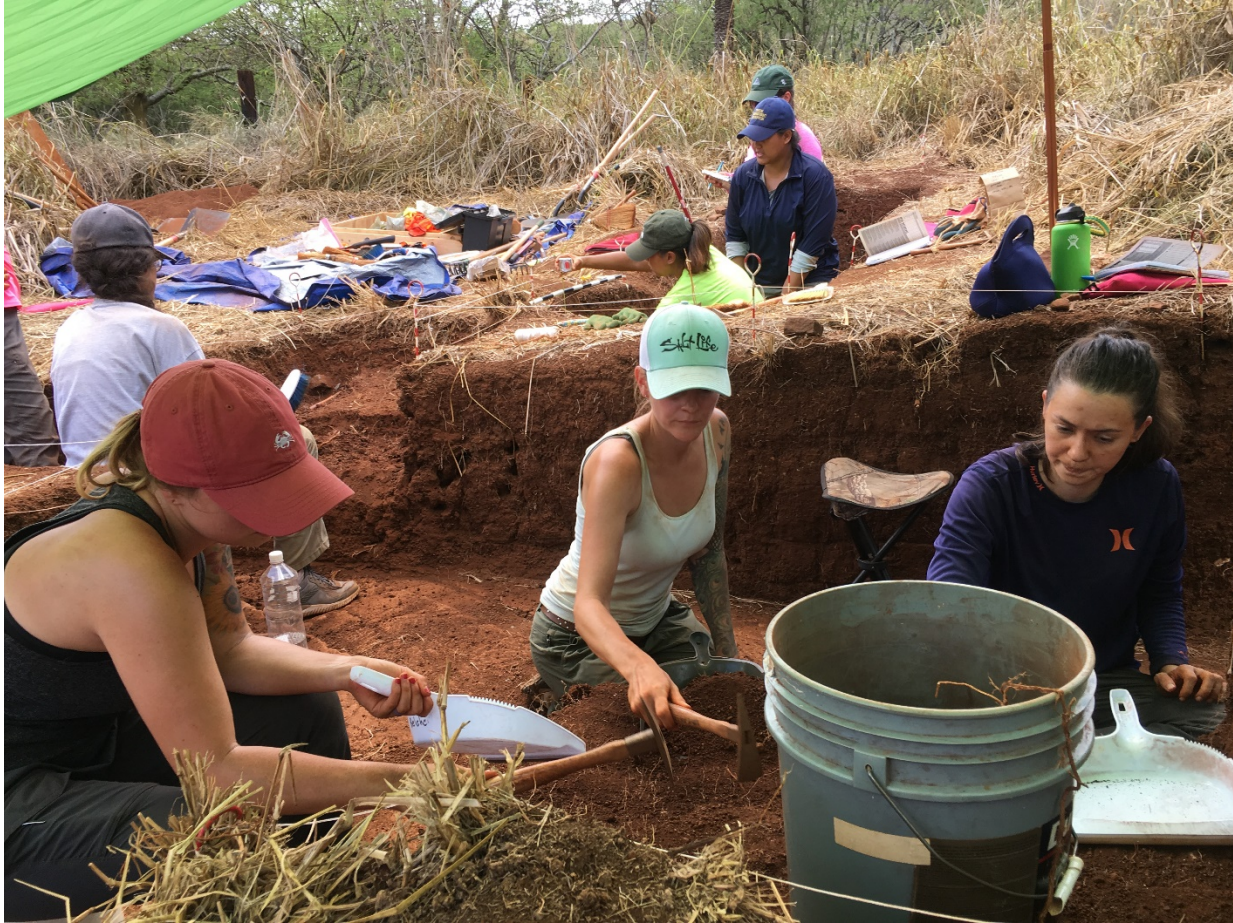
Figure 11. Excavating of a test pit in Compound I (Feature I-7) using small hand picks; Miranda Eddy, Rachel Williamson, and Jennifer Lai Hipp (left to right).

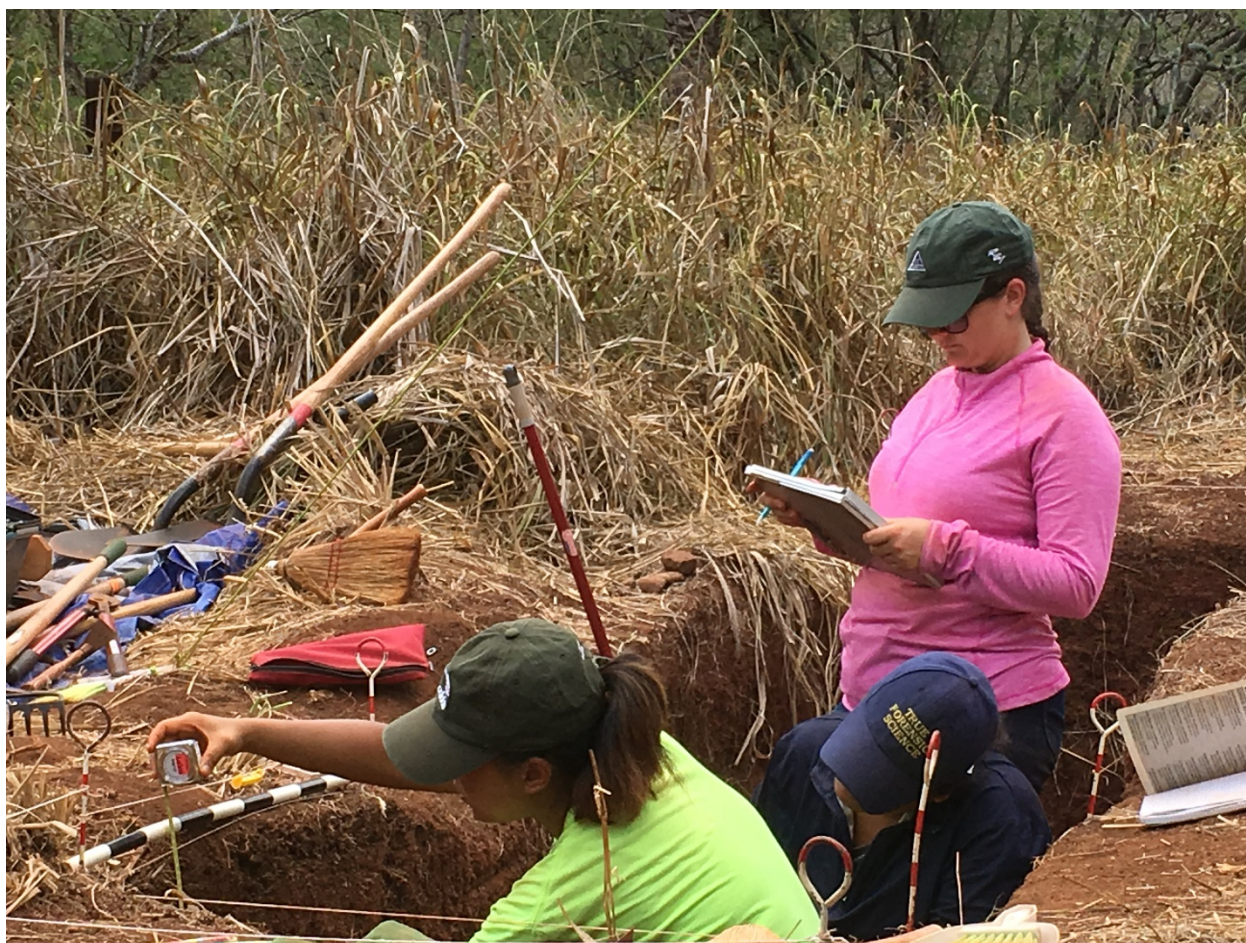
Figure 13. Drawing a section; Erika Peralta, Cyana M.V. Andres-Pagirigan, and Kennedy Chance (left to right).

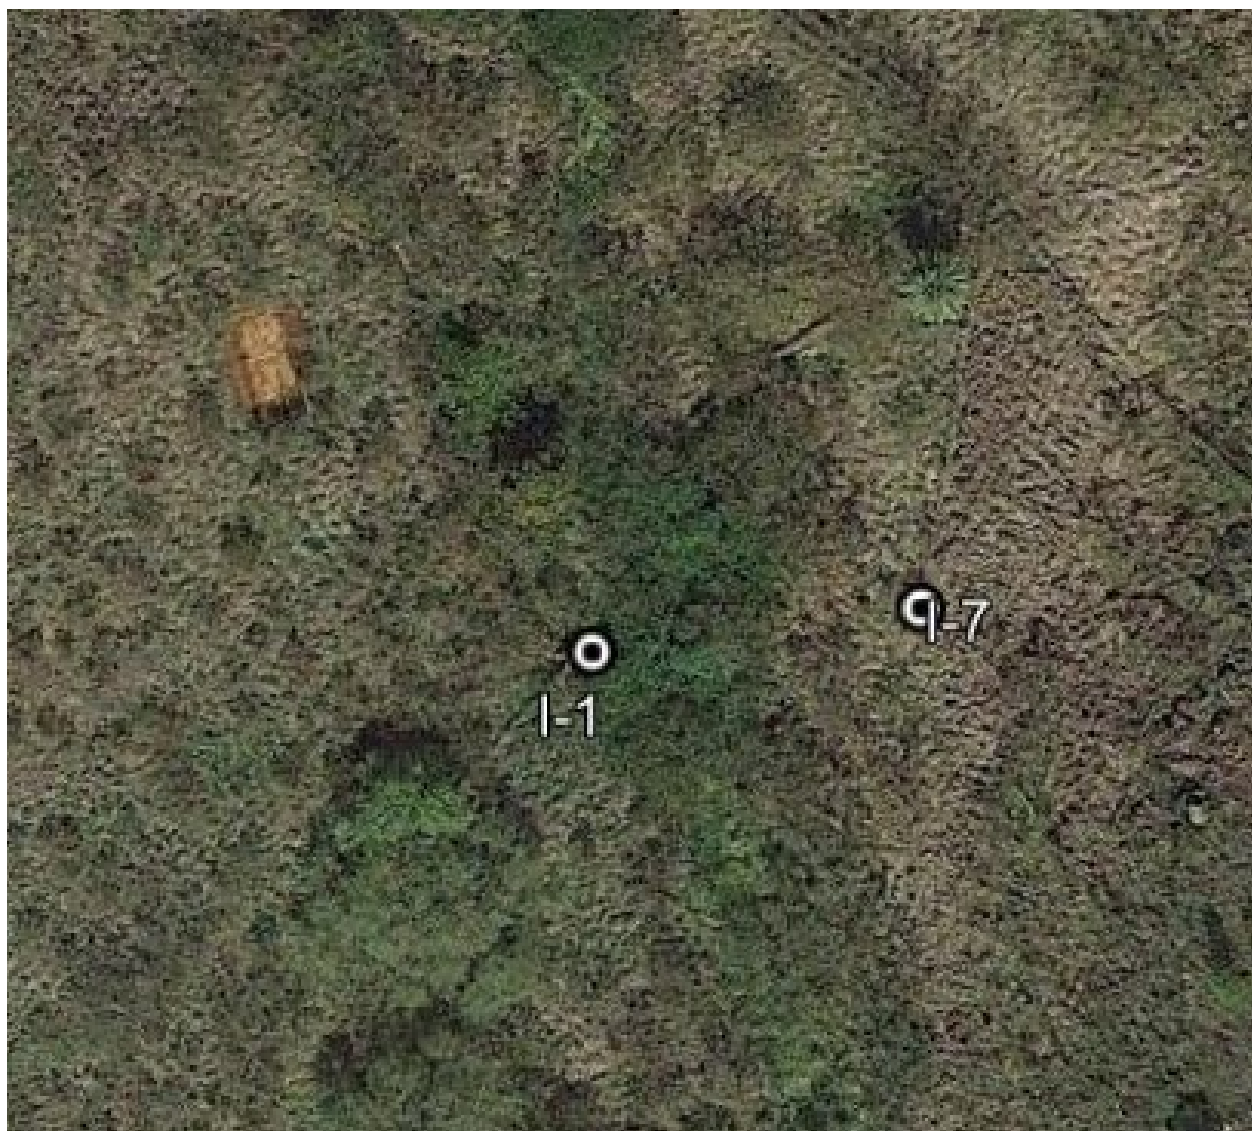
Figure 14. Location of General Feature I-7 Area in Compound I.

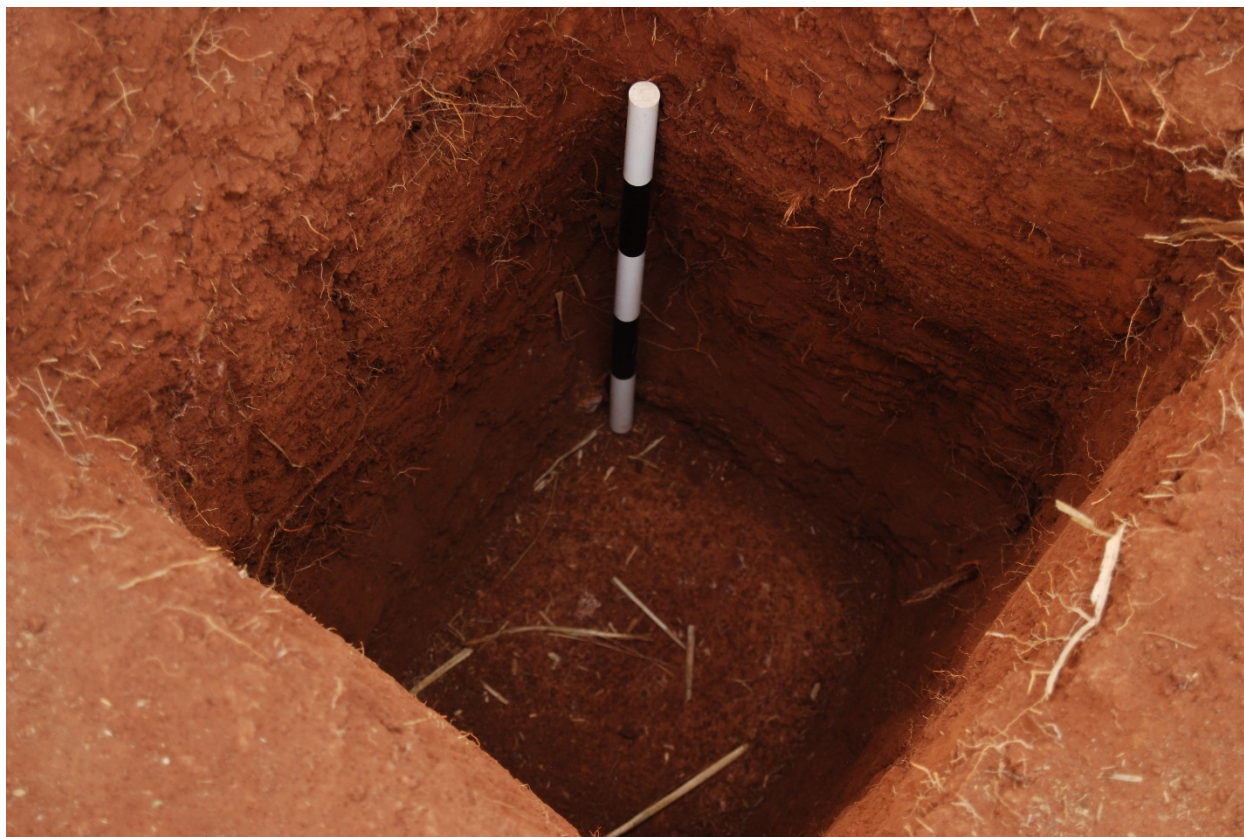
Figure 16. Feature I-7, TP-1 (2016); top – photograph (scale is in decimeters); bottom - section drawing.

Key:
 Ao: Loose yellow, red
 clayey silt; 7.5YR 4/6
 I: Loose yellowish red
 Silt with small gravel;
 7.5 YR 4/6
 II: Clayey silt with small
 gravel and large roots;
 2.5YR 4/4 dark reddish
 brown.
 III: Clayey silt with
 increasing small gravel;
 5YR 4/3 reddish brown

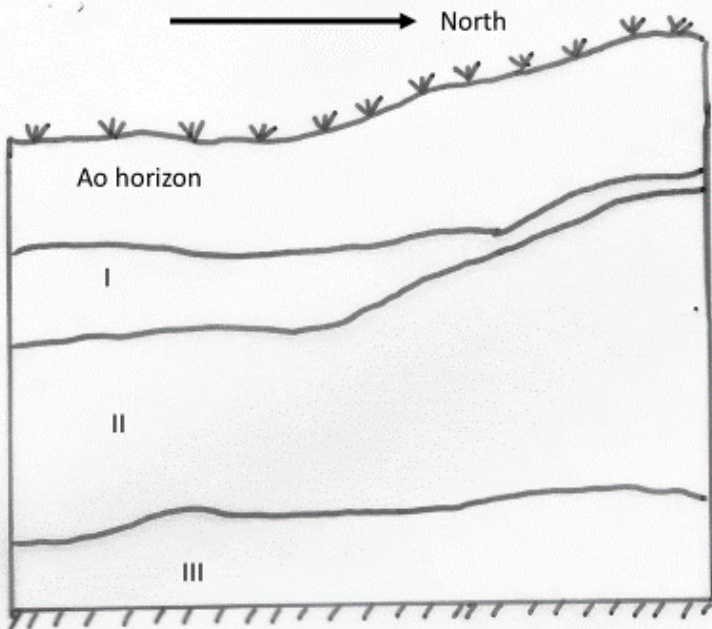
Feature I-7 Concrete Platform
 FACING WEST

Figure 17. Feature I-7, 2017 Test Pit B, West Wall, Section Drawing.

- I – 10YR 3/3 Dark Brown, silty clay (dry and hard)
- II – 10YR 3/6 Dark Yellowish Brown, clayey silt
- III – 10YR 3/4 Dark Yellow brown, clayey silt
- IV – 10YR 3/4 Dark Yellowish Brown, clayey silt
- V – 10YR 4/4 Very Dark Brown, clayey silt
- VI – 10YR 3/4 Dark Yellow Brown, compact, laminated clay

Laminar sediments occur over the platform itself with at least four stratigraphic units of medium to coarse reddish brown clayey silts mixed with courser particles of clay peds, coral gravel, and fragmented basalt rock. Cultural materials are presented within these sediments, but primarily include asphalt shingle fragments, agricultural plastic, metal (including nails, etc.), and glass

fragments (Figures 17 to 22). Based on these cultural sediments and the present of laminar silts, these sediments are primarily alluvial in origin and probably originate from a nearby erosional channel, which trends upward and northeasterly from the feature to the surrounding agricultural fields above Honouliuli Gulch (Figures 23).

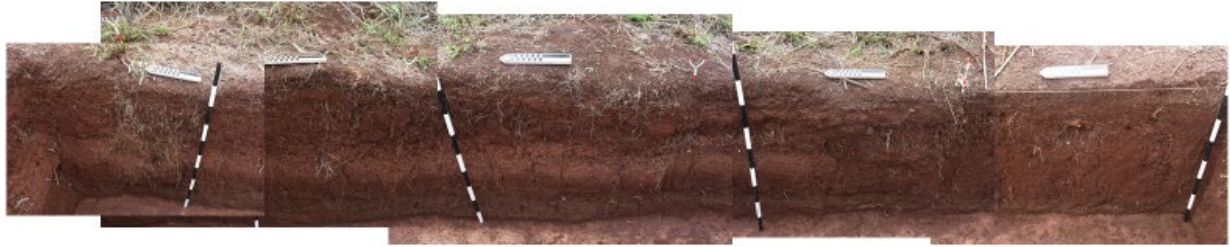
Figure 20. Photomosaic of Section of Feature I-7 – East Wall, Trending North (left) to South (right), Test Pits D, I, A, and M.

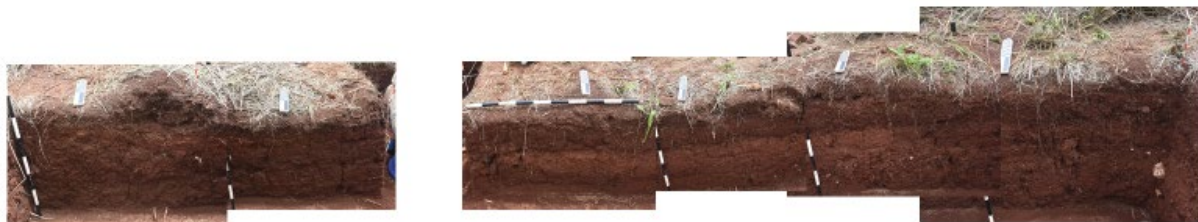
Figure 22. Photomosaic of Section of Feature I-7 – North Wall, Trending East (right) to West (left); Test Pits H, F, (K), B, L, G, and E; space is a non-contiguous wall of TP-K.

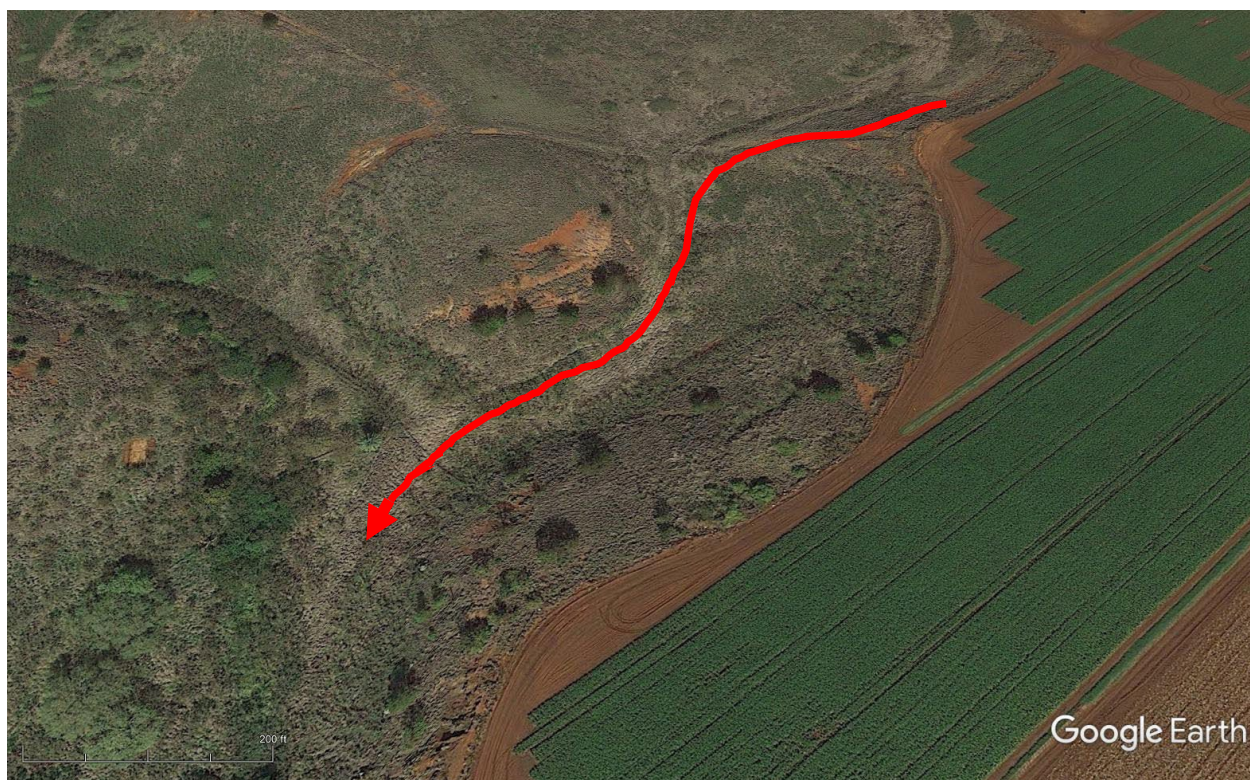
Figure 23. Map showing possible source of sediment that buried Feature I-7.

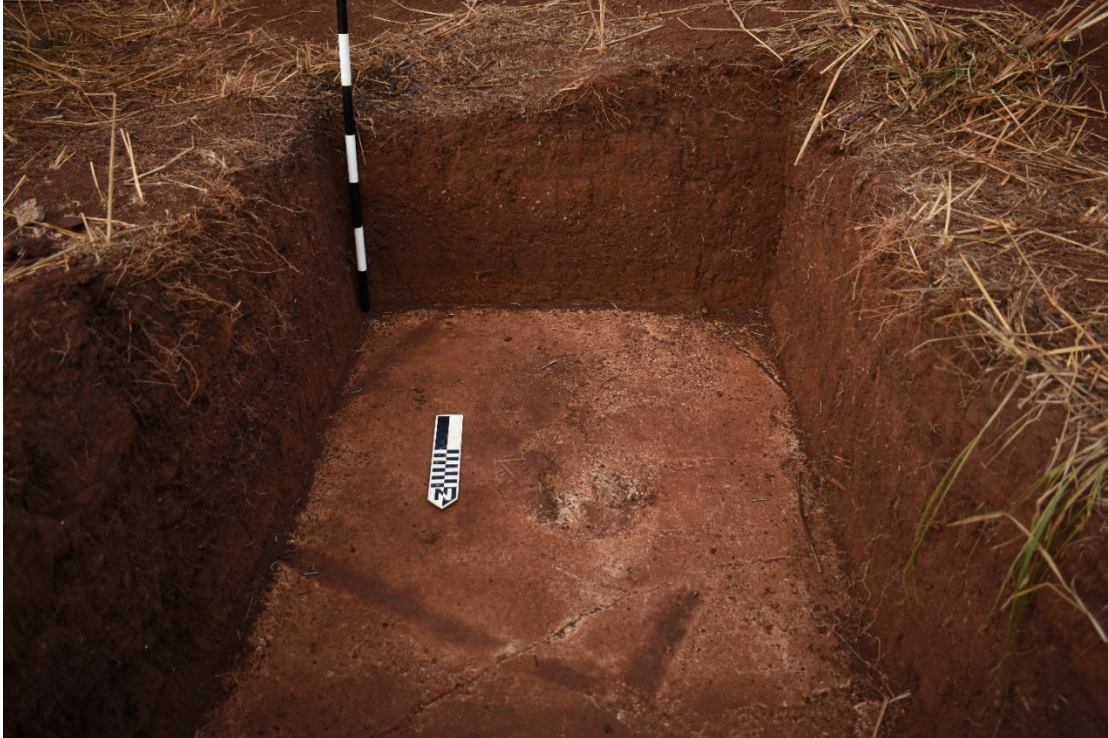
Figure 24. Photograph of “wooden” stain on concrete floor of Feature I-7, TP-H, facing south (2018).

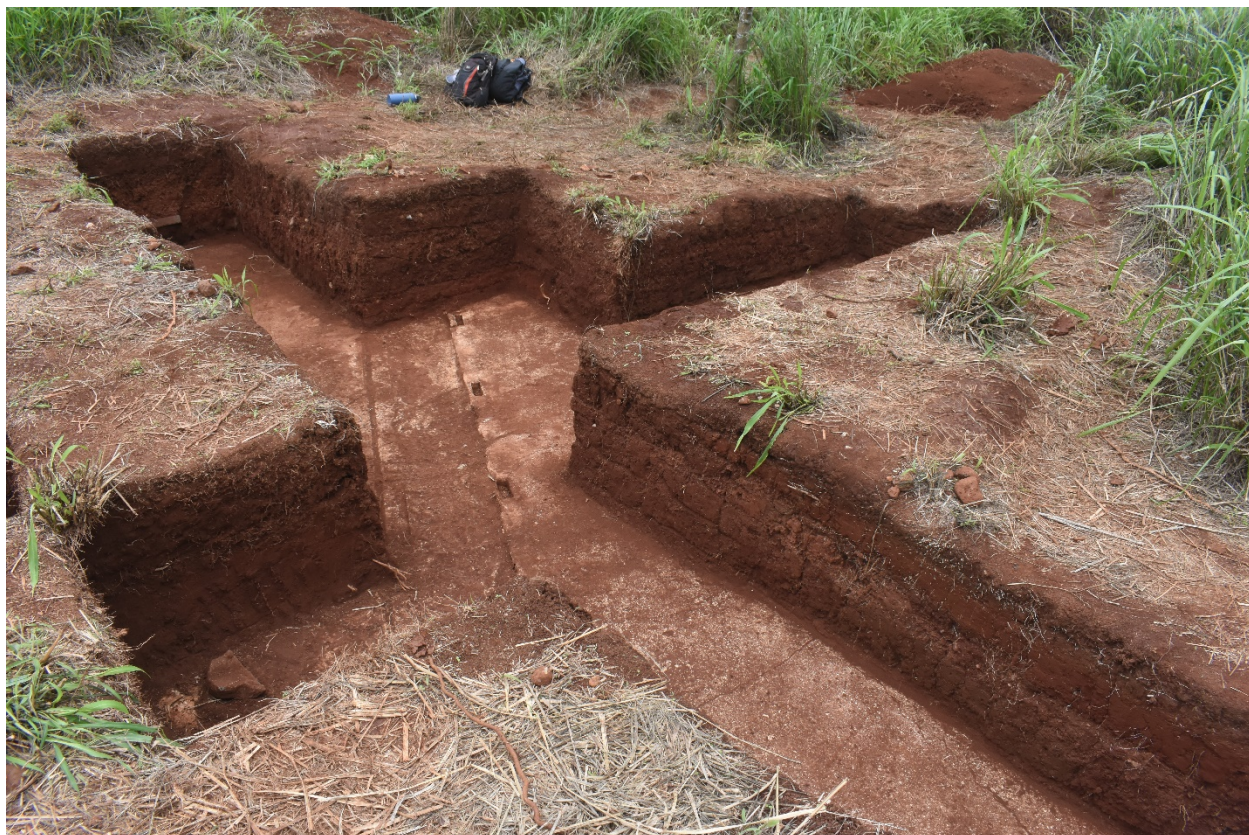
Figure 26. Completed 2019 Excavation of Feature I-7, facing southeast.

Although we have completed 16 square meters of surface area, we do not yet know the dimensions or extent of Feature I-7 (Compound I POW mess hall); continued excavation is necessary. Additionally, pedestrian reconnaissance and survey is necessary for Compounds I and II, particularly along the Honouliuli Stream edges, as this was not accomplished during 2019 field season.

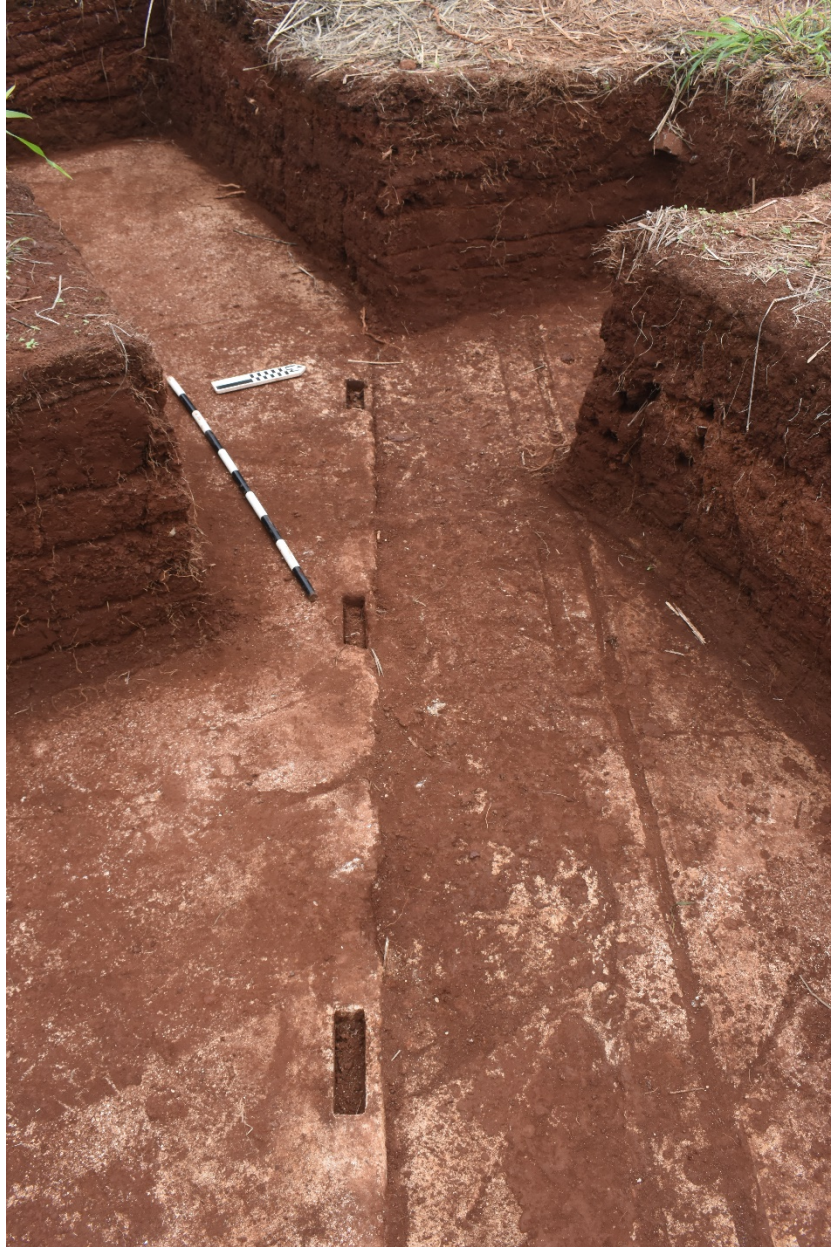
Figure 27. Detail of “tracks” and post molds in Feature I-7, facing northwest.

Various cracks are present over much of the exposed concrete, including pitting and spalling (Figure 25). The most conspicuous aspect of the platform is a rough “track” system that is approximately 12 to 14 inches across with ¼-inch to ½-inch furrows on both sides (Figures 26 to 29); the intermediate portion of this “track” is approximately 1/8-inch below the level concrete platform. It is trending roughly northwest/southeast (based on the magnetic grid system). On the southwest side are three shallow rectangular post holes that appear to have created using 6-x-2-inch lumber and measures 1.5 by 5.5 inches and approximately 1 inch deep (Figure 30). These post molds are spaced approximately 24-inches apart. The purpose of this portion of the concrete platform is currently unknown.

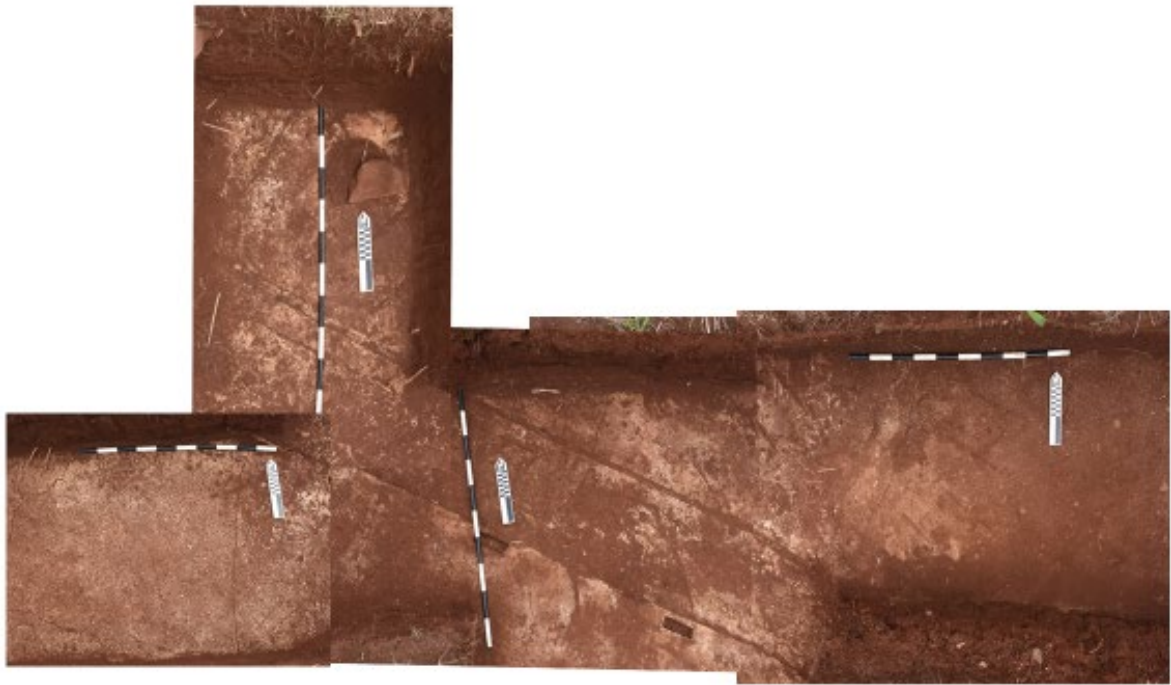
Figure 29. Detail of center excavation of Feature I-7 showing post molds and “trough”.

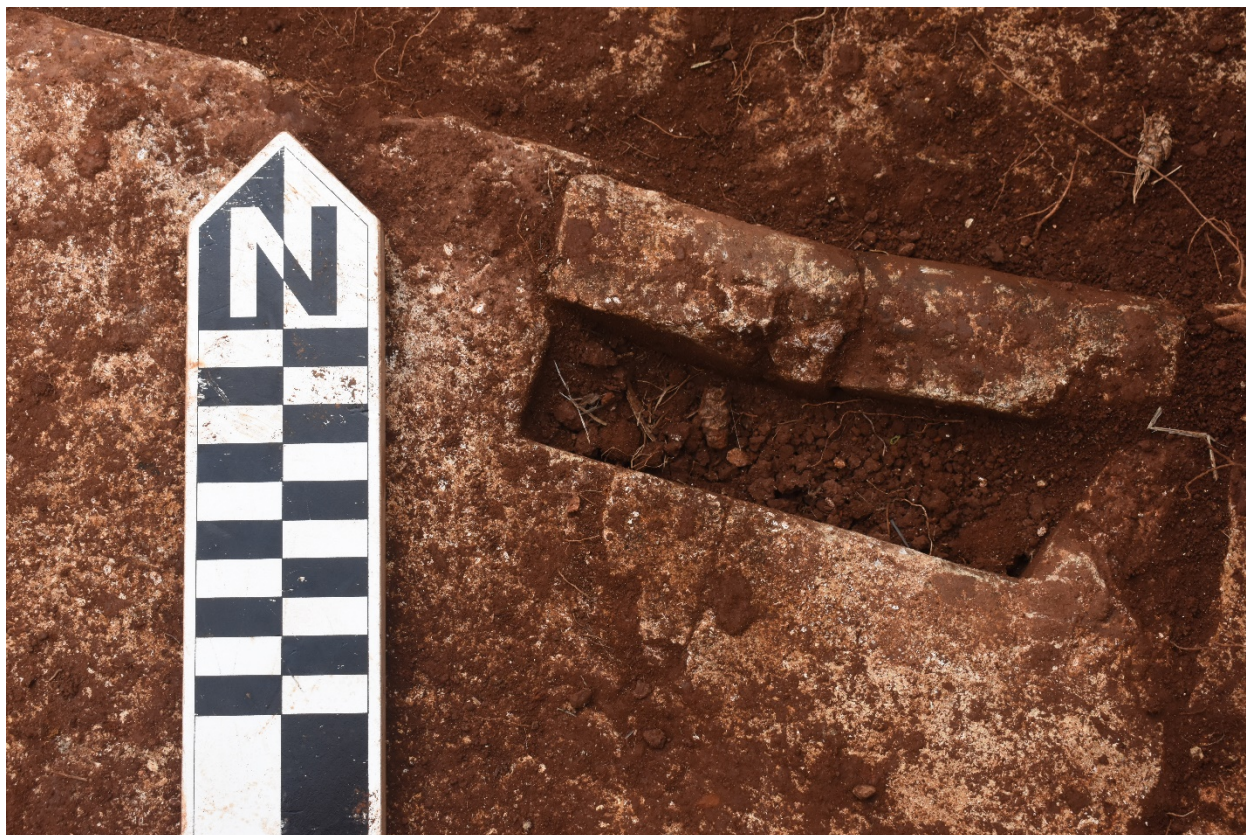
Figure 30. Post Mold details.

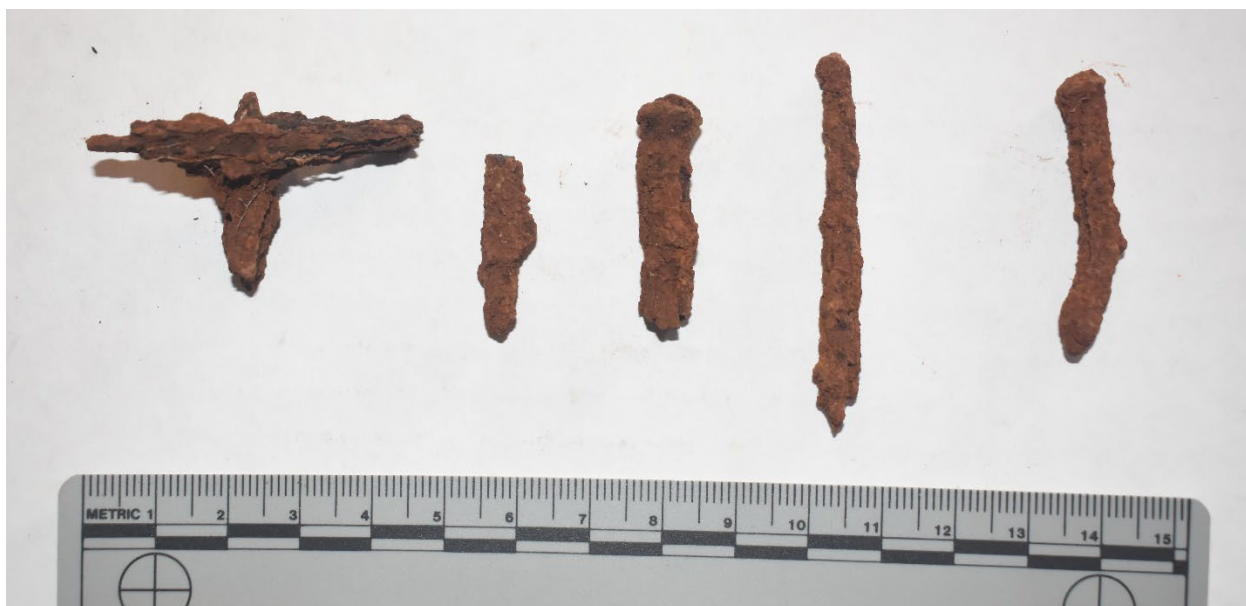
Figure 31. Representative Sample of Nails and Nail Fragments. Scale is in cm.

Many artifacts were encountered during the excavation, but most of the significant materials were located just above or in direct contact with the concrete platform (Table 1). These included primarily nails, unidentifiable metal fragments, and asphalt shingle fragments (Figures 31). One large metal piece was encountered in TP-Q (see Figure 32). Its function and identification are currently unknown. Additional items were recovered within the sediment column but included fragments of coral gravel (probably related to road fill) and bioplastic used to cover agricultural fields during fumigation. A single fragment of brown glass (probably the base of a beer bottle) and a fragment of blue glass (probably an insulator) were recovered from the 2016 TP-1 in 2016, but based on Scientific Research and Collecting Permit Study # HONO 2016-0001, Permit # HONO 2016-SCI-001 (dated 18 May 2016). These items were not retained and reburied in their original context in TP-1 (see Figure 33); both 2016 test pits (TP-1 and TP-2) were filled in at the end of the 2016 field season.
