ARCHEOLOGICAL FEATURE ASSESSMENT AT HONOULIULI NATIONAL HISTORIC
SITE: APPENDIX C – THE 2019 UNIVERSITY OF HAWAI‘I WEST O‘AHU
ARCHEOLOGICAL FIELD SCHOOL

WILLIAM R. BELCHER

HAWAI‘I-PACIFIC ISLANDS COOPERATIVE ECOSYSTEM STUDIES UNIT

21 NOVEMBER 2019

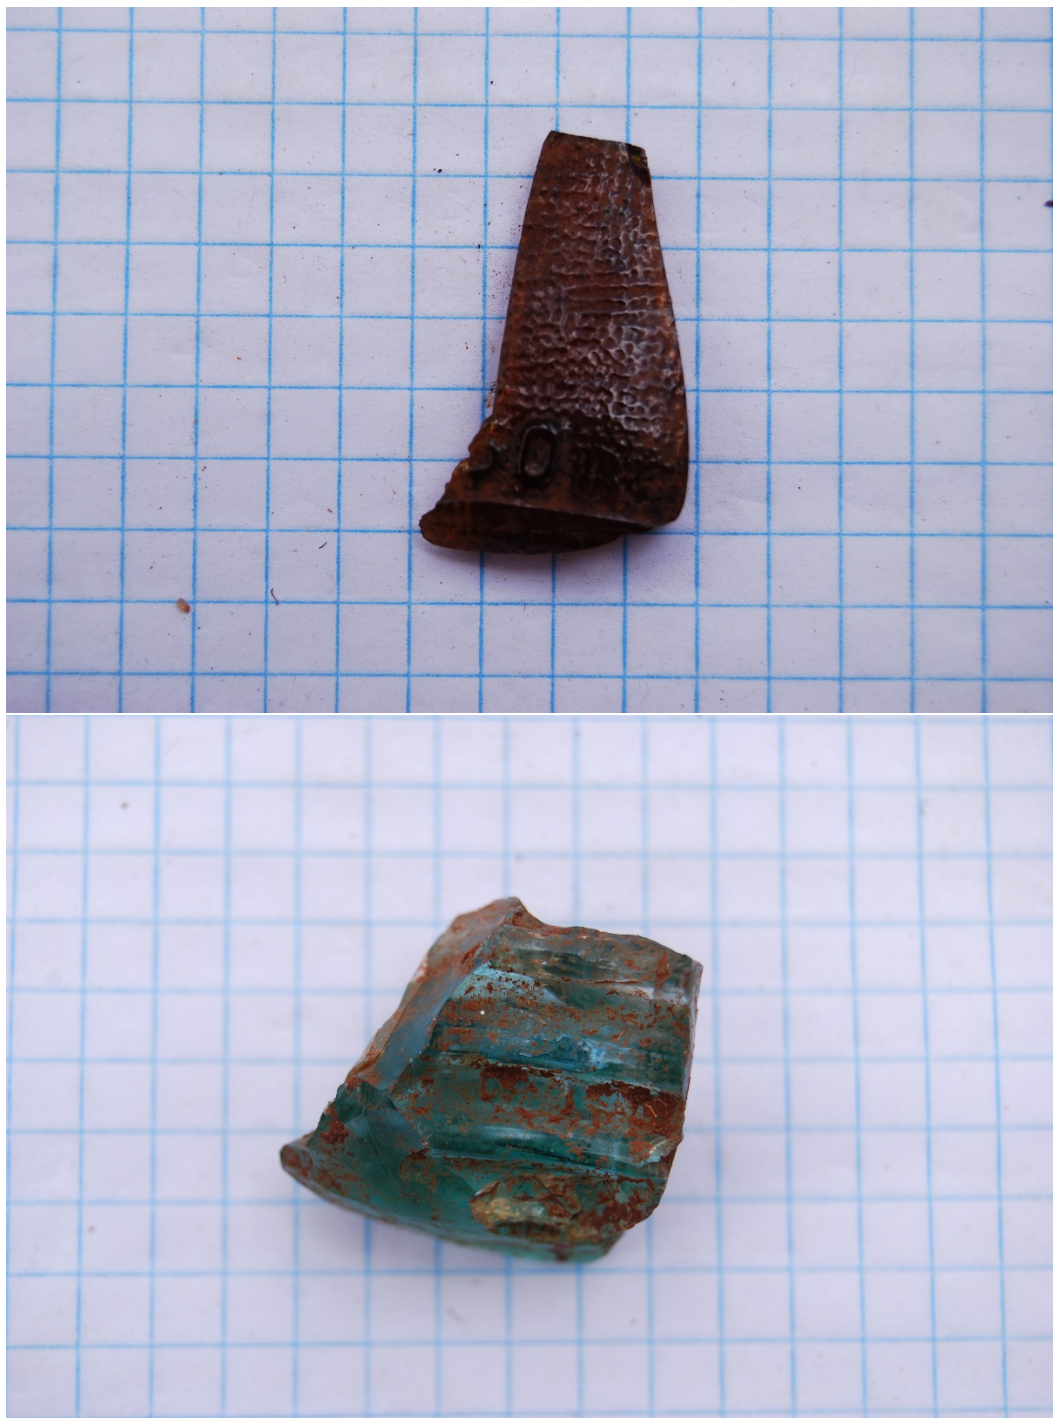
Figure 33. Glass Fragments from 2016 Testing from TP-1 (top – possible base of brown glass beer bottle; bottom – possible insulator glass fragment). Each square is a quarter-inch.

Many artifacts were encountered during the excavation, but most of the significant materials were located just above or in direct contact with the concrete platform (Table 1). These included primarily nails, unidentifiable metal fragments, and asphalt shingle fragments (Figures 31). One large metal piece was encountered in TP-Q (see Figure 32). Its function and identification are currently unknown. Additional items were recovered within the sediment column but included fragments of coral gravel (probably related to road fill) and bioplastic used to cover agricultural fields during fumigation. A single fragment of brown glass (probably the base of a beer bottle) and a fragment of blue glass (probably an insulator) were recovered from the 2016 TP-1 in 2016, but based on Scientific Research and Collecting Permit Study # HONO 2016-0001, Permit # HONO 2016-SCI-001 (dated 18 May 2016). These items were not retained and reburied in their original context in TP-1 (see Figure 33); both 2016 test pits (TP-1 and TP-2) were filled in at the end of the 2016 field season.
