Honouliuli POW and Internment Camp

Archaeological Investigations at *Jigoku-Dani*
2006-2017

Mary M. Farrell

December 2017

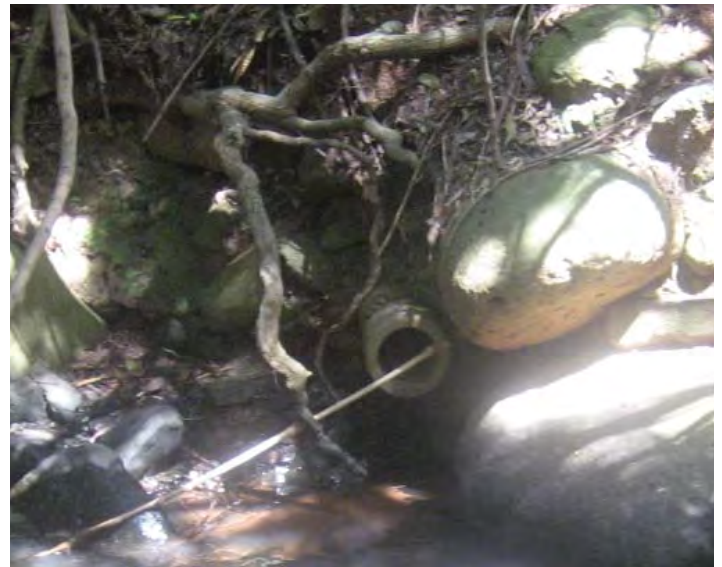
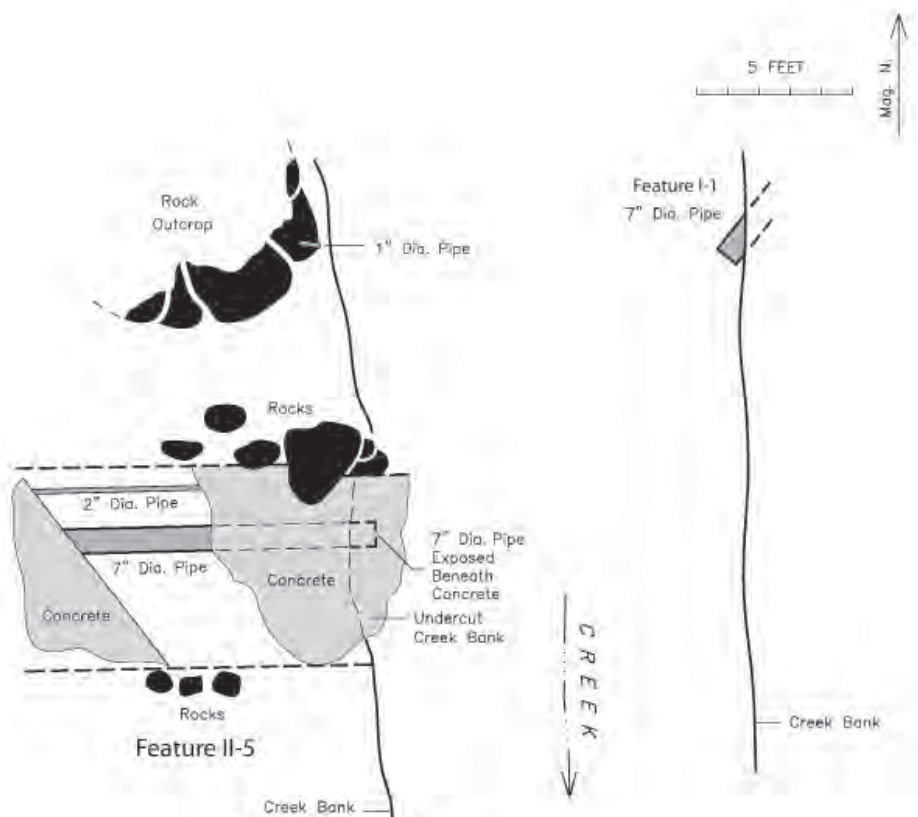
Feature I-1: Pipe (Figures 5.4 and 5.5)

This feature is a possible sewage outlet pipe, which may have carried overflow from a cesspool shown on the U.S. Army blueprints as 750 feet to the east. The concrete pipe is 7 inches in diameter, extending slightly from the east bank of the stream, about 2 feet 6 inches below the ground surface. It is located just across the stream from Feature II-5, another concrete pipe of the same diameter. It was recorded in 2008.

Figure 5.4. Feature I-1, concrete pipe (2008).

Figure 5.5. Features I-1 and II-5, concrete and metal pipes.

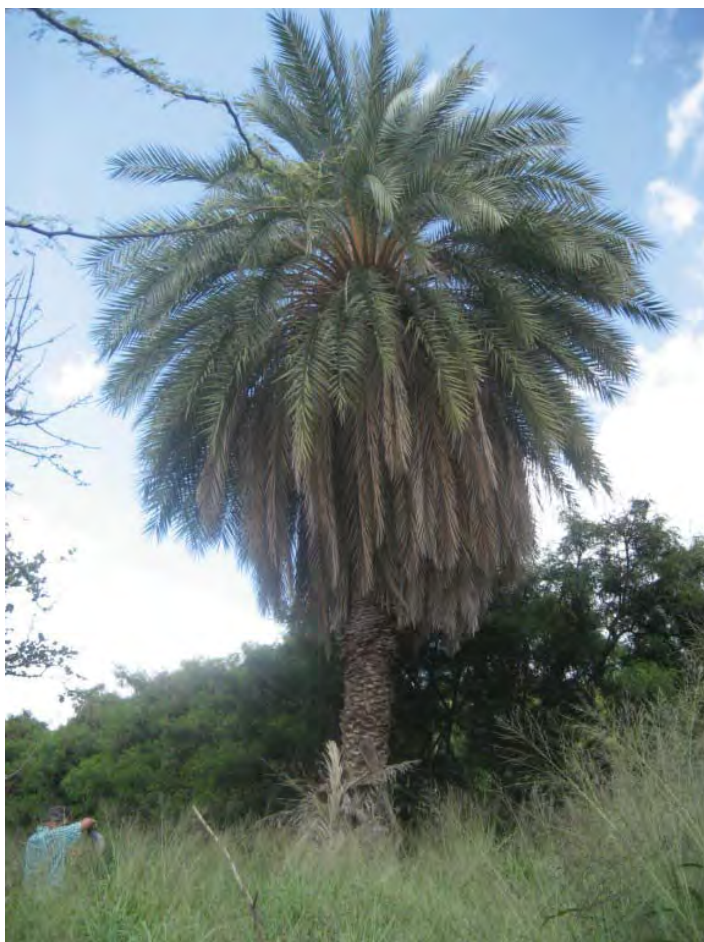
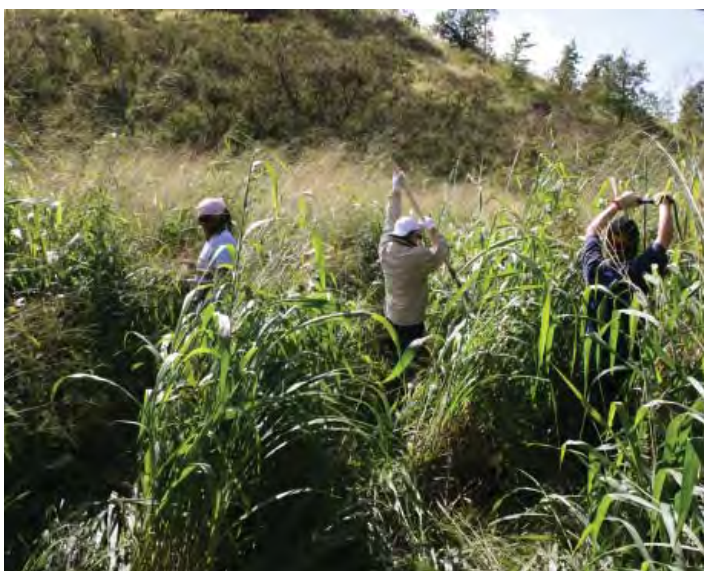
Feature I-2: Mess Hall Location (Figures 5.6 and 5.7)

The location is marked by a tall landmark palm tree, possibly dating to the World War II era. Historic photographs show obviously planted palm trees outside of barracks in Compound V, and the palm tree in Compound I may have been planted, as well. According to the U.S. Army blueprints, it is located near what would have been the northwest corner of the Compound I mess hall. The palm tree was noted as likely near the mess hall in 2008, and the area was probed with a steel soil probe in 2009 and 2014. Due to the dry and compact sediments, probing in 2009 did not extend below 2 feet. Probing in 2014, when the soils were saturated and more pliable, struck a solid surface at a depth of 3 feet in one area, but it could not be determined if this was a rock, concrete, or compacted soils.

Figure 5.6. Feature I-2, palm tree at Compound I mess hall location (2008).

Figure 5.7. Feature I-2, searching for mess hall foundation (2009).

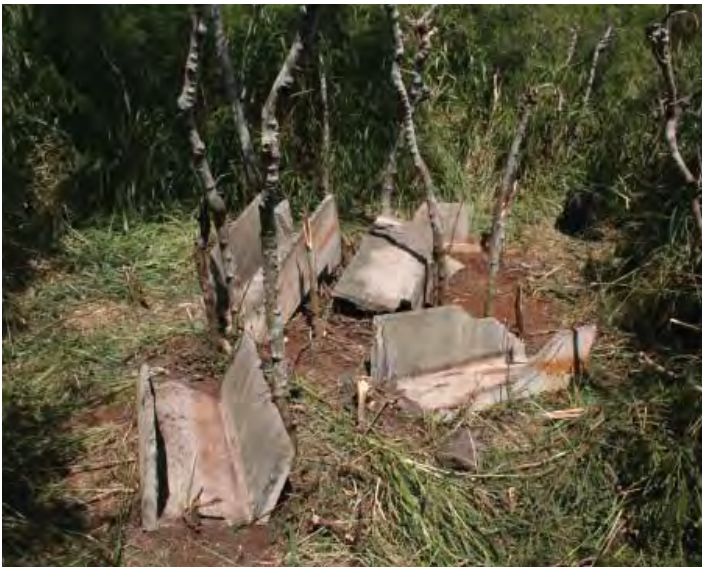
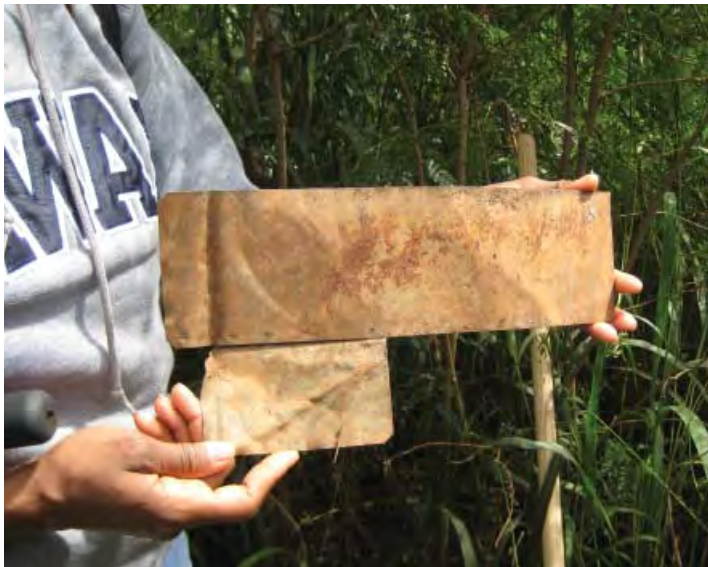
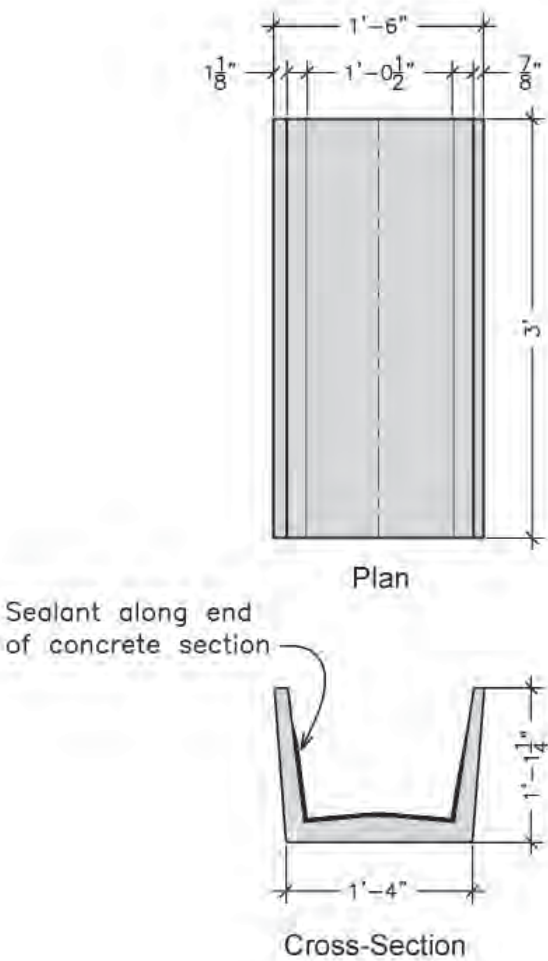
Feature I-3: Concrete Trough (Figures 5.8-5.10)

This feature consists of at least nine segments of open-ended concrete troughs and trough fragments, in four

concentrations. Each complete trough is 36 inches long and 1 foot 1¼ inches deep. The troughs flare outward slightly, so that the bottom of each measures 1 foot 4 inches and across the open top they measure 1 foot 6 inches. The floor of each trough slopes outward toward both sides from a raised center. At some of the ends, there is evidence of a petroleum-based seam sealant or adhesive on the interior, suggesting that the troughs were once connected end-to-end and used to convey liquid. One of the trough segments has two square outlet holes, one in each side wall at one end; one of the square holes is closed by a metal strip. A piece of shaped and folded sheet metal (see Figure 5.9) and other metal fragments at the feature may also be related to the troughs. The troughs and fragments are spread out in an area about 30 feet east-west by 60 feet north-south in size, extending north from the location of a shower building as depicted on the U.S. Army blueprints. A feature drawing of a sample trough segment was completed in 2009. This feature and Feature I-4, below, would be related to post-war cultivation.

Figure 5.8. Feature I-3, concrete irrigation trough (2009).

Figure 5.9. Feature I-3, Folded metal object (2009).

Figure 5.10. Feature I-3, concrete irrigation trough.

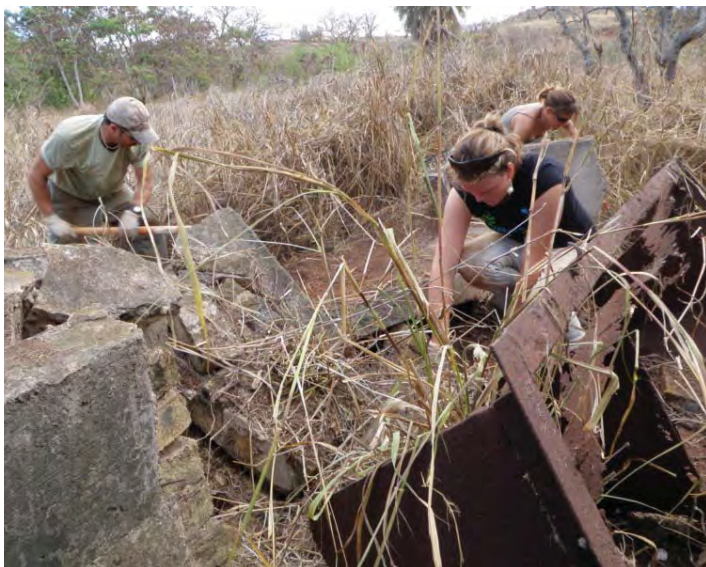
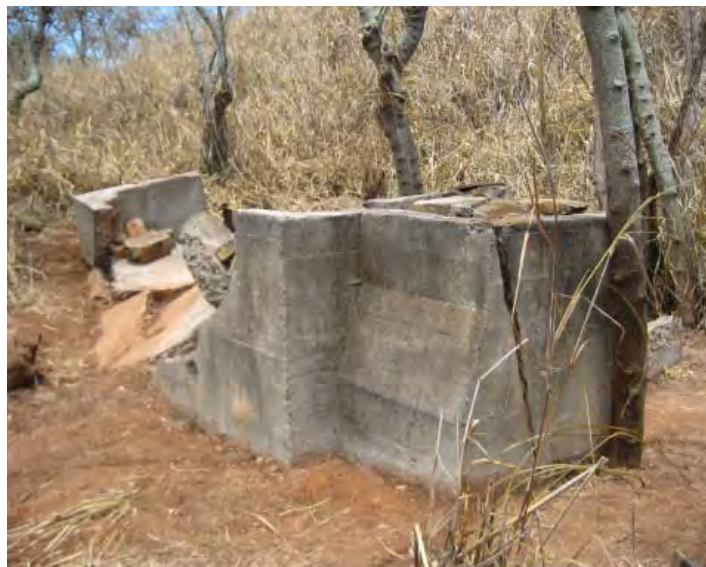
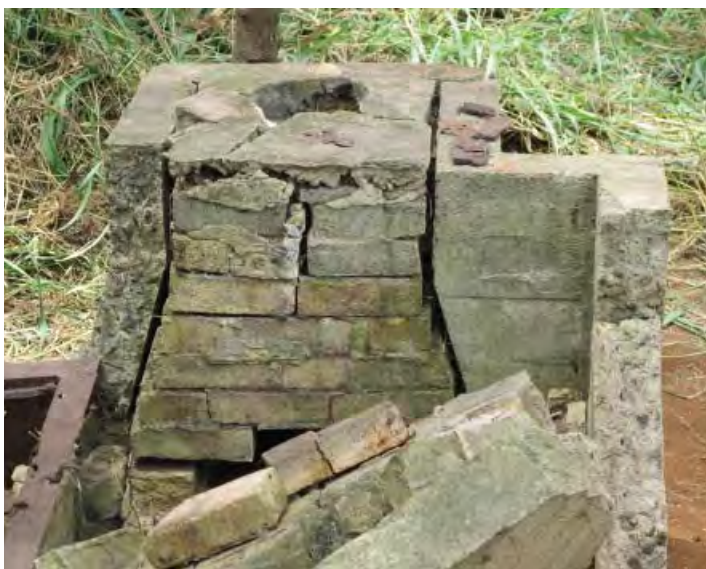
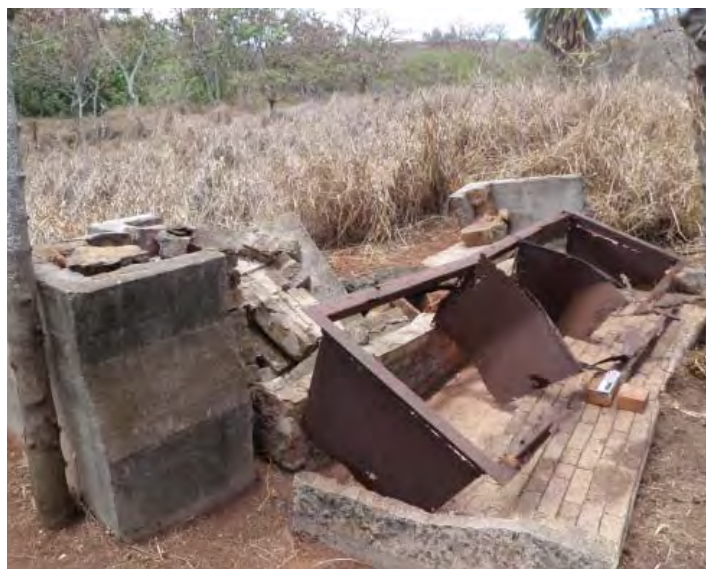
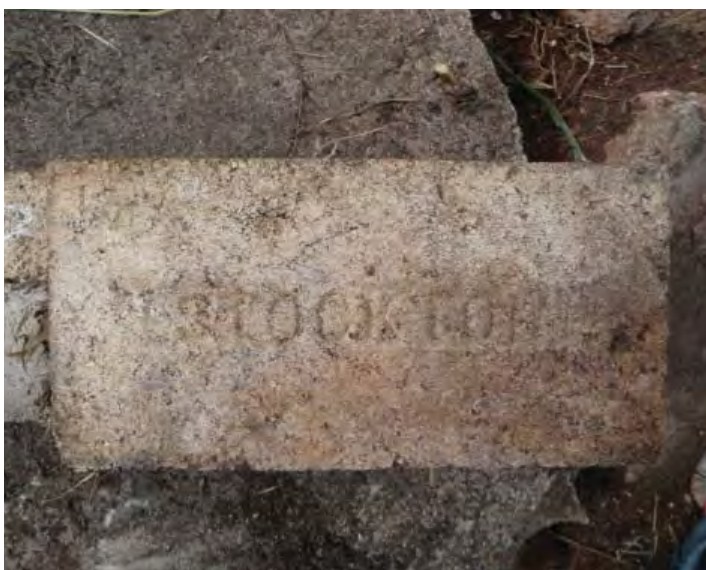
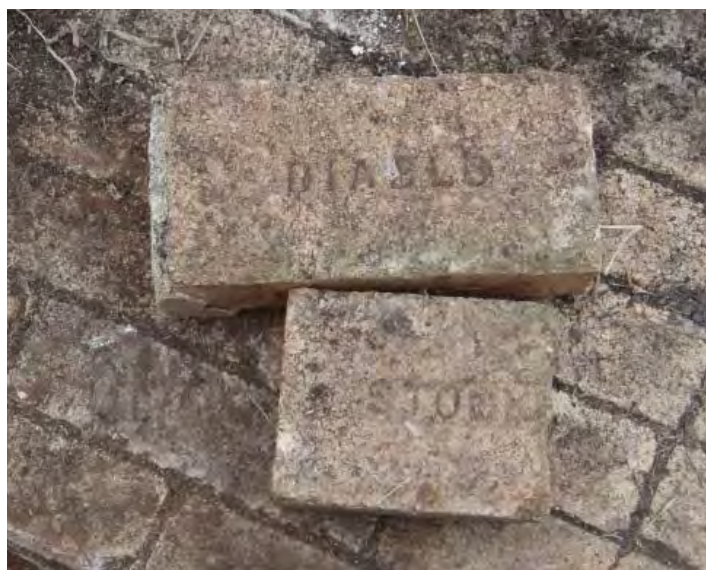
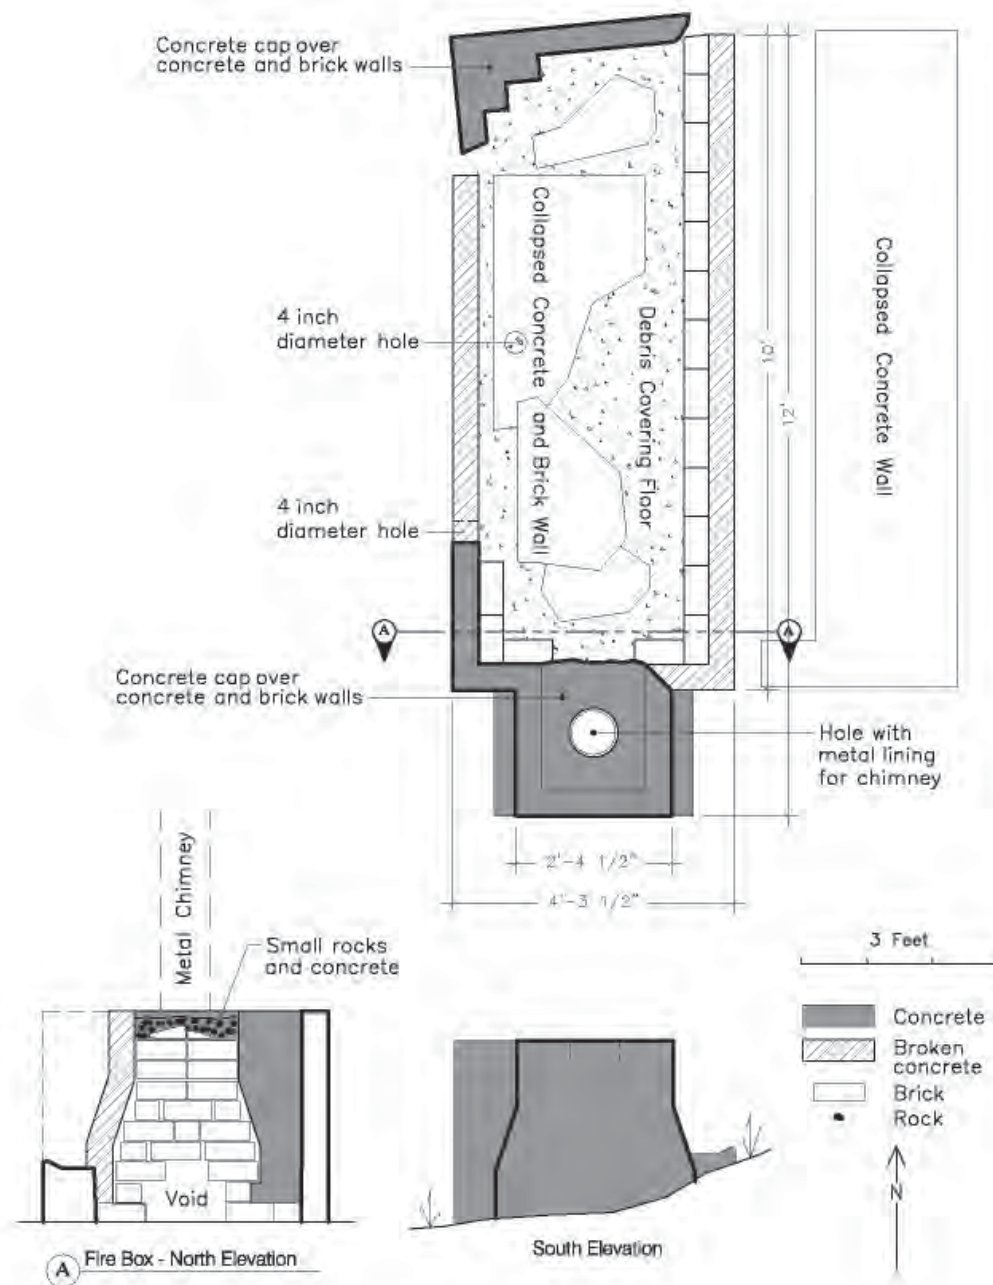
Feature I-5: Garbage Incinerator (Figures 5.13-5.21)

Discovered in 2010, this feature had been cleared of vegetation, photographed, and plotted on the site map, but feature drawings had not been finished. The incinerator was completely obscured by new vegetation growth at the start of the 2011 field work. Vegetation was again removed so that scale drawings of the

incinerator could be completed. The incinerator is about 12 feet in length, over 4 feet wide, and 3 feet tall, with walls of poured concrete about 4 inches thick. Although the Compound I incinerator is similar to the incinerator previously recorded in Compound III (Feature III-1), its concrete is broken in several

places so that the brick-lined combustion chamber lies in pieces on the ground, probably from purposeful demolition at the end of the camp occupation. In other respects, Feature I-5 is more intact than Feature III-1. A heavy-gauge sheet metal frame lies alongside the concrete; it appears to have functioned as a liner for the combustion chamber, dividing the chamber into three sections. The chimney end is still lined with fire bricks, and a broken and cracked concrete collar holds a remnant of the stove pipe. Several fire bricks are stamped “DIABLO,” a brand made by the Stockton Fire Brick Company of Stockton, California, from 1935 to 1942 (Gurcke 1987:224-225). At least one is stamped with “STOC[KTON],” made by the same company from 1927 to 1942 (Gurcke 1987:302-303). The chimney of this incinerator is visible in the distance in one of R.H. Lodge’s historic photographs, and it appears to be similar to the two south of the Compound III mess hall photographed by Lodge.

Figure 5.13. Feature I-5, clearing incinerator (2011).

Figure 5.14. Feature I-5, incinerator (2010).

Figure 5.15. Feature I-5, incinerator (2011).

Figure 5.16. Feature I-5, incinerator (2010).

Figure 5.17. Feature I-5, embossed brick from incinerator (2011).

Figure 5.18. Feature I-5, embossed bricks from incinerator (2011).

Figure 5.19. Feature I-5, incinerator.

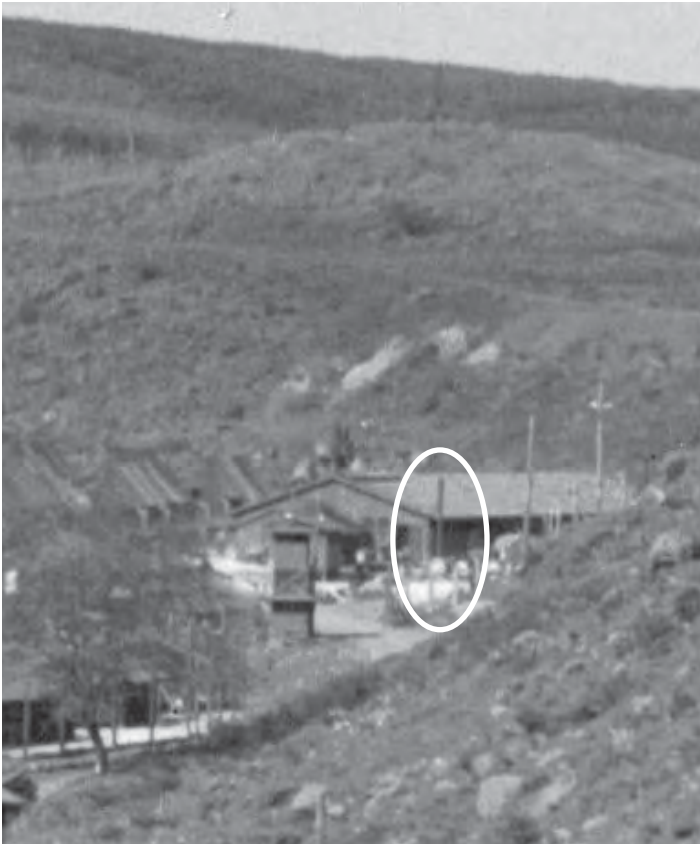
Figure 5.20. Incinerator at Compound II mess hall ca. 1945 (detail of R.H. Lodge photograph).

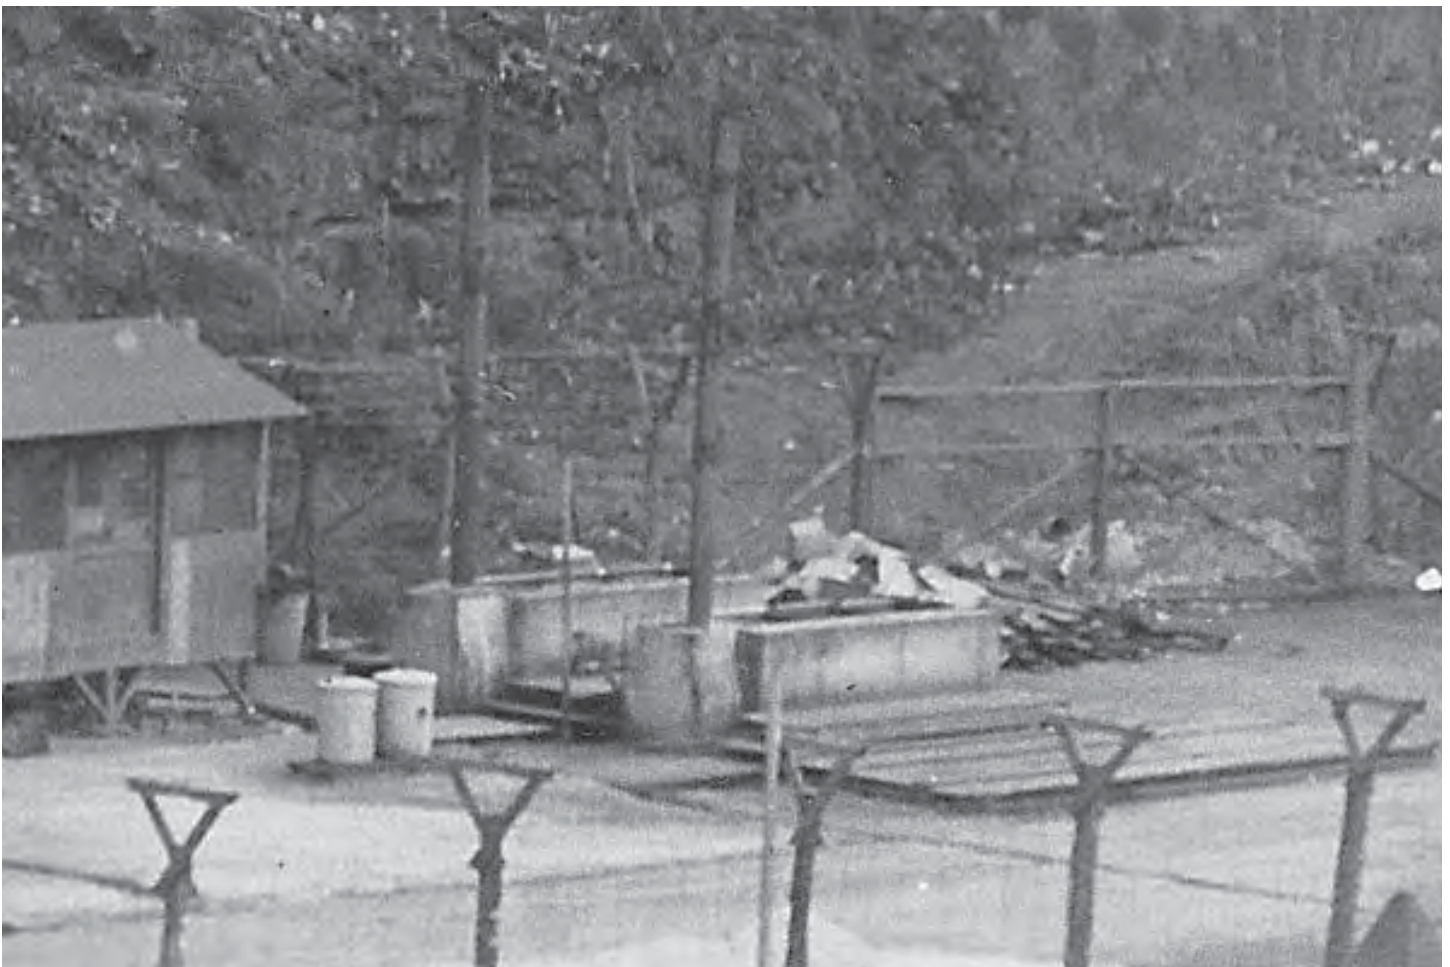
Figure 5.21. Incinerators at Compound IV mess hall ca. 1945 (detail of R.H. Lodge photograph).

Noted in 2006, this incinerator was cleared and mapped in 2008. Although in Compound III as delineated by the military blueprints, the feature is located just south of the Compound II Mess Hall foundation, and was undoubtedly associated with that structure. The incinerator is shaped like a trough, but open on one end and with a chimney at the closed end. The intact portion of the feature measures almost 12 feet long overall, 4 feet 3 inches wide, and 3 feet 4 inches tall. The exterior of the chimney, at the east end of the structure, measures 1 foot 10½ inches by 2 feet 3 inches. The interior of the chimney and the east end of the trough are lined with fire bricks, and there are three evenly spaced round holes through the south side wall. Part of the north wall of the structure has been broken off, and the western end is displaced slightly. Feature III-1 is now partially filled with trash, both modern (such as a 55-gallon-drum lid, glass beer bottles, and aluminum beverage cans) and older (such as lumber, wire, metal pipe, two 55-gallon drums, a jerrycan, fencing, and fragments of metal and wood). Although this incinerator is not depicted in the available historic photographs or U.S. Army blueprints, it appears to be similar to two located south of the Compound III mess hall photographed by R.H. Lodge (see Figure 5.21).

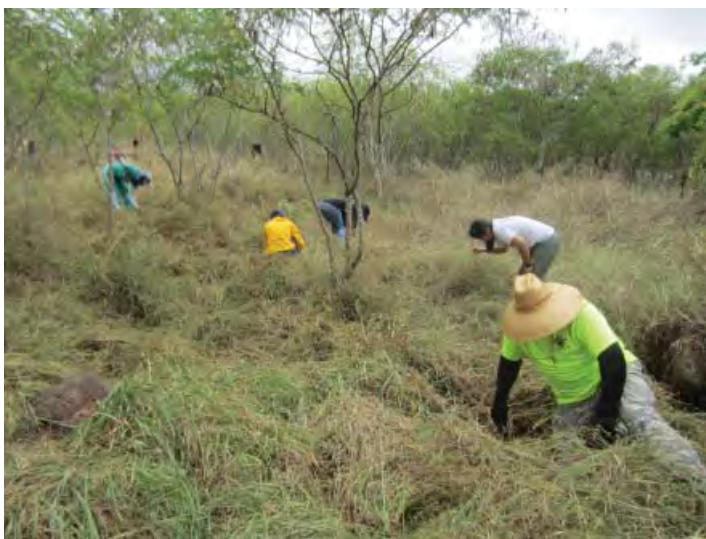
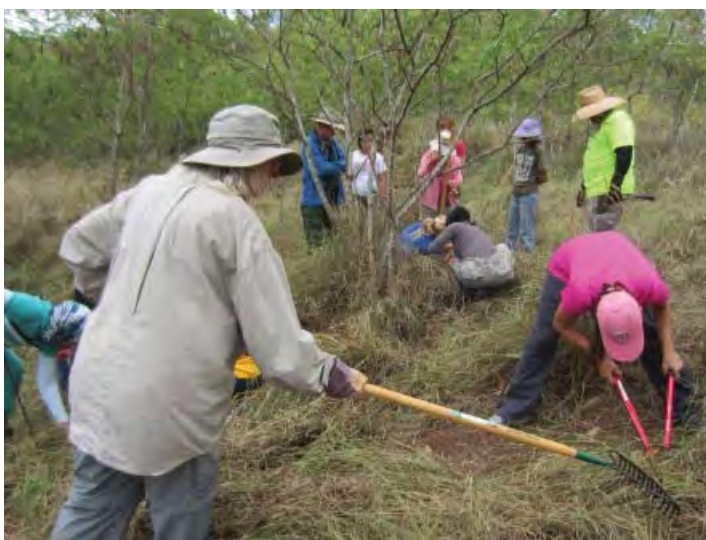
Compound II is located west and south of Compound I, near the north end of the camp (Figures 5.22 and 5.23; see Figure 5.1). In U.S. Army blueprints as well as in historic photographs, almost the entire compound is west of the stream, but one of the three guard towers within the compound and an access road were located to the east. The blueprints show a mess hall, a dispensary, and a group of five buildings including a shower building, two water-borne latrines, and two pit latrines. Another shower building and four latrines are depicted on the map and keyed in the legend as “buildings not in use.” The historic photographs show over 50 single-peak pyramidal tents and four double tents, all surrounded by a double fence. The Compound II mess hall is separately fenced, and there is a guard tower just to the east. Although much of this compound is overgrown with Guinea grass, 30 features and several artifacts were found here, including foundations for a mess hall and two shower buildings, other structural remains and debris, an inscription, and water and sewage system remains. The mess hall was recorded and mapped in 2010; in 2014, we searched for the guard tower footings, but were not able to find them in the thick Guinea grass.

Figure 5.22. Searching for guard tower foundation in Compound II (2014).

Figure 5.23. Searching for guard tower foundation in Compound II (2014).

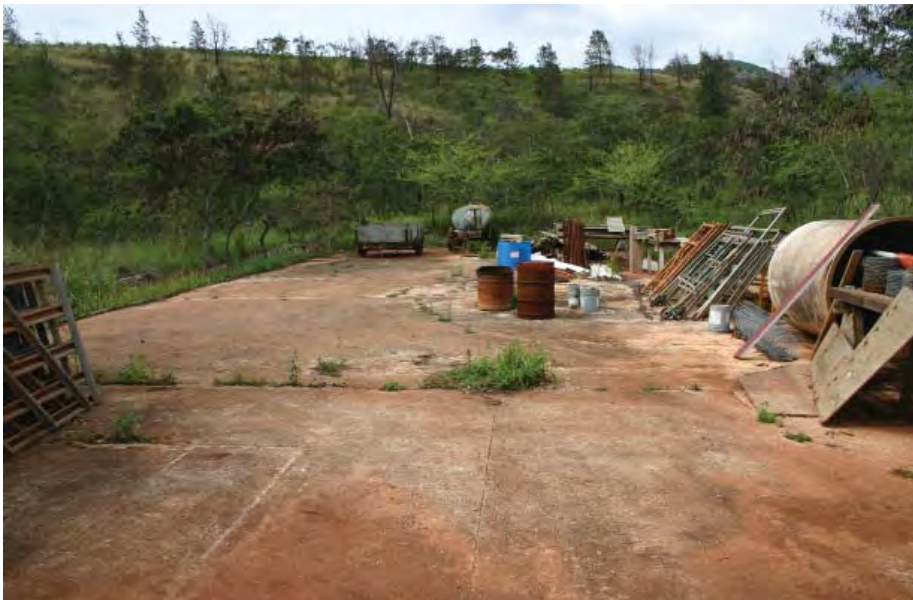
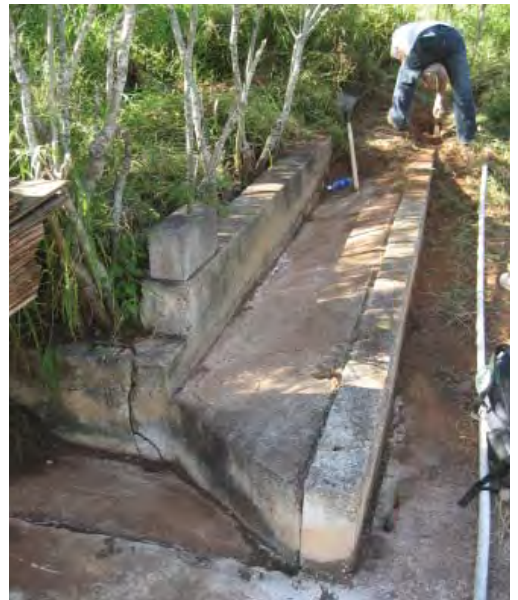
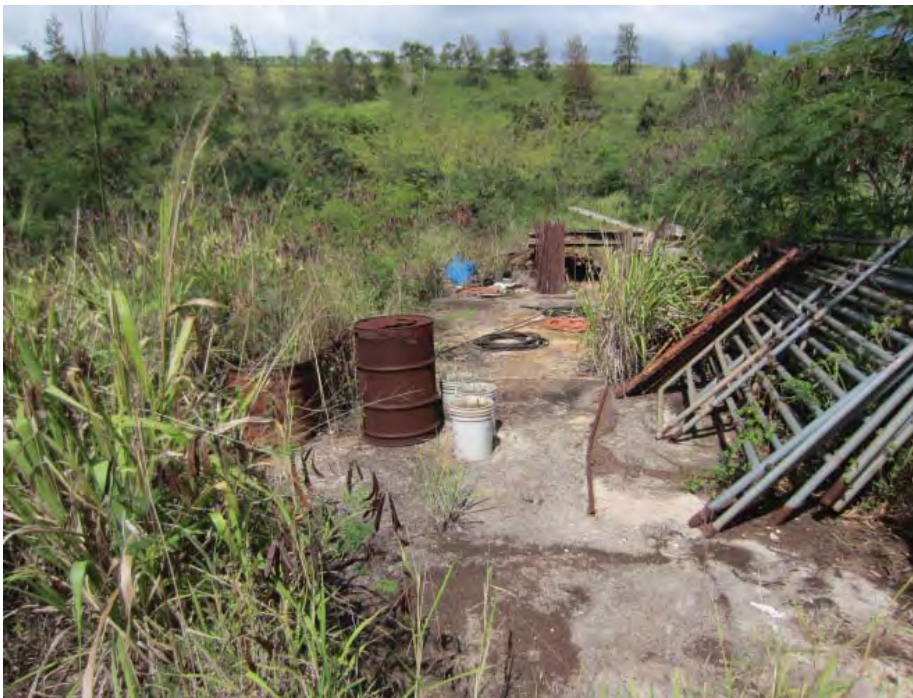
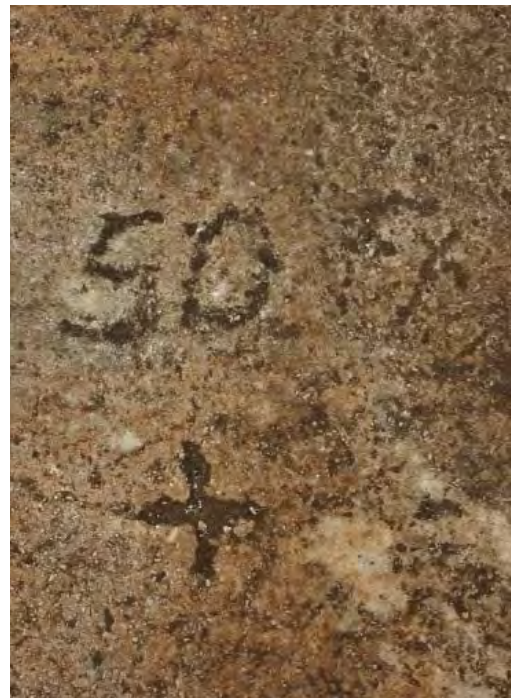
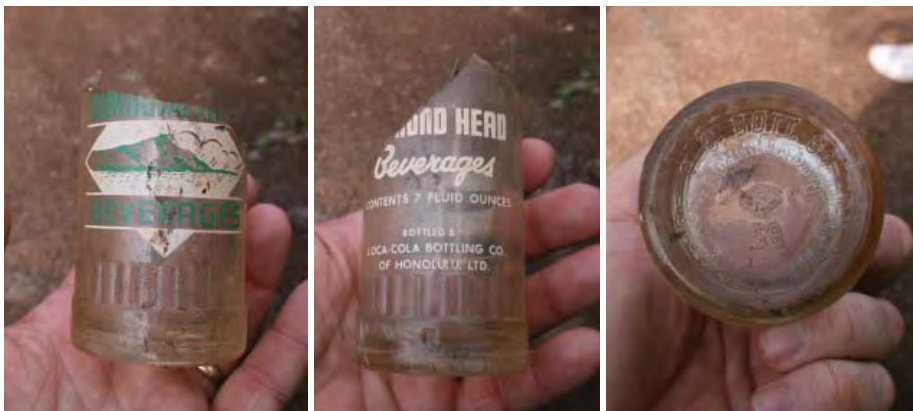
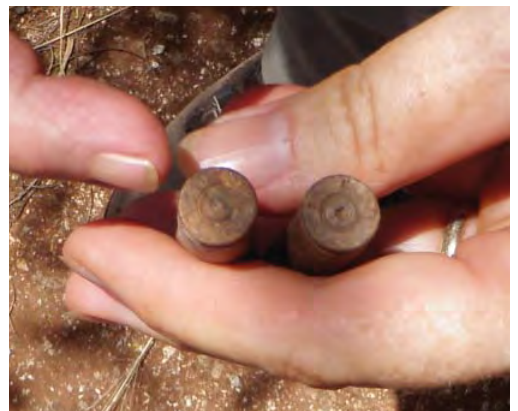
Feature II-1: Mess Hall Foundation (Figures 5.24-5.32)

This feature, at the location of a mess hall on the U.S. Army blueprints, was recorded, partially cleared, and mapped over the course of three field sessions, in 2006, 2008, and 2009. Oriented roughly east-west, the main slab measures 103 feet long by 45 feet wide. There are

two extensions at the northeast corner. One, measuring almost 20 feet long and 16 feet wide (320 square feet), extends north from the east end of the north side. The other, measuring 18½ feet by 11 feet (203 square feet), extends to the east. The main slab has a sloping apron surrounding the slab on the long north and south sides, and a raised concrete stem wall along the west end. Both extensions have raised perimeter walls, except for a doorway between the two. Small rectangular slots along the perimeter wall of the north extension probably held anchors for the superstructure. A concrete apron and retaining wall on the west side of the north extension slab appears to have been a later modification to improve drainage. In the south-

east corner of the main concrete slab, a small room measuring approximately 16 feet by 14 feet is defined by traces of partition walls. Two vertical pipe inlets and a drain in this room suggest the location of a sink. On the large slab, “50+” has been inscribed in the concrete.

Historical photographs may correlate with some of the modifications of the mess hall foundation. One photograph shows a group of men, some wearing cooks’ aprons, standing in front of the mess hall, which at that time had wire screens in place of walls (see Figure 5.31). By the time of Lodge’s photograph, the mess hall appears to have been enclosed (see Figure 5.32). Lodge’s photograph also shows an additional extension off the south side of the mess hall, with a raised post-and-pier foundation; we did not search for evidence of this addition.

At the time of its recording in 2006, modern supplies and equipment like lumber, ladders, metal fence posts, barbed wire, fence gates, hoses, buckets, plastic pipe, plastic and metal barrels, three water trailers, a utility trailer were stored on the slab. In 2008 there was an

agricultural tractor parked on the slab. Subsequently many of these items were removed, however much remains. One notable artifact found while clearing a portion of the slab in 2008 is a clear glass bottle base embossed “PROP. OF C.C. BOTT. CO. / MADE IN JAPAN / 59.” It has a painted label with “DIAMOND HEAD BEVERAGES” and “DIAMOND HEAD BEVERAGES / CONTENTS 7 FLUID OUNCES / BOTTLED BY COCA-COLA BOTTLING CO., OF HONOLULU, LTD” (see Figure 5.28). The bottle was manufactured in 1959, in Japan. Two cartridge casings were also found at that time (see Figure 5.29).

Figure 5.24. Feature II-1, mess hall foundation (2006).

Figure 5.25. Feature II-1, mess hall foundation (2009).

Figure 5.26. Feature II-1, mess hall foundation (2014).

Figure 5.27. Feature II-1, inscription in mess hall concrete slab (2006).

Figure 5.28. Feature II-1, bottle found at mess hall foundation (2008).

Figure 5.29. Feature II-1, cartridge casings found at mess hall foundation (2011).

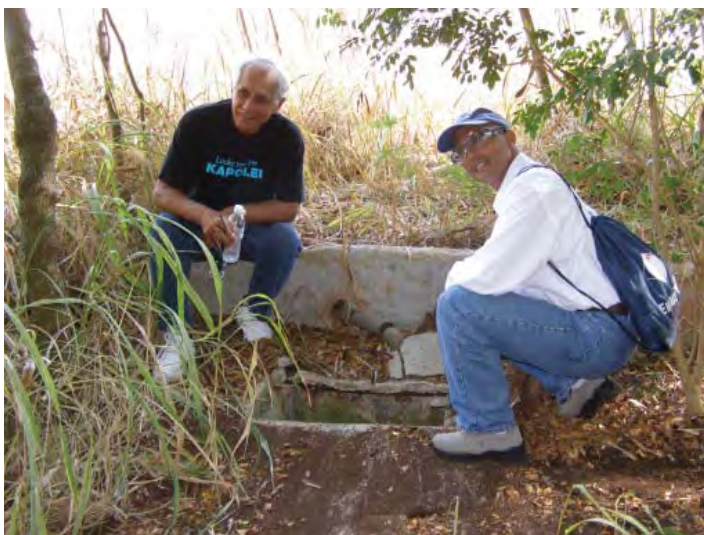
Figure 5.153. Feature V-1, mess hall septic tank prior to clearing (2007).

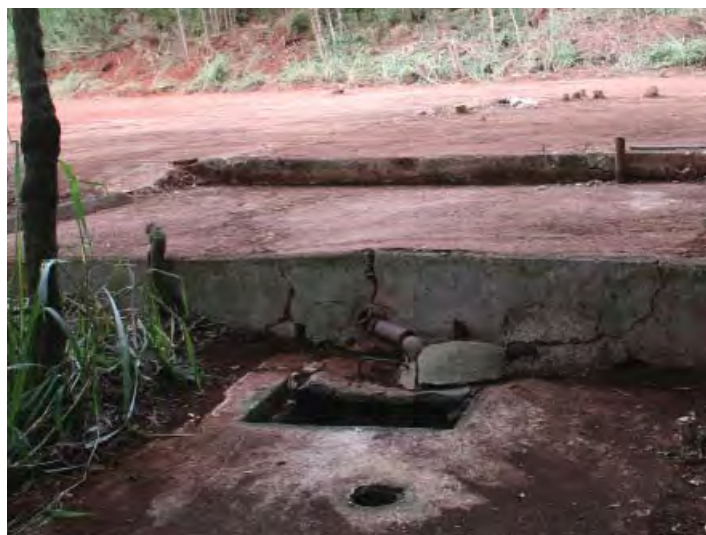
Figure 5.154. Feature V-1, mess hall septic tank after clearing (2009).

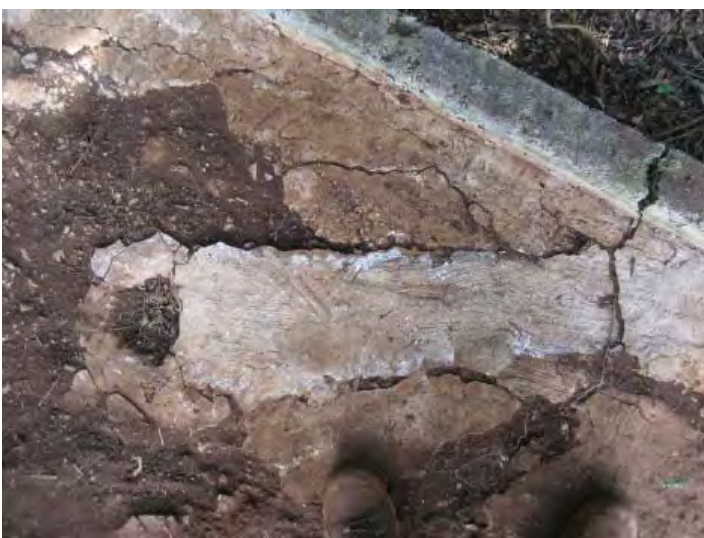
Figure 5.155. Feature V-1, concrete patch in west extension slab (2009).

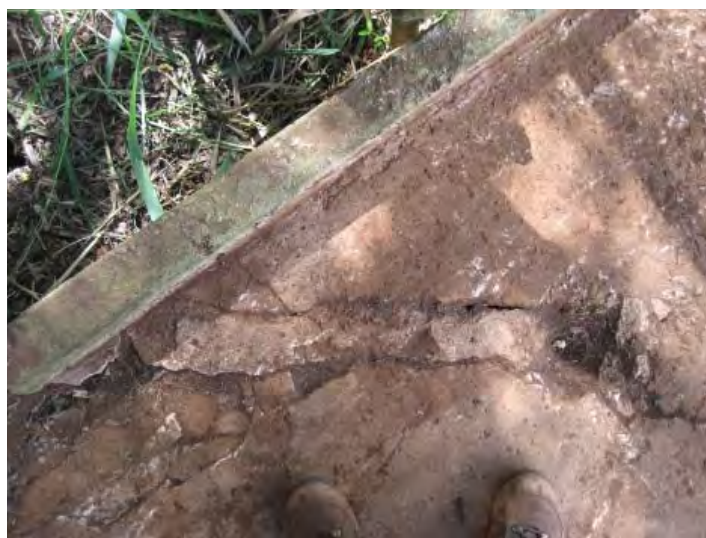
Figure 5.156. Feature V-1, concrete patch in west extension slab (2009).

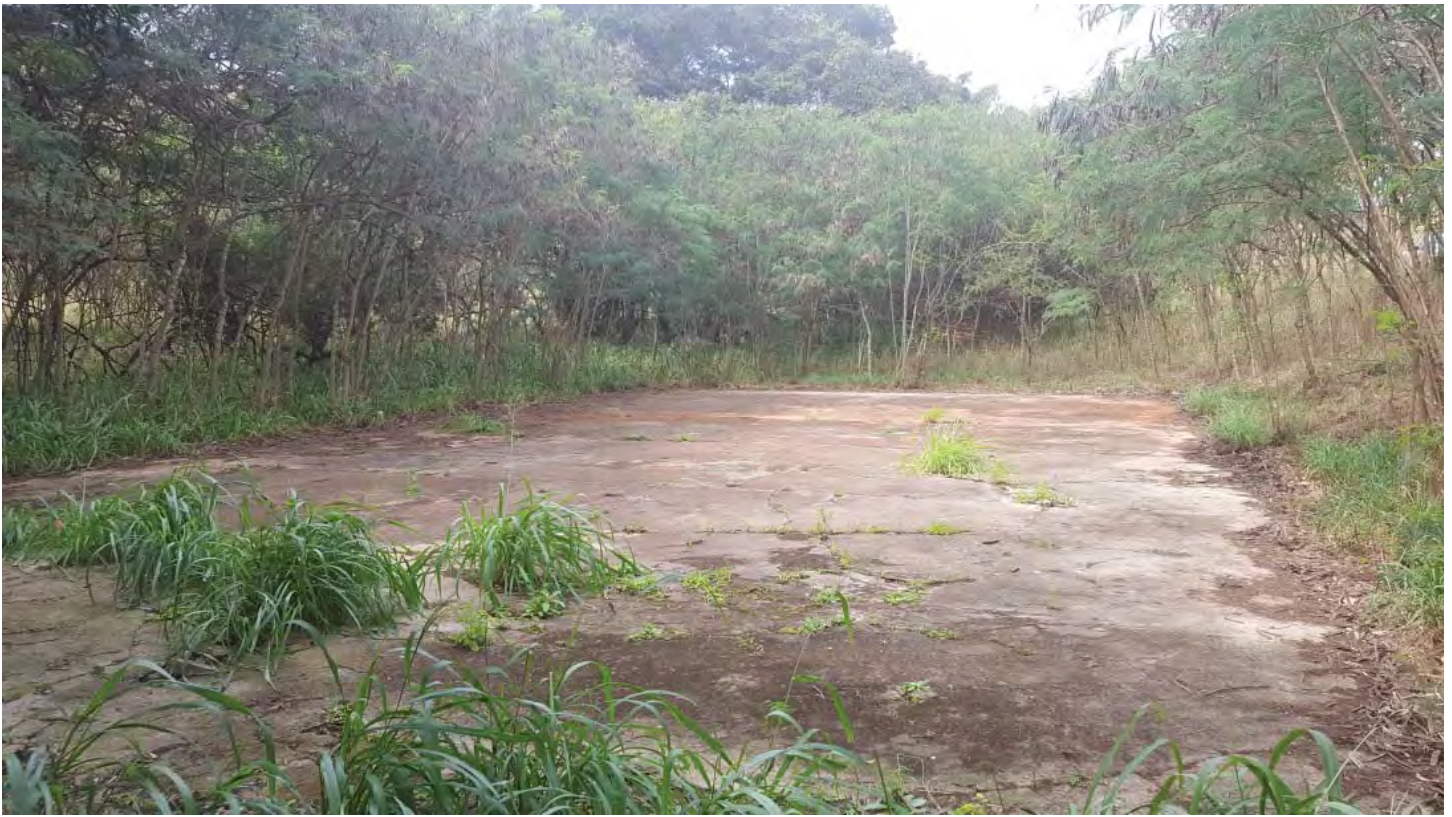
Figure 5.165. Feature V-1, internee mess hall foundation today (2017).

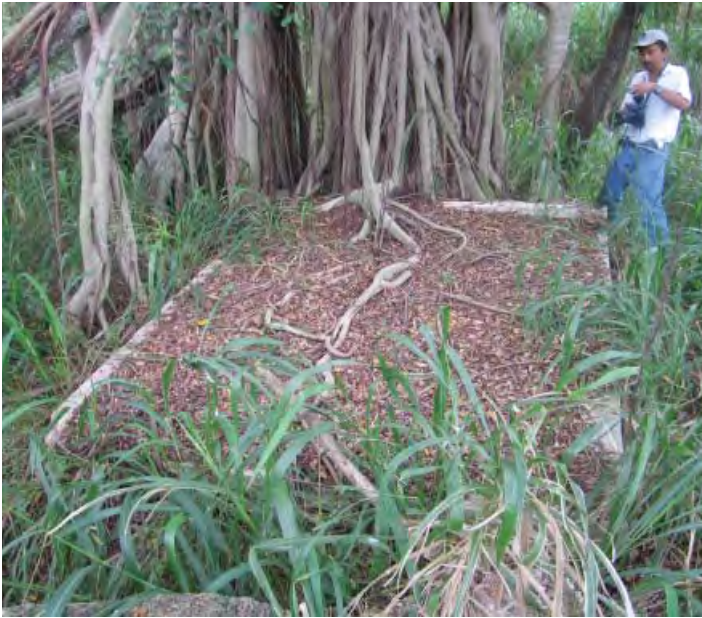
Two concrete slabs, apparently upside down, are at the location of a water-borne latrine on the U.S. Army blueprints. One measures 10 feet 1 inch by 9 feet 4 inches, the other 10 feet by 8 feet 5 inches. Both are about 16 inches thick. Noted during the 2006 reconnaissance, they were recorded in 2008.

Figure 5.167. Feature V-2, displaced concrete slabs (2006).

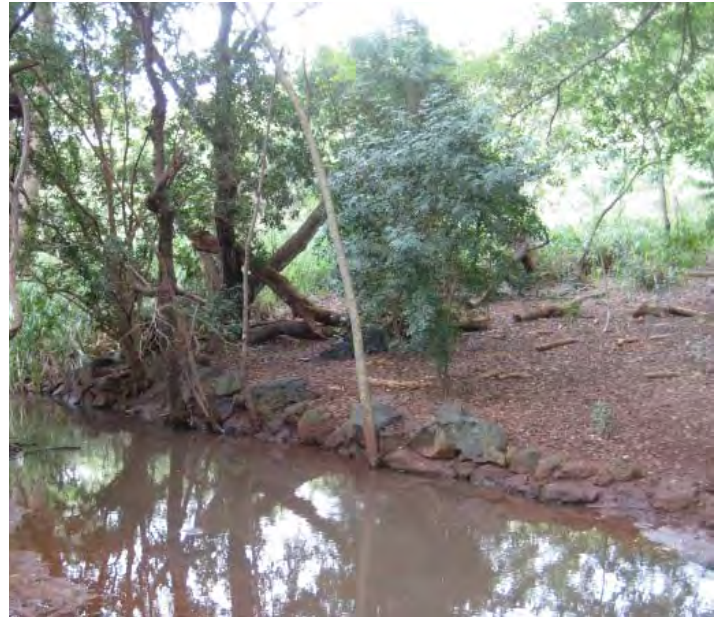
This feature is a rock retaining wall along the stream bank, composed of dense basalt and vesicular basalt cobbles and boulders up to over 2 feet in length. The retaining wall is up to 31 inches high, mostly just one to two courses, and at least 40 feet long (it extends upstream into dense brush). The wall may have been constructed to stabilize the Honouliuli Gulch stream channel; historic photographs and the U.S. Army blueprints show a footbridge at this location. The wall is visible in historic photographs. Noted during the 2006 reconnaissance, it was recorded in 2008.

Figure 5.168. Feature V-3, rock wall (2008).

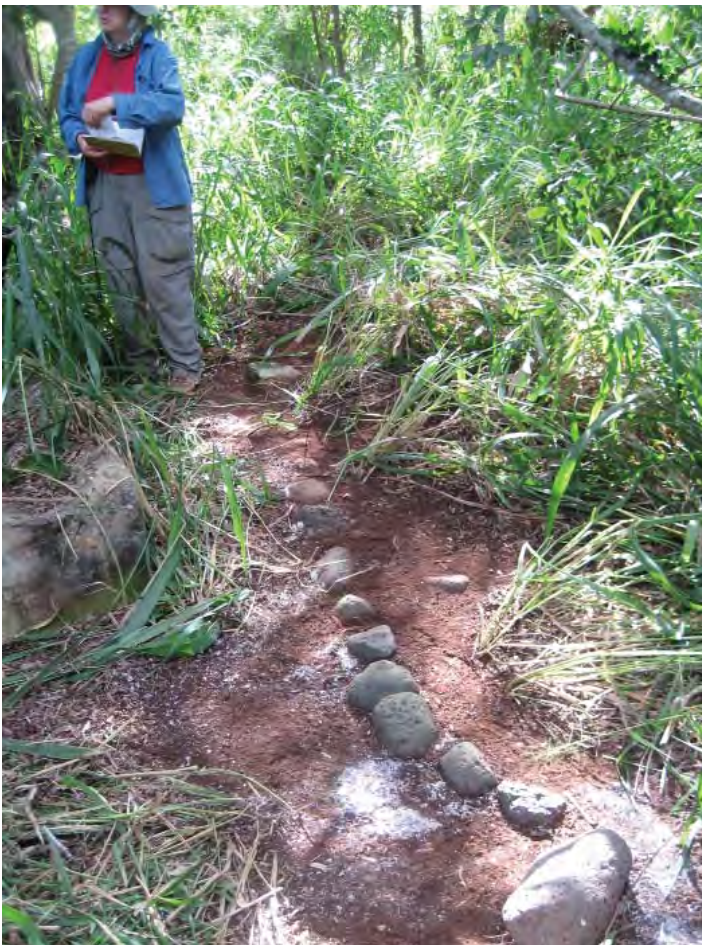
This rock alignment is at least 13 feet long, composed of about 18 rocks that form a straight line for about 9 feet roughly perpendicular to the road, then curve to the north for another 5 feet. The rocks may have lined a pathway, since other rocks and concrete fragments in the vicinity may indicate a building platform. Further complicating interpretation of this feature is an overturned latrine slab (Feature V-2), which indicates the area has been subject to heavy ground disturbance. The alignment was noted in 2006, and further examined in 2008 and 2009.

Figure 5.169. Feature V-4, rock alignment (2009).

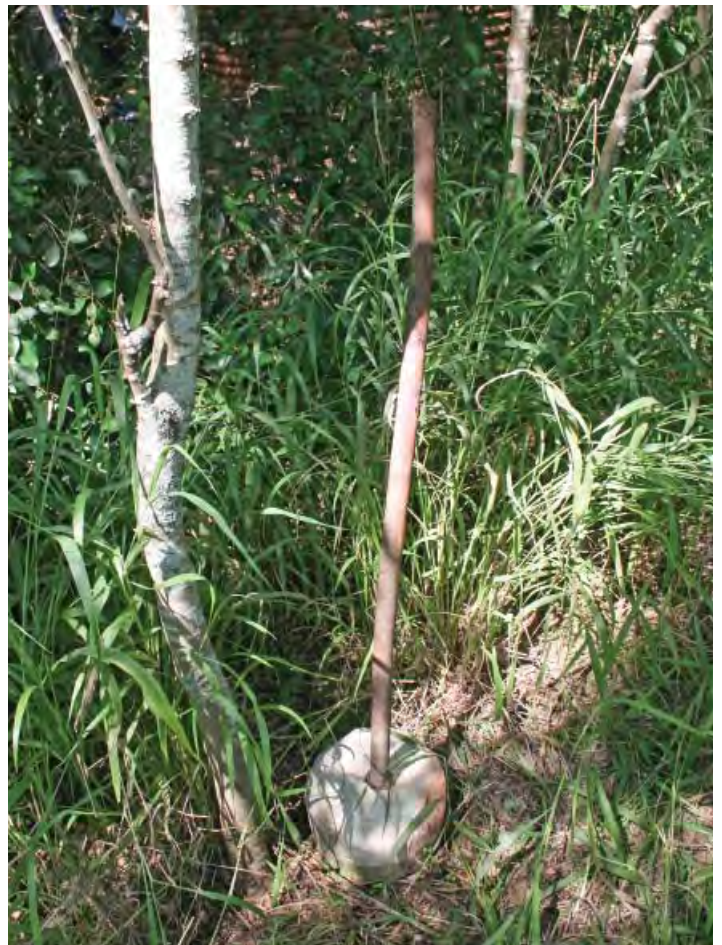
Figure 5.170. Feature V-5, post with concrete support (2017).

Recorded in 2008, this feature is a hollow metal post set in a round concrete base. The post is 4 feet 3 inches long; the concrete is 6 inches high and about a foot in diameter. It appears as though a bucket (with nails

inside) was used as the form. The feature may be from the post-World-War-II ranching era. There is a concrete fragment 1 foot by 8 inches in size located 100 feet west.

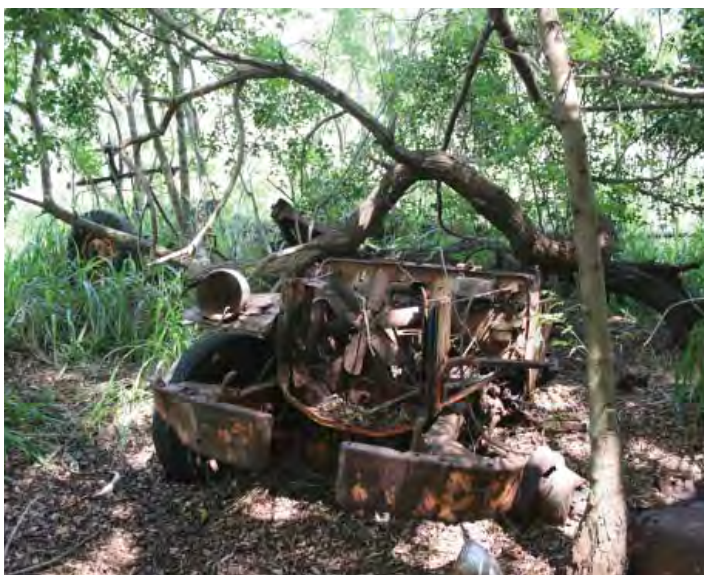
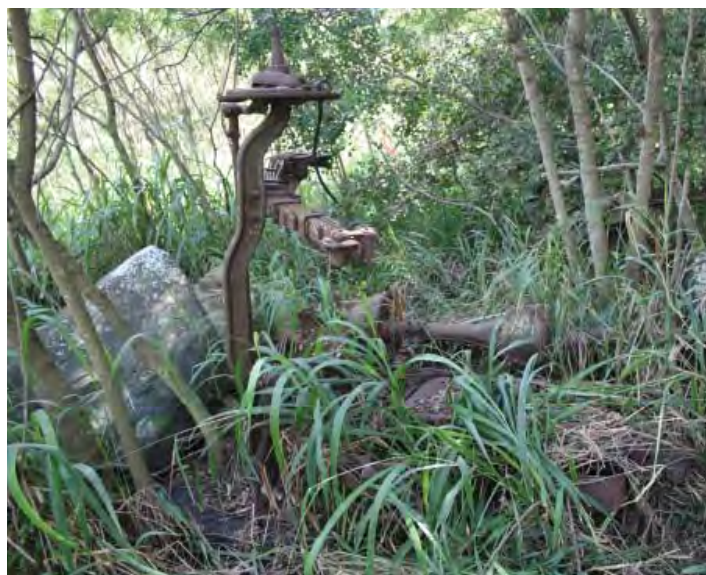
Figure 5.171. Feature V-6, vehicle (2008).

Figure 5.172. Feature V-6, vehicle parts (2008).

Vehicle parts, representing at least two vehicles, were abandoned adjacent to the Compound V mess hall, including the front end of a truck; a differential with a tire and a separate gas tank; another differential; and a front axle with leaf spring and tire and steering linkages. Plate glass fragments, pieces of chrome and other metal, a license plate (“ALOHA / 63-380 / HAWAII”), and wire cable were also found. The vehicle parts were noted during the 2006 reconnaissance, and in his 2010 class project, Joseph Zdyrski examined the front end of the truck more closely and compared it to World-War-II vehicles. Zdyrski (2010) concluded that it was similar to a Dodge 1/2-ton 4-wheel-drive truck dating to the early 1940s, but its abandonment here may postdate the camp. Feature VI-6, pier foundations for a garage, is located just to the south.
