Honouliuli POW and Internment Camp

Archaeological Investigations at *Jigoku-Dani*
2006-2017

Mary M. Farrell

December 2017

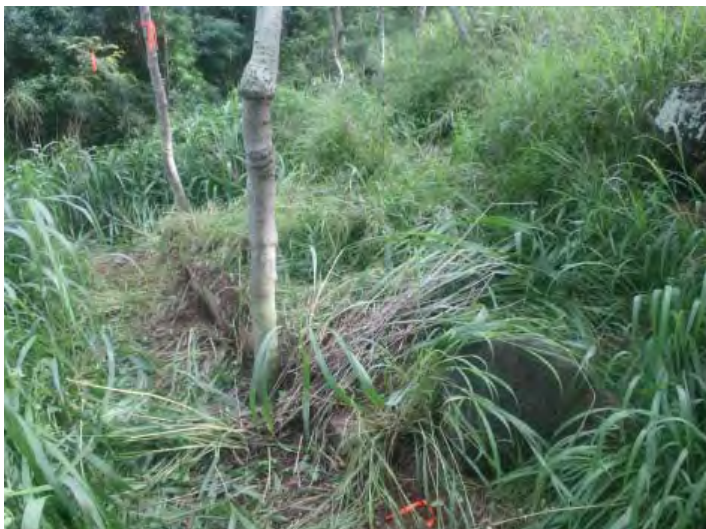
Found in 2008 and partially cleared and mapped in 2010, this feature is a concrete foundation, located on the artificial terrace above the barracks of Compound V. A “water borne latrine” is shown here on the U.S. Army blueprint; historic photographs show a rectangular building at the location (see Figure 5.181). The concrete foundation measures 26 feet by at least 12 feet; overburden over a foot deep and boulders cover the western portion, estimated to be about a third of the overall slab. A stem wall, 4 inches wide and 4 inch-

es tall, defines the perimeter of the slab. Portions of the stem wall are broken off along the northeast edge of the slab, but the wall remnants indicate doorways on each end of the building and a closet or storage room in the north corner. A channel had been chiseled into the concrete slab to drain water away. The larger, open portion of the slab has four toilet drains, each with four small holes where bolts held the toilet base. Bolt holes between the toilets indicate there were partitions between them. Fragments of a white porcelain toilet include the lid, which is stamped inside: “K 4541 / 81 / 9 8 42.” The last set of numbers indicates the date the toilet was manufactured, that is, September 8, 1942. A deteriorated metal urinal was found in the northeast corner. Three pieces of electrical porcelain (a complete split-knob marked “KNOX[?] No. 2½”, a split-knob base, and a solid spool insulator) indicate the building had electrical lights.

Figure 5.173. Feature V-7, internee latrine foundation prior to clearing (2008).

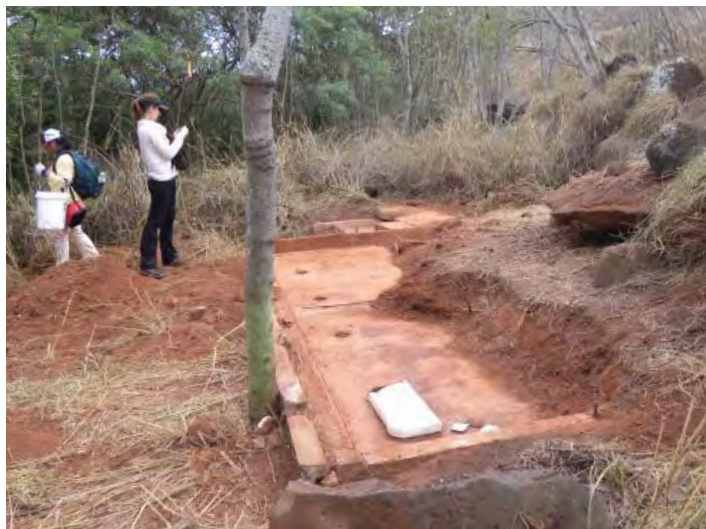
Figure 5.174. Feature V-7, internee latrine foundation after partial clearing (2008).

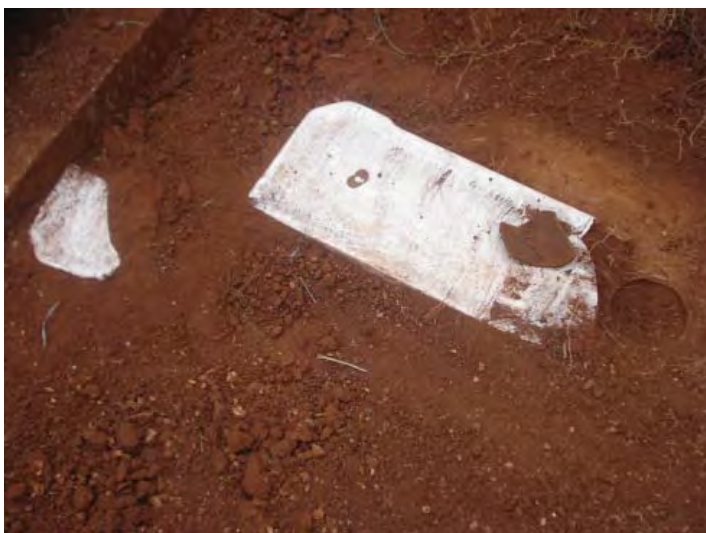
Figure 5.177. Feature V-7, broken toilet tank top uncovered at latrine (2008).

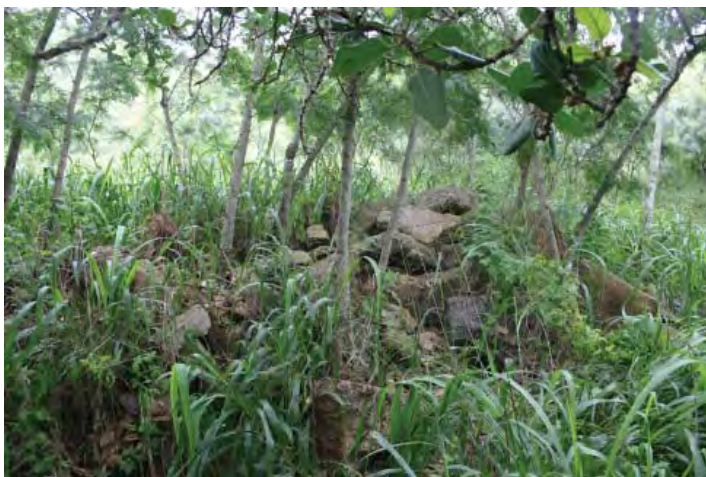
Recorded in 2008, this feature consists of concrete debris pushed into a pile about 40 by 20 feet in size, now overgrown with grasses and small trees. Near the location of a water-borne latrine on the U.S. Army blueprints, the debris includes slabs, some with small regularly spaced peck marks (possibly shower floors made slightly irregular to improve traction). Also in the pile are two fragments of concrete sink, one marked “... WESELY & CO / PAT. / [S]EPT 29, 1885 / [J]UNE 19, 1886.”

Figure 5.182. Feature V-8, concrete debris from latrine (2008).

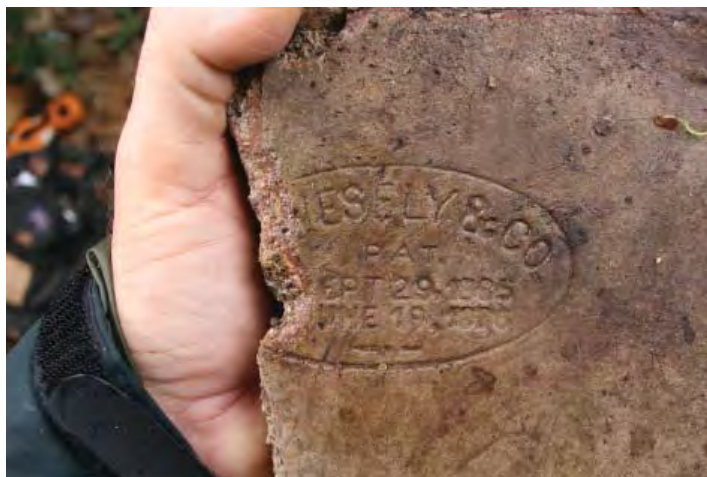
Figure 5.183. Feature V-8, sink fragment (2008).

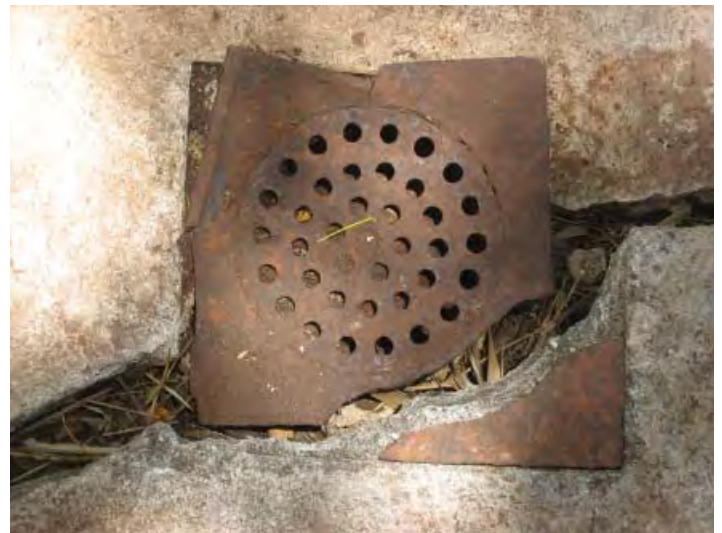
Figure 5.346. Feature VI-32, drain detail (2011).

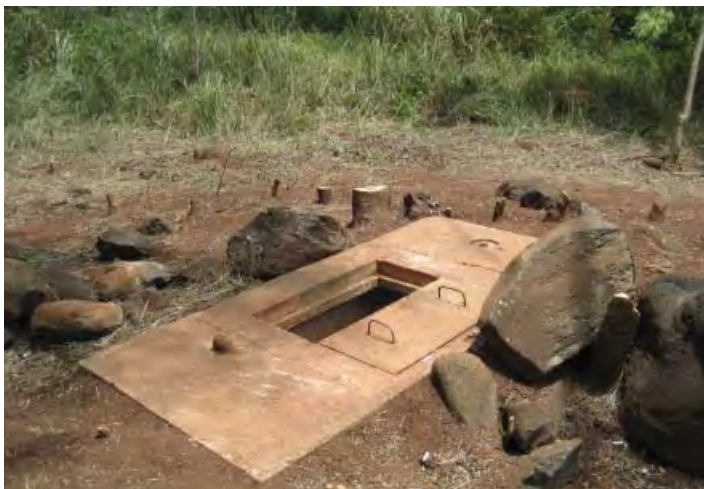
This concrete feature is a septic tank shown on the U.S. Army blueprints and visible in the background of some of Glenn Heern’s photographs (see Figure 5.361). Located on the slope below the latrine and shower building, it is a partially buried rectangular concrete box. When first recorded in 2008, measurements were imprecise because it had been partially covered with dirt and basalt boulders from the slope above; this debris was removed for the 2011 recording. On the surface it measures about 9 feet by 4½ feet, with a central hatch

opening about 3 feet 4 inches square. The top is up to 4 inches above the ground surface, and the interior is at least 7 feet deep. One of the two hatch covers is missing. On the top of the tank there is a 6¾-inch-diameter clean-out pipe at the downhill end, and a 2¼-inch-diameter vent pipe at the uphill end.

Figure 5.362. Feature VI-33c, septic tank after clearing (2011).

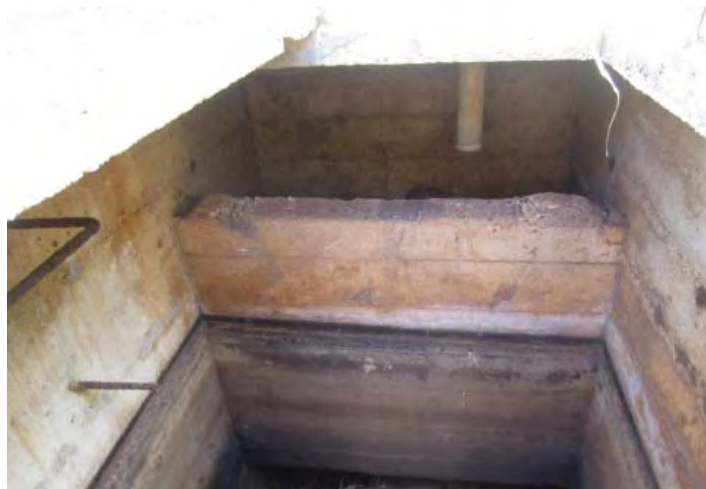
Figure 5.363. Feature VI-33, septic tank interior (2011).

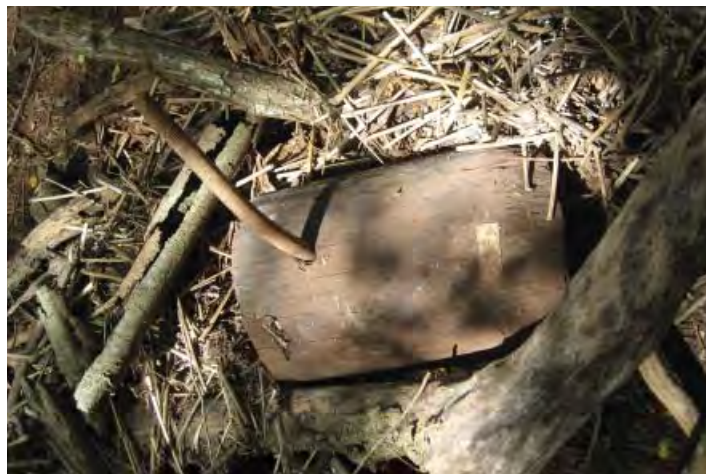
A short pole, about 1 foot in diameter and 1 foot 4 inches long, was found attached to the ground near the Honouliuli stream in 2008. The pole has a sunken hexagonal-headed bolt (and possibly a metal washer) in the side. On the bolt head are the initials "PFC." At the approximate southern boundary of the Japanese men's compound, the pole may have been associated with the security fence or a stream crossing. The pole was moved by a flood in 2009.

Figure 5.370. Feature VI-35, displaced wood pole section (2009).

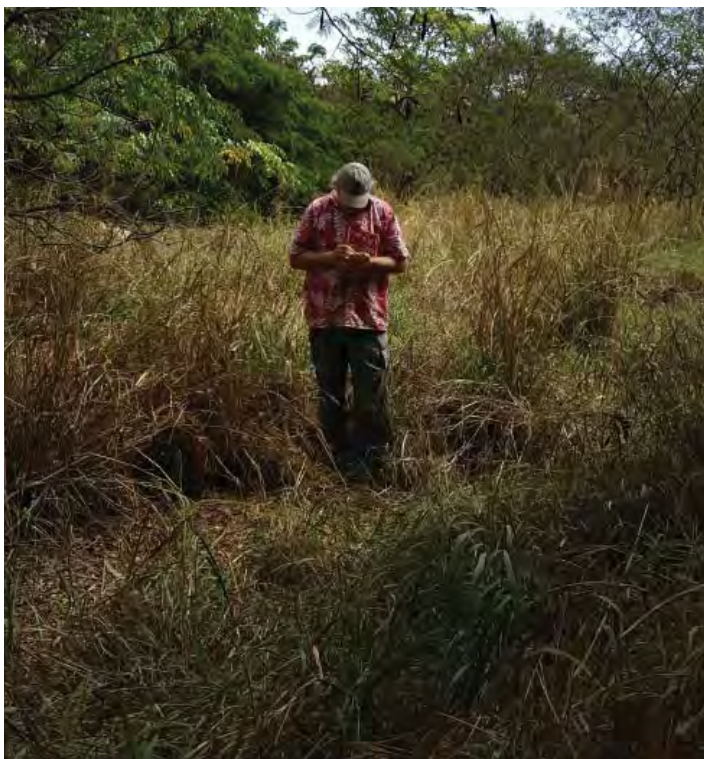
Depicted on the U.S. Army blueprints, this manhole is similar to the others in the camp system. This feature, recorded in 2008, is missing its lid.

Figure 5.371. Feature VI-36, sewer manhole depression (2017).

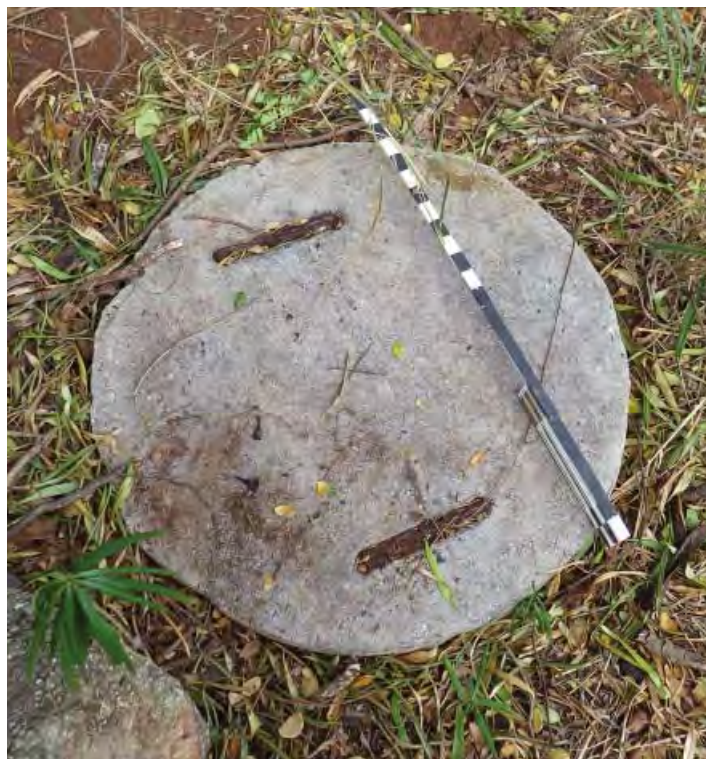
This manhole lid, recorded in 2008, may have been from the manhole recorded as Feature VI-36, above, but was found about 75 feet away. It has a handle made of rebar, similar to that of Feature V-9, but without an inscription.

Figure 5.372. Feature VI-37, displaced sewer manhole cover (2017).

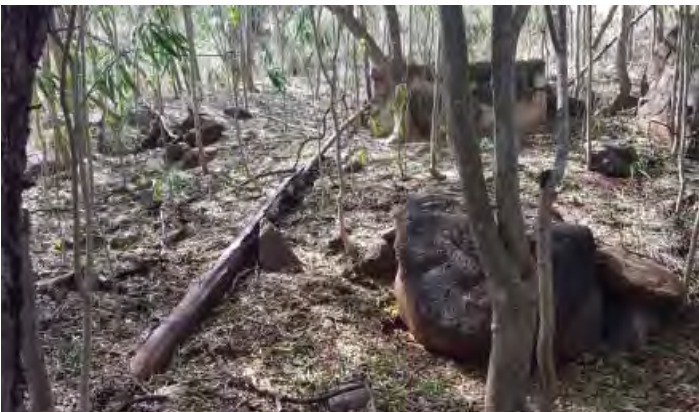
This feature, depicted on the U.S. Army blueprints, consists of a large concrete foundation, measuring 6 feet 1 inch square in plan. Set on a slope, the flat top is 2 feet 8 inches above the ground surface on the downhill side, and less than a foot above the ground surface on the uphill side. About 50 feet of a once-connected water pipe measuring 2 3/8 inches in diameter is exposed on the ground surface. Water appears to have come from the northwest to the feature (with an outlet coupling on the upslope side) and then continued down the southeast side of the foundation sheathed

in metal, rubber, and green and white insulation remnants. There is no rust stain visible, but its solid construction and the adjacent water pipe indicates the foundation was probably a foundation for a water heater.

Figure 5.375. Feature VI-38, water heater building foundation and insulated water pipe (2017).

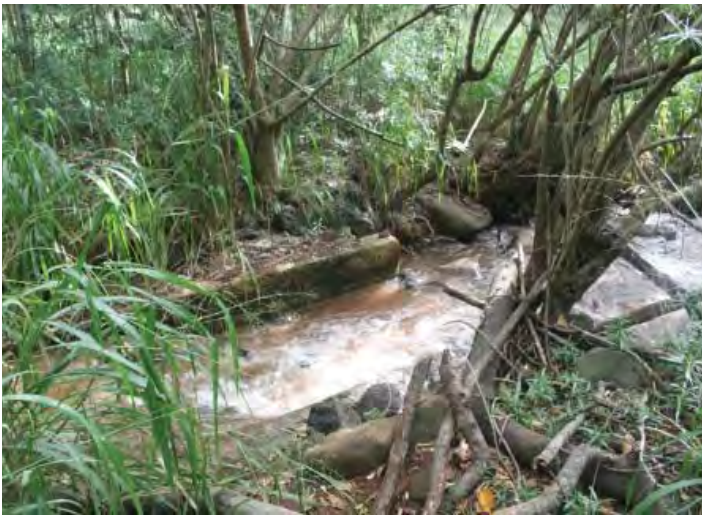
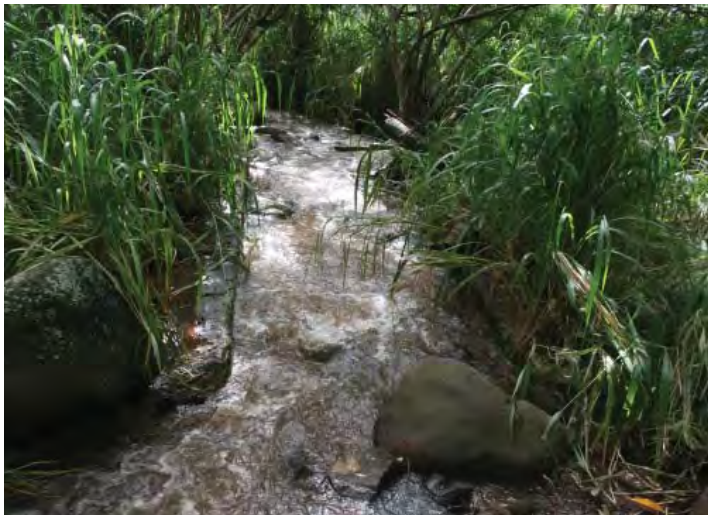
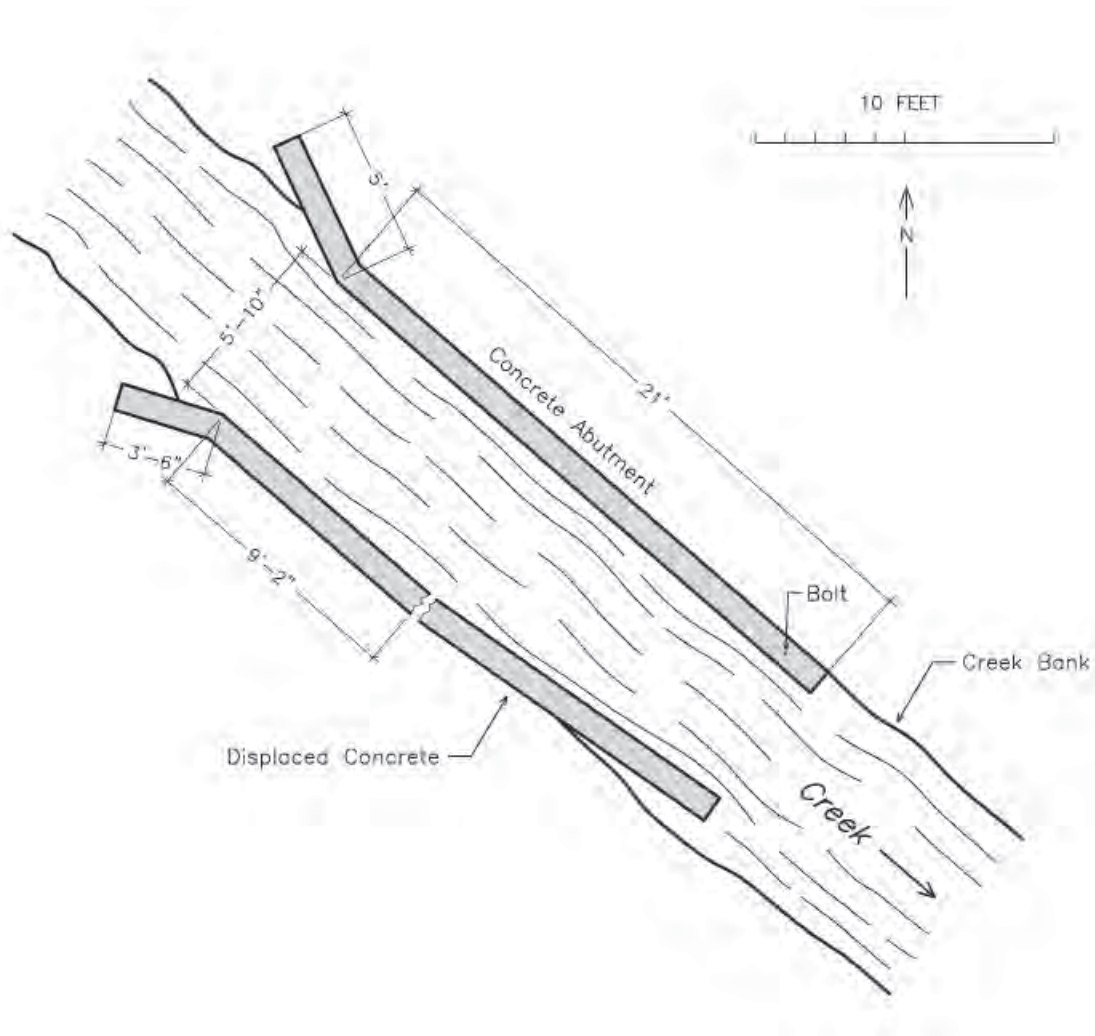
This feature, mapped in 2008, consists of concrete bridge abutments along the banks of Honouliuli stream. The bridge, for a road, is depicted on the U.S. Army blueprints. The abutment on the northeast bank is 26 feet long total, almost a foot wide, and at least 2 feet tall. The abutment on the southwest bank

is slightly shorter and broken, with the southernmost section slightly displaced. The northwest (upstream) ends of both abutments angle slightly back toward their respective banks, to keep the water flow within the channel.

Figure 5.380. Feature VI-41, concrete bridge abutments (2008).

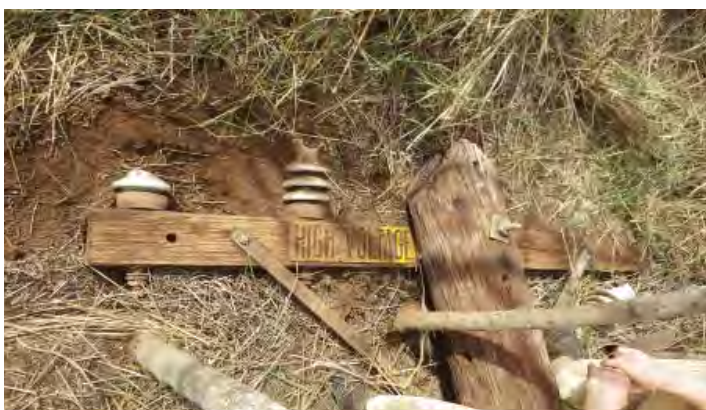
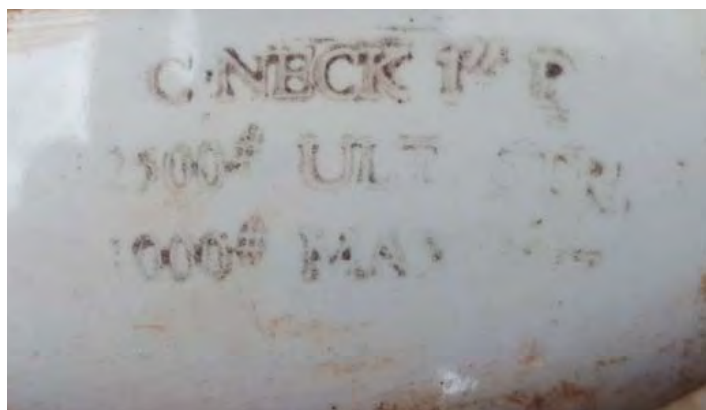
Feature VII-16: Cut Wood Power Pole (Figures 5.504-5.507)

Figure 5.505. Feature VII-16, top of cut wood power pole (2017).

Figure 5.506. Feature VII-16, detail of ceramic power pole insulator (2017).

When first noted in 2014, Feature VII-16 was recorded as a cut-off power pole, standing about 3½ feet tall, and 1 foot in diameter. When revisited in 2017, vegeta-

tion was less dense, and the rest of the pole was visible, lying on the ground with the crosspiece and insulators still attached. The length on the ground is 36.6 feet; insulators are printed “LAPP 15” and “C NECK 1” (?) / 2500 # ULT STR / 1000 # MAX ...(?).”

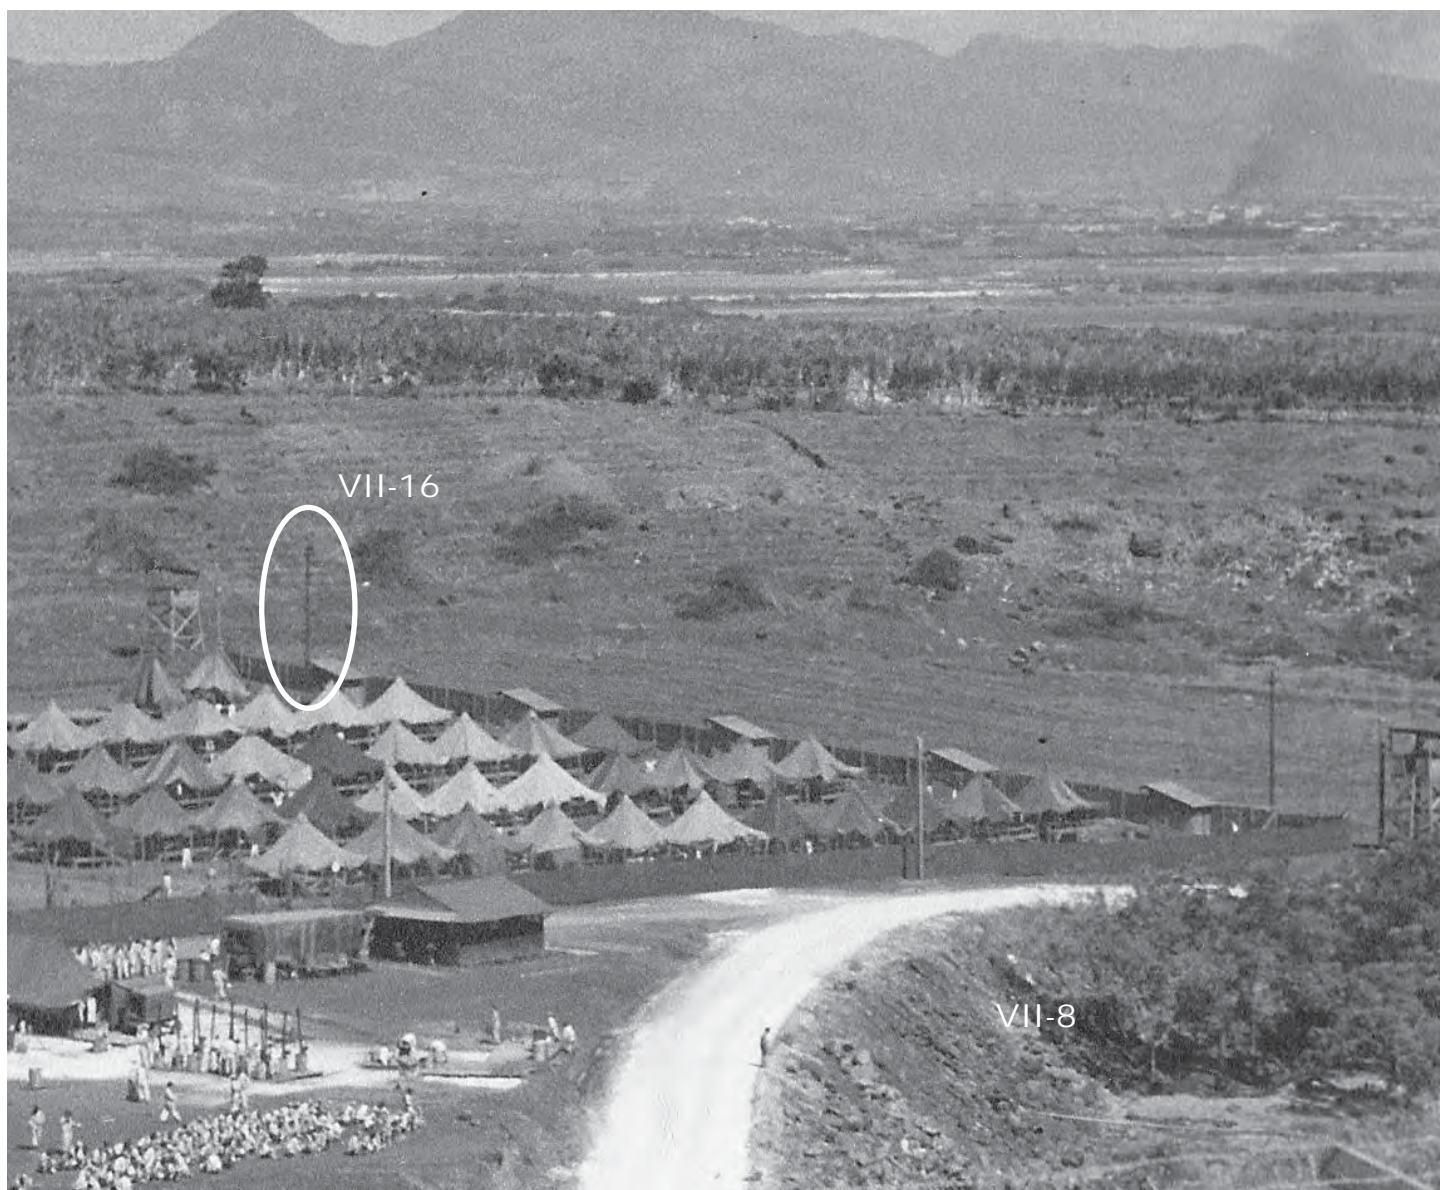
Figure 5.507. Feature VII-16, wood power pole ca. 1945 (detail of R.H. Lodge photograph).

This power pole is visible just outside the security fence in one of the historic Lodge photographs (see Figure 5.507). It is also depicted on the 1945 Disciplinary Compound blueprint as one of three poles along a “high-tension power line” that stretches southwest to northeast just southeast of the security fence.

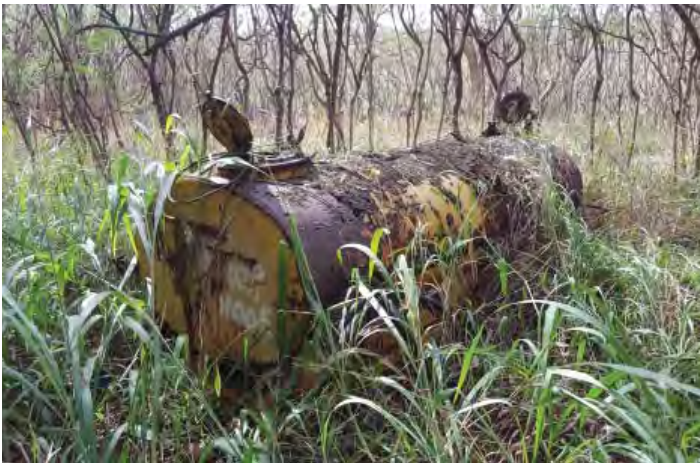
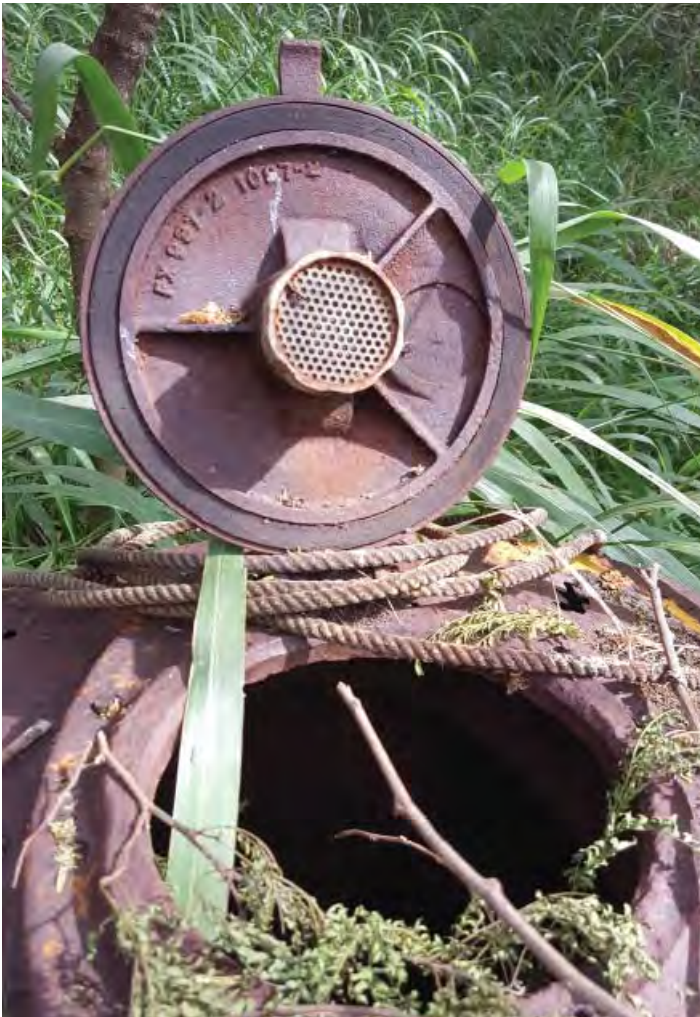
Feature VII-17: Portable Fuel Tank (Figures 5.508 and 5.509)

field visit. Although it looks similar to a water trailer, it was more likely an above-ground petroleum storage tank. One of the cast-iron hatches is embossed “Clay & Bailey,” a company founded in 1913 to produce steel tanks for the petroleum industry. The company had moved to Kansas City, Missouri, by 1923 (www.claybailey.com), but still focuses on petroleum-related products. “Marine Corps” is neatly painted in white letters on one end; casually scrawled over that is “91-(?)029/#005.” Inside one of the lids is embossed: “FX (or FY?) 937-2 109(?)7-2.” There are two hatches on top, one at each end of the tank, and both lids appear to be vented. The tank sits on skids, rather than a trailer. It is not known if this tank was associated with Honouliuli camp, or if it was reused military surplus acquired for the later sugar cane fields.

Figure 5.508. Feature VII-17, fuel tank (2017).

Figure 5.509. Feature VII-17, detail of fuel tank (2017).

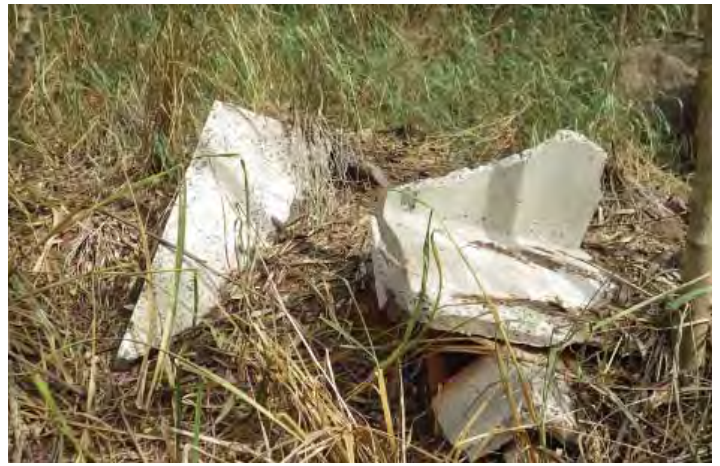
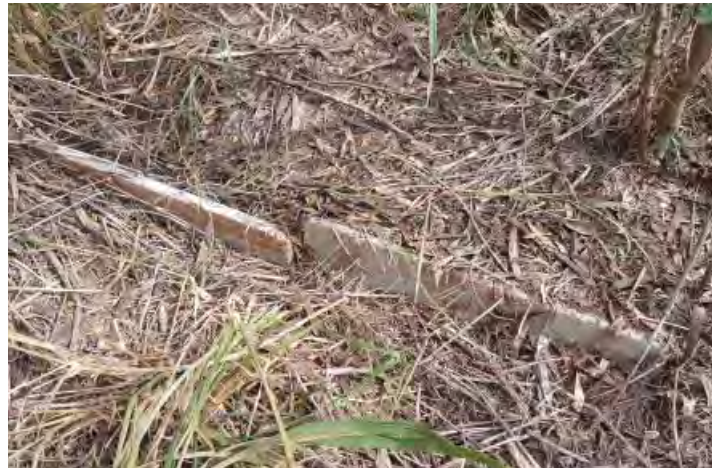
Feature VII-18: Concrete Trough (Figures 5.510 and 5.511)

Figure 5.510. Feature VII-18, concrete irrigation trough fragments (2017).

Figure 5.511. Feature VII-18, concrete irrigation trough (2017).

These fragments of a post-World-War-II concrete trough were noted in 2017.

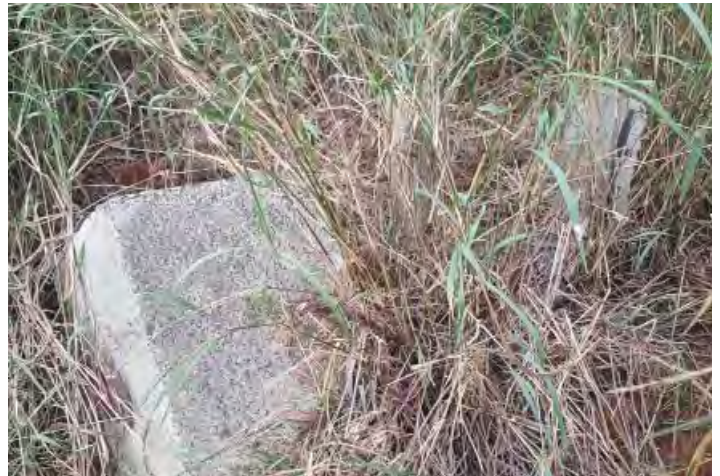
Feature VII-19: Concrete Trough (Figure 5.512)

Figure 5.512. Feature VII-19, concrete irrigation trough fragments (2017).

This concrete trough, also noted in 2017, is located on Monsanto Hawai'i land, just beyond the monument boundary.

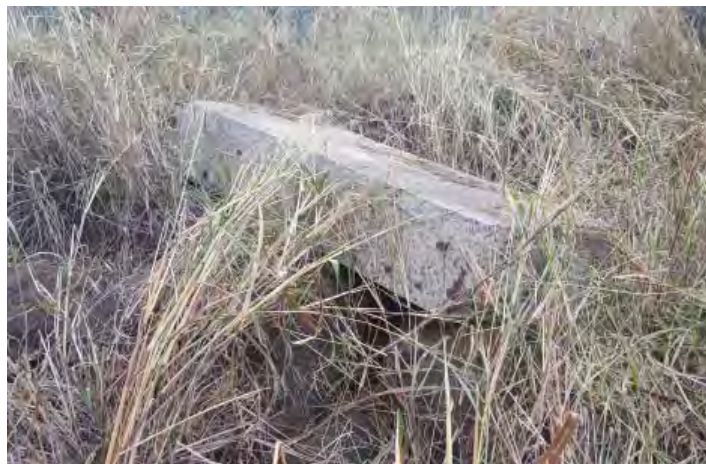
Feature VII-21: Cut Concrete Slab (Figure 5.514)

Figure 5.514. Feature VII-21, cut concrete (2017).

Noted in 2017 and located south of the former communications site, this concrete fragment appears to be a foundation remnant.

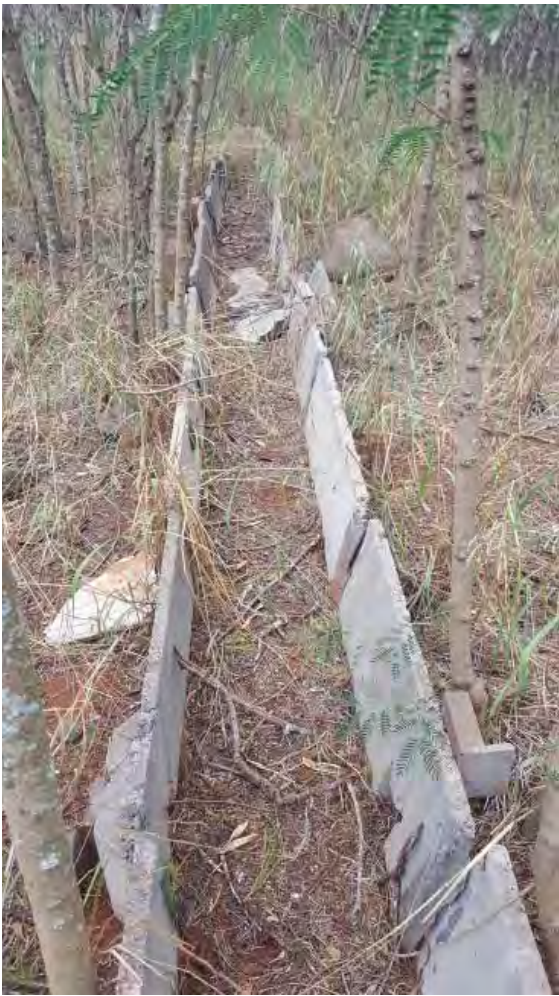
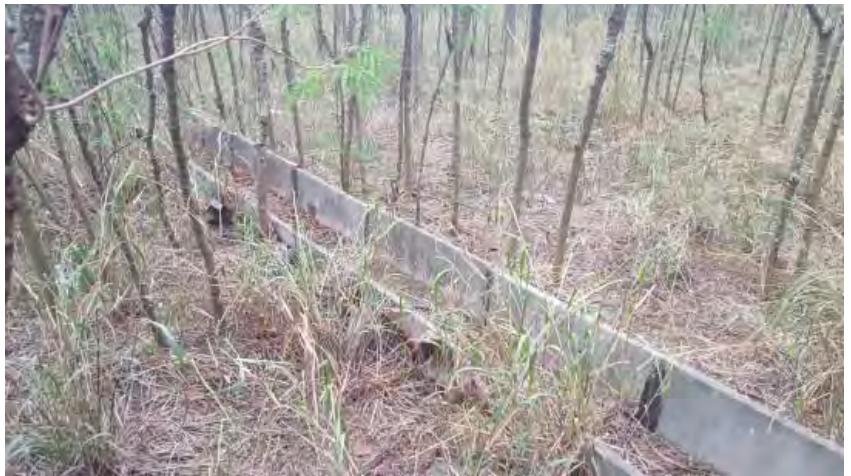
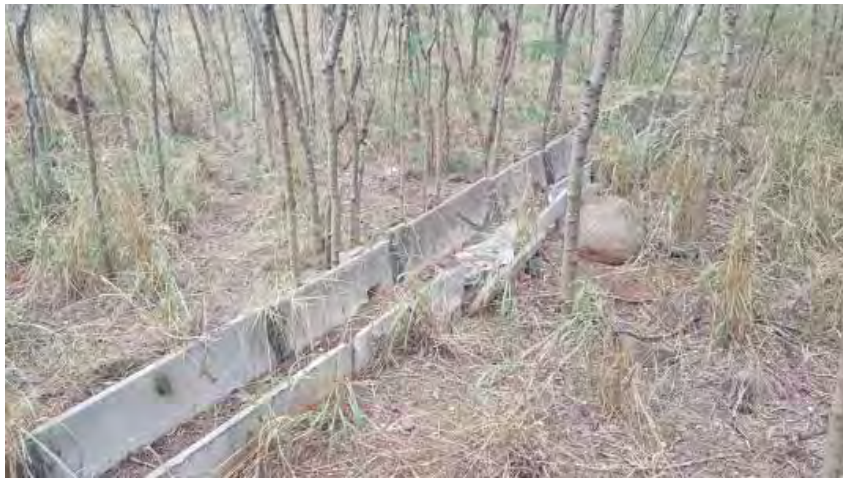
Feature VII-22: Concrete Trough (Figures 5.515-5.517)

This concrete trough, composed of numerous connected segments, was observed in 2017. It is at least 90 feet long.

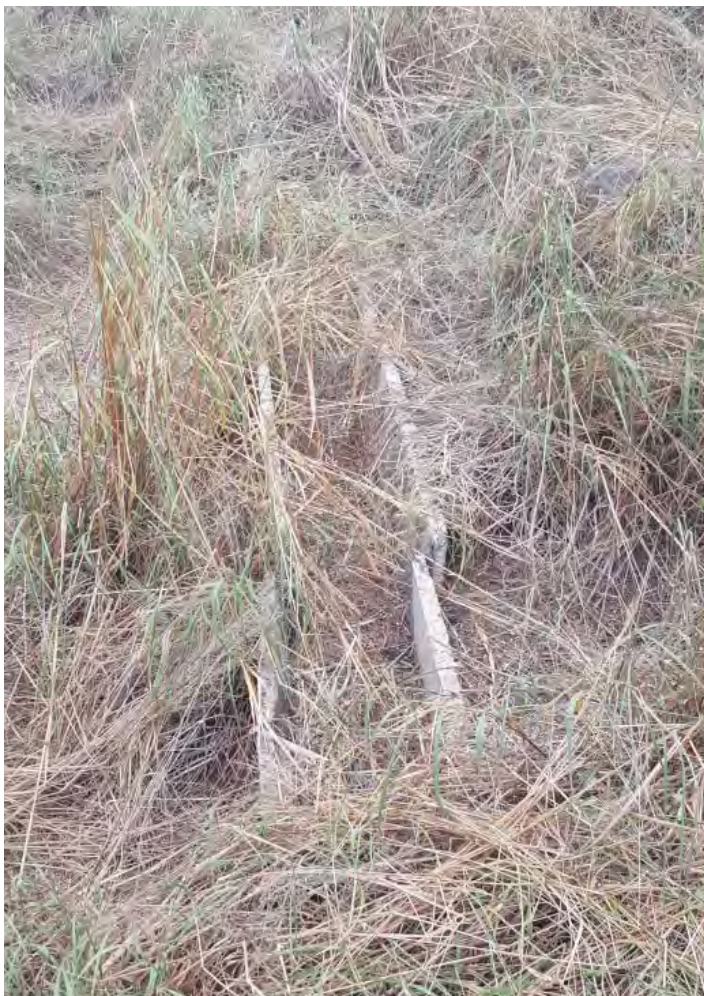
Feature VII-23: Concrete Trough (Figure 5.518)

This trough, observed in the sparse vegetation conditions of the 2017 visit, is about 165 feet long, overall, but about 20 feet of it is missing, buried, or overgrown.

Figure 5.518. Feature V-23, concrete irrigation trough (2017).

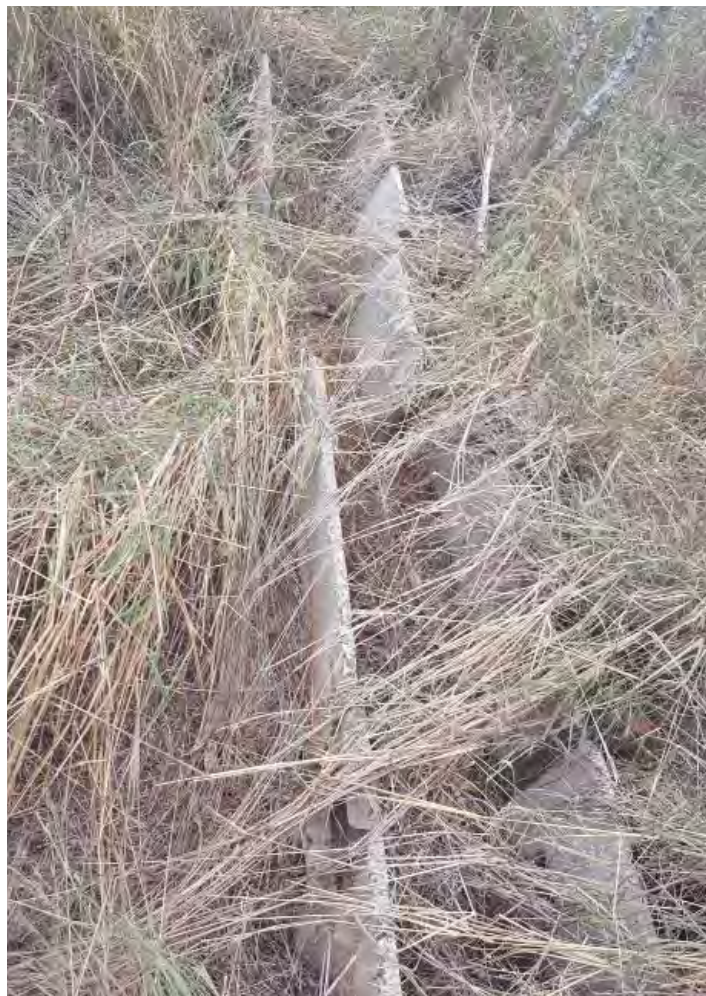
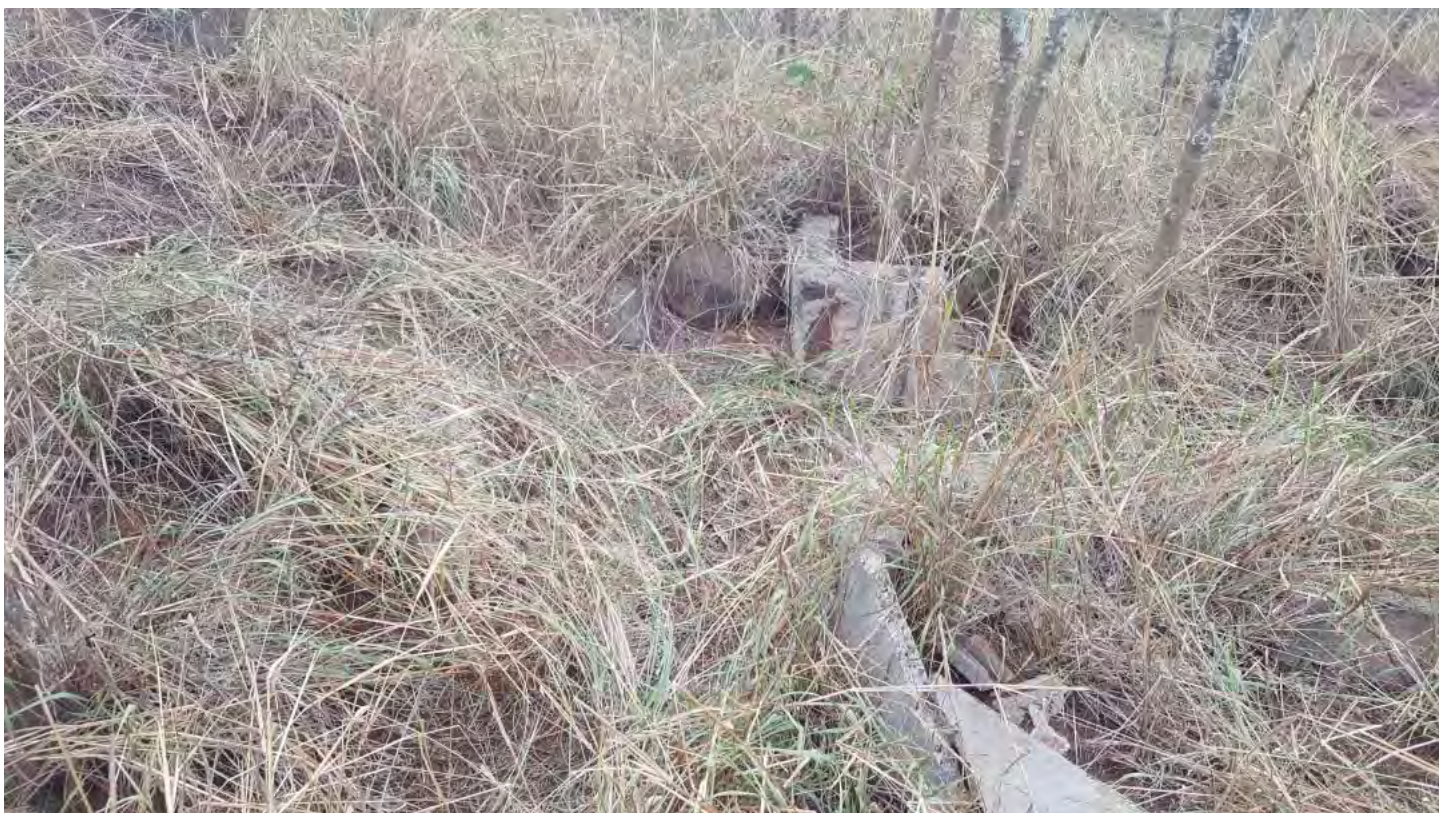
Feature VII-24: Concrete Trough (Figures 5.519 and 5.520)

Observed in 2017, this trough is 190 feet long. At one end the trough branches in two, with one branch extending at least 15 feet.

Figure 5.519. Feature V-24, concrete irrigation trough (2017).

Figure 5.520. Feature V-24, concrete irrigation trough (2017).

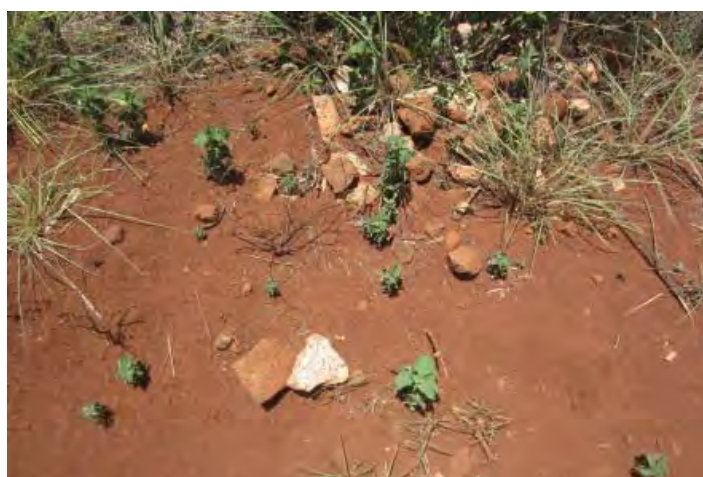
Feature VIII-1: Concrete Fragments (Figure 5.523)

These small fragments of concrete were recorded during the 2012 reconnaissance. Although they were found near where the sewage treatment plant is depicted on the Army blueprints, the fragments are too small to have been part of sewage treatment facilities. Septic tanks and cesspools at Honouliuli are among the most massive features at the site, and sewage treatment

facilities at mainland internment camps are even more substantial. Nevertheless, the fragments are not far from unidentified structures on the Army blueprints, and may be related to the World War II occupation of the gulch. The feature is located on Monsanto Hawai'i land, outside the monument boundary.

Figure 5.523. Feature VIII-1, concrete fragments (2012).

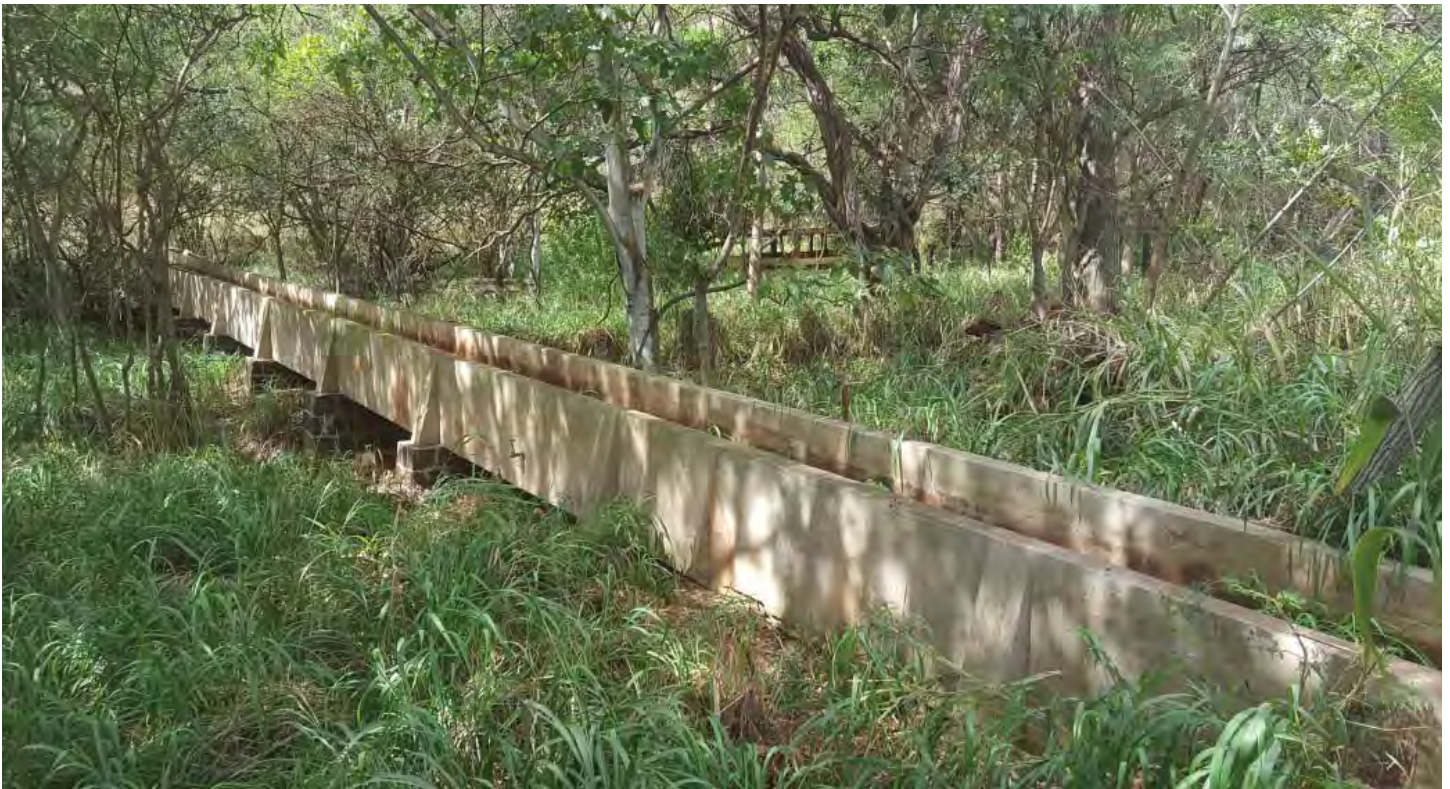
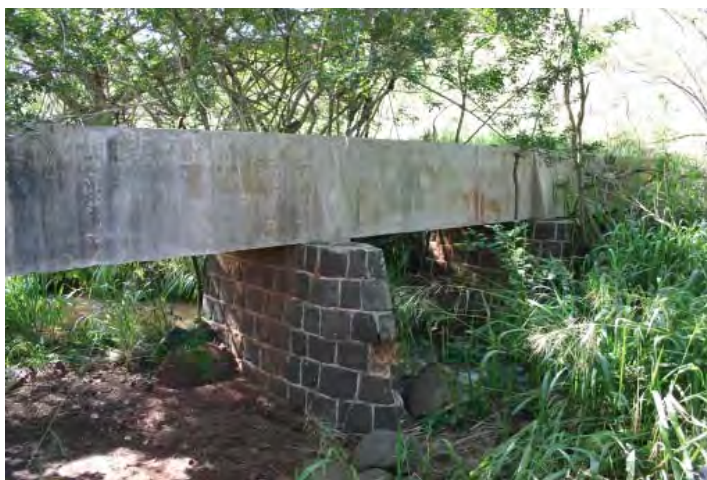
Feature L-1a is the aqueduct that carries the ditch water across the Honouliuli stream (see Figure 5.525 and 5.534) and is visible in historic photographs. Of concrete, it is approximately 170 feet long and is supported by massive piers set at 16-foot intervals. Square-trimmed basalt and mortar give the piers an ashlar facing, although the interior construction is unknown. In cross-section, the concrete aqueduct measures 5 feet 4 inches wide and 4 feet deep overall, with the side walls 8 inches thick and the channel 4 feet wide. The side walls are reinforced by 12-inch-wide concrete pilasters above each pier. The aqueduct channel was cleared of trees and other vegetation in 2012.

Figure 5.525. Feature L-1, aqueduct (2017).

Figure 5.534. Feature L-1a, aqueduct (2006).

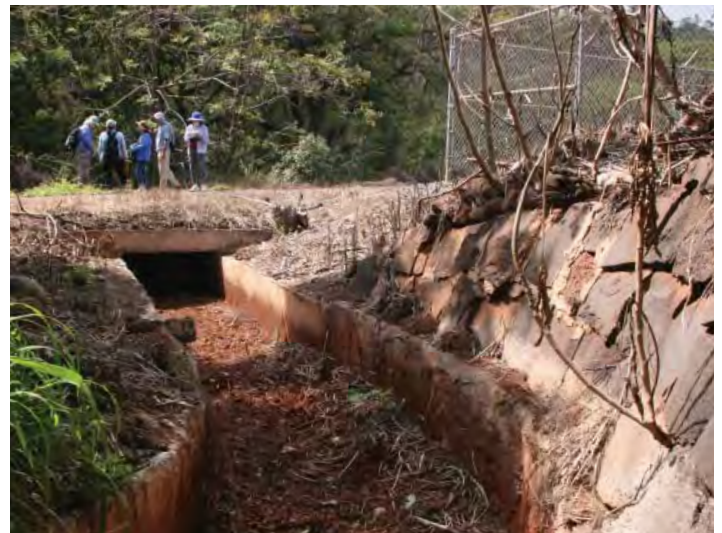
Figure 5.527. Feature L-1, concrete ditch under current road (2008).

The concrete-lined ditch measures about 5 feet 6 inches wide overall, with the channel 4 feet 6 inches wide by at least 2 feet 6 inches deep (sediments preclude accurate depth measurement). The ditch is trapezoidal in cross-section, with the side walls sloping slightly inward so that the channel's width is slightly less at the bottom. Feature V-15, described above, serves as a retaining wall for the ditch. The concrete-walled ditch passes under the road east of the aqueduct (Figure 5.526); a large concrete slab visible under the east edge of the road shoulder may be part of the original road-crossing support (Figure 5.527). Cracks in the ditch expose cobbles used as

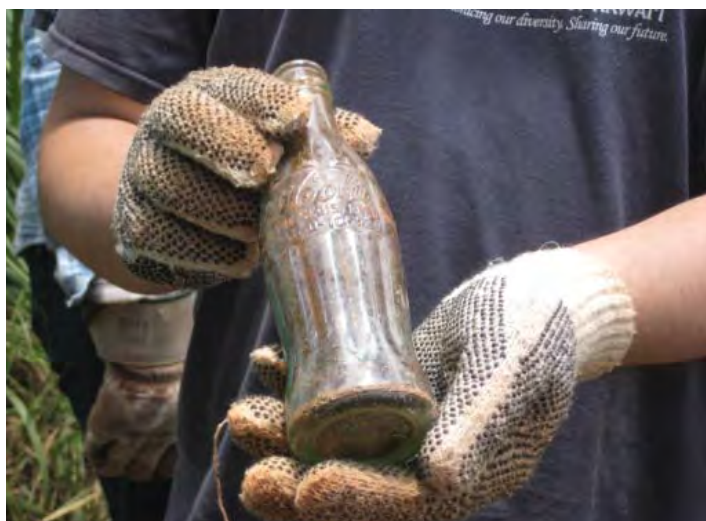
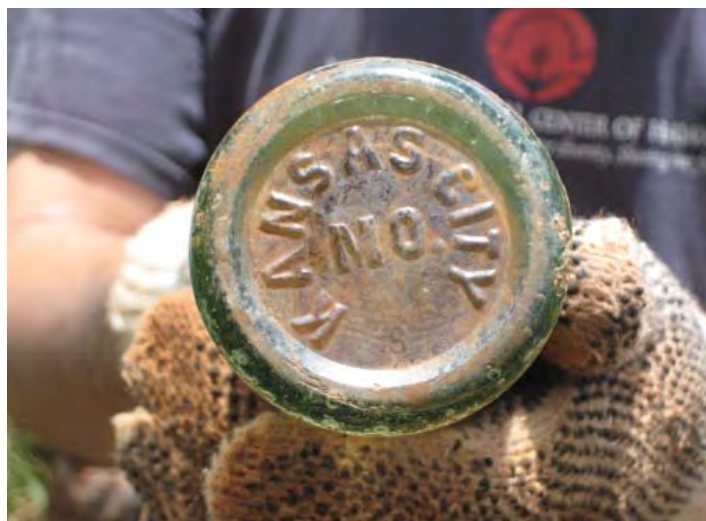
In 2010 a short section of the concrete on the rim of the ditch was uncovered as part of the search for evidence of the guard tower at the boundary between Compounds V and VI. When the post-hole foundations for that guard tower were found on each side of the ditch, a single posthole that had been recorded in 2008 at the rim of the ditch was reevaluated as possibly part of the foundation for another guard tower visible in historic photographs. However, the posthole had been buried under a small landslide sometime between the 2008 and 2010 fieldwork, and the original GPS reading on the feature was imprecise, due to limited satellite availability at the time. Therefore, in 2011 recent sediments along approximately 100 feet of the ditch were removed, to expose the ditch's concrete edge and adjacent ground surface where the Feature V-13 posthole had been recorded. During that excavation, a 1939 Coke bottle made in Kansas City, MO (Figures 5.532-5.533), barbed wire, and a section of wire cable were recorded.

Figure 5.532. Feature L-1, bottle found during ditch clearing (2011).

Figure 5.533. Feature L-1, bottle found during ditch clearing (2011).

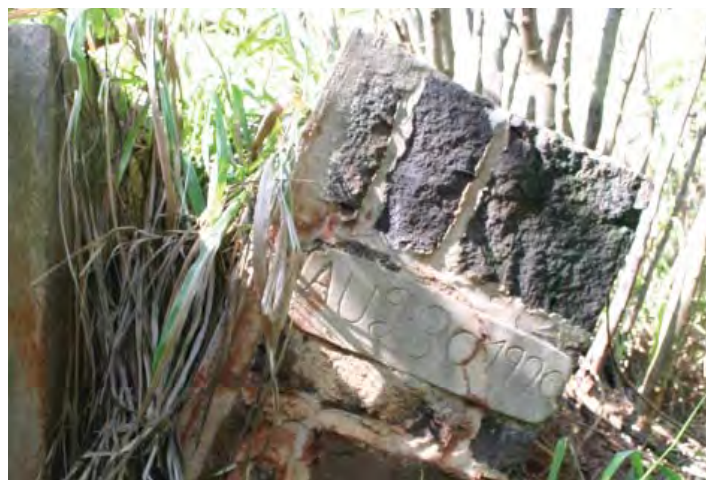
Figure 5.535. Feature L-1b, aqueduct (2006).

Feature L-1b is a concrete and rock abutment or pier with an inscribed date of "Aug 30, 1920" (see Figure 5.535). The pier measures 25 by 42 inches by 50 inches high. Out of plumb and tilted to the north, the abutment appears to have been originally constructed adjacent to the aqueduct as an auxiliary support near its western end. If so, its slight shift since its construction has had no obvious adverse effect on the aqueduct itself.

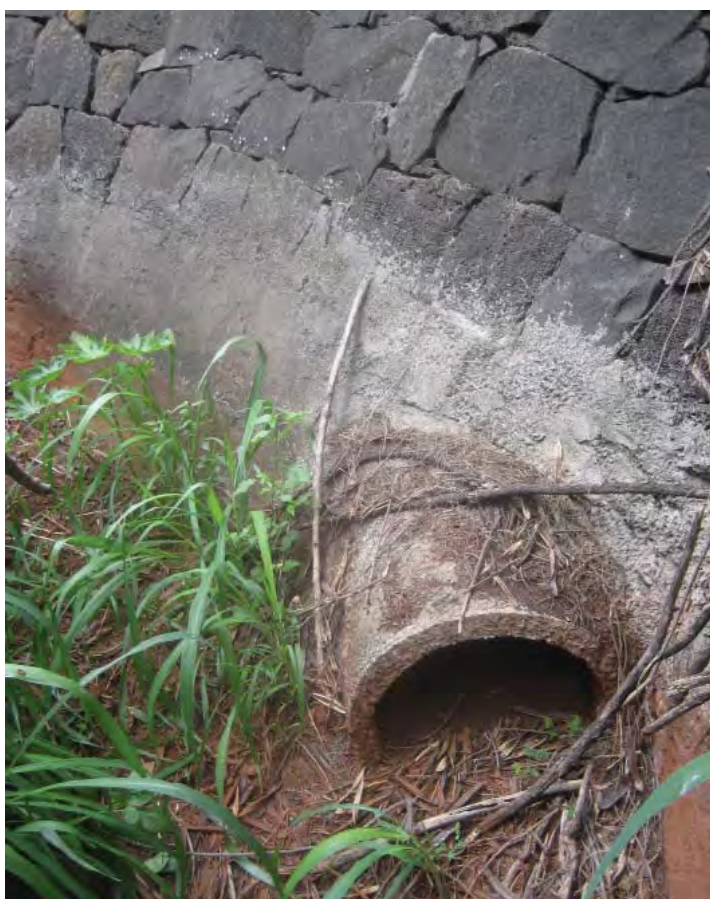
Figure 5.536. Feature 1c, concrete pipe into ditch (2008).

Recorded in 2008, Feature L-1c is a concrete pipe, opening into the ditch just east of the aqueduct (see Figure 5.536).
