Honouliuli POW and Internment Camp

Archaeological Investigations at *Jigoku-Dani*
2006-2017

Mary M. Farrell

December 2017

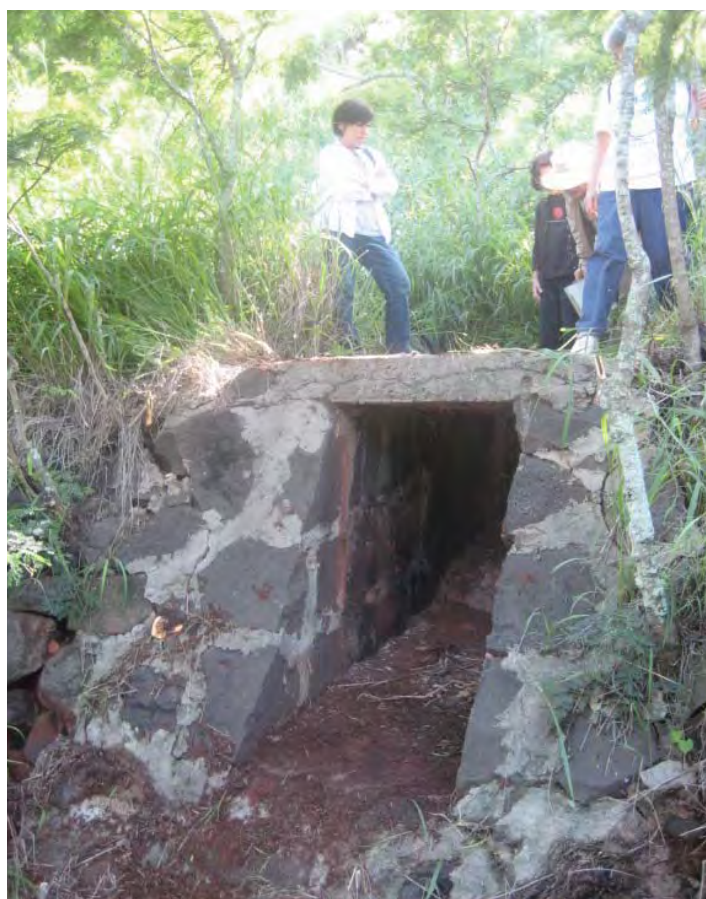
Figure 5.537. Feature L-1d, ditch outlet gate (2008).

Recorded in 2008, Feature L-1d is a former concrete and rock gate along the aqueduct to divert water from the aqueduct to presumed fields on the stream terrace below (see Figure 5.537). Along the west edge of the site near the boundary between Compounds V and VI, the gate was permanently closed with concrete inscribed "Jan 21 - 1943" on top. A guard tower (Feature VI-50, above) was constructed above the aqueduct at the gate.

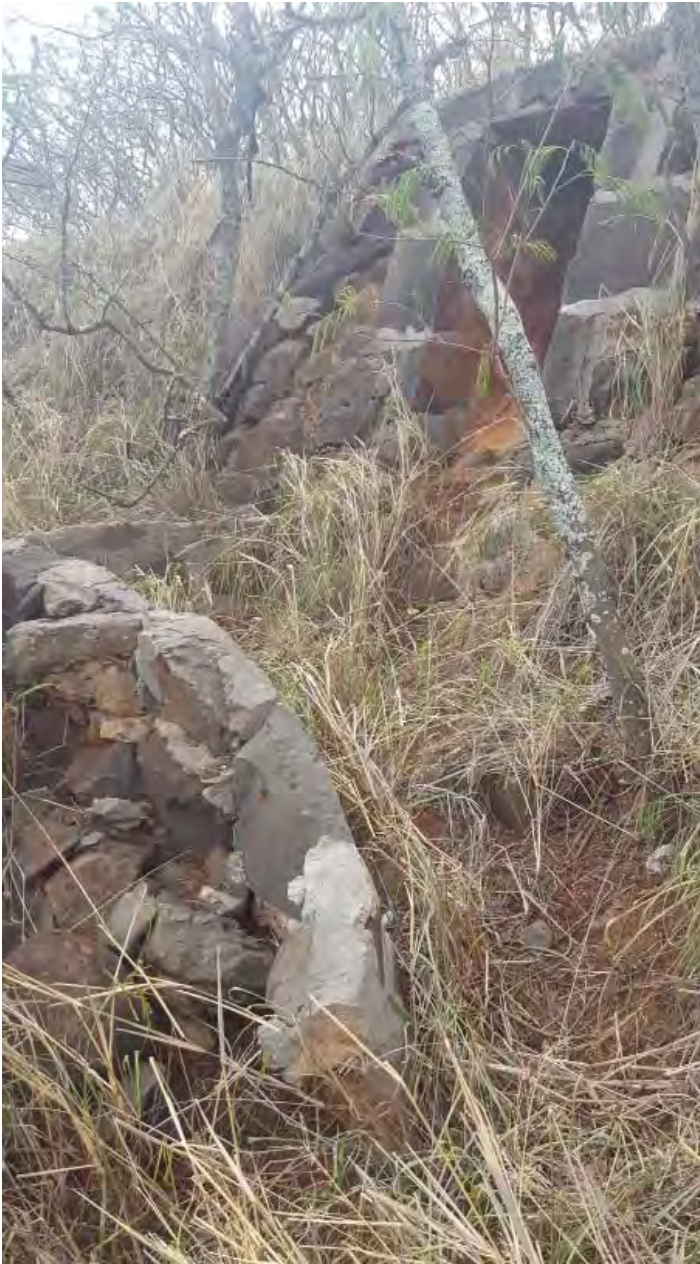
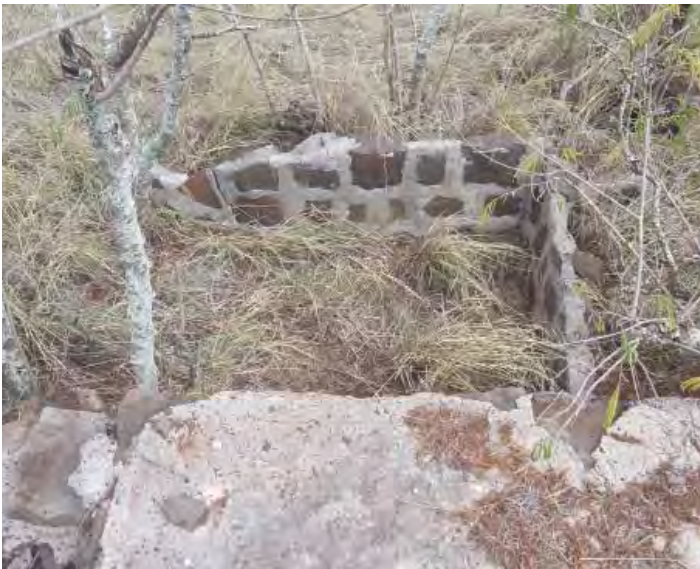
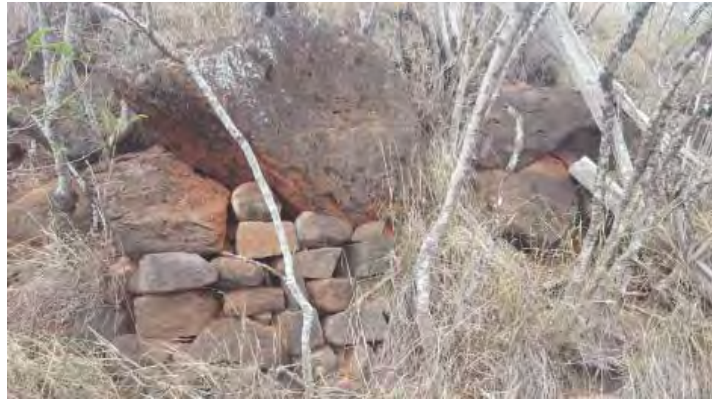
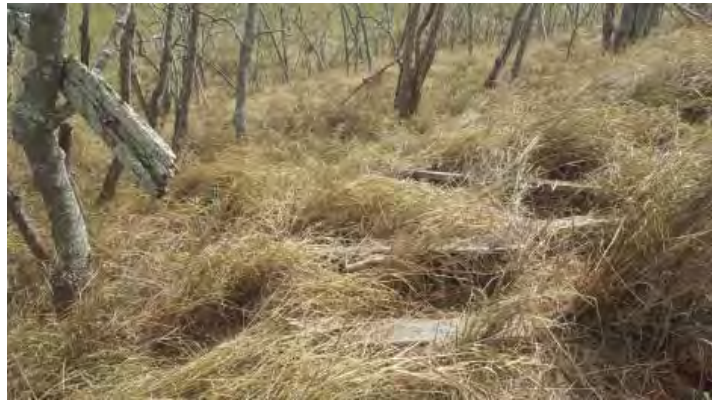
Also recorded in 2008, Feature L-1e is another sealed gate along the ditch, within Compound VI, the guard camp area (see Figures 5.538-5.541). Below the gate is an "L"-shaped single-wythe mortared rock wall that would have deflected water coming out of the gate, probably to reduce the potential for erosion. The wall's construction, with the flat faces of rock facing the ditch and the back of the wall irregular, suggests a retaining wall, rather than a stand-alone wall. Lumber scattered below the gate includes four-by-four-inch posts and one-by-twelve-inch boards, which would have been

appropriate sizes for a gate closure. Above the ditch at the gate is an uncoursed, dry-laid rock wall under a boulder; it may have been constructed to keep the boulder from falling on, and damaging, the ditch.

Figure 5.538. Feature L-1e, ditch outlet gate (2017).

Figure 5.540. Feature L1-e, rock support wall (2017).

Figure 5.541. Feature L-1e, lumber (2017).

Figure 5.539. Feature L-1e, ditch outlet gate (2017).

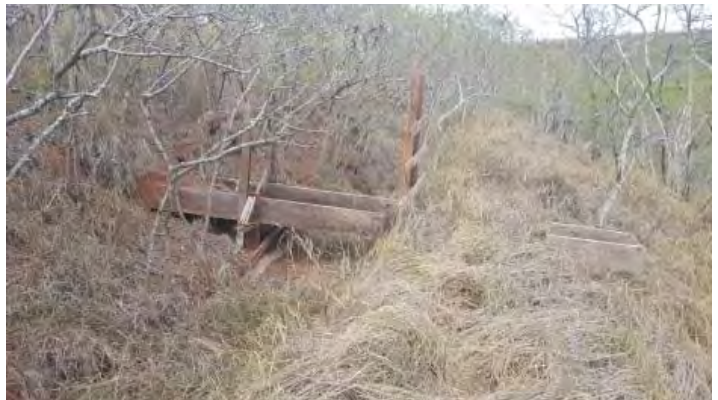
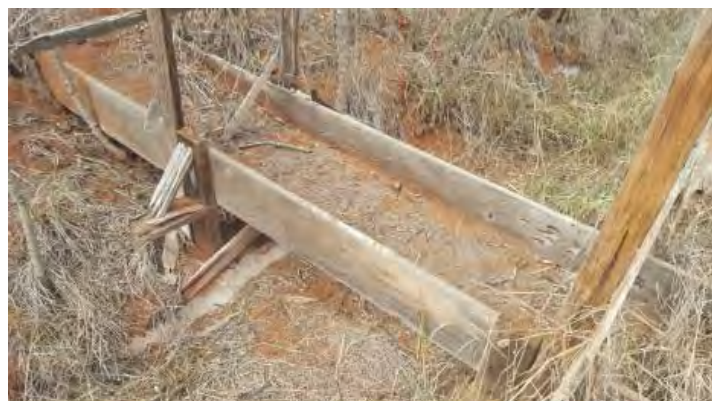
Feature L-1f is a wooden flume over the ditch, within Compound VI, the guard camp area. It was recorded in 2008 (see Figures 5.542 and 5.543). On either side of the ditch the flume is supported by a wooden brace composed of four-by-four-inch posts and smaller dimension lumber. The origin or destination of the flume

Figure 5.542. Feature L-1f, wood flume crossing ditch (2017).

Figure 5.543. Feature L-1f, wood flume crossing ditch (2017).

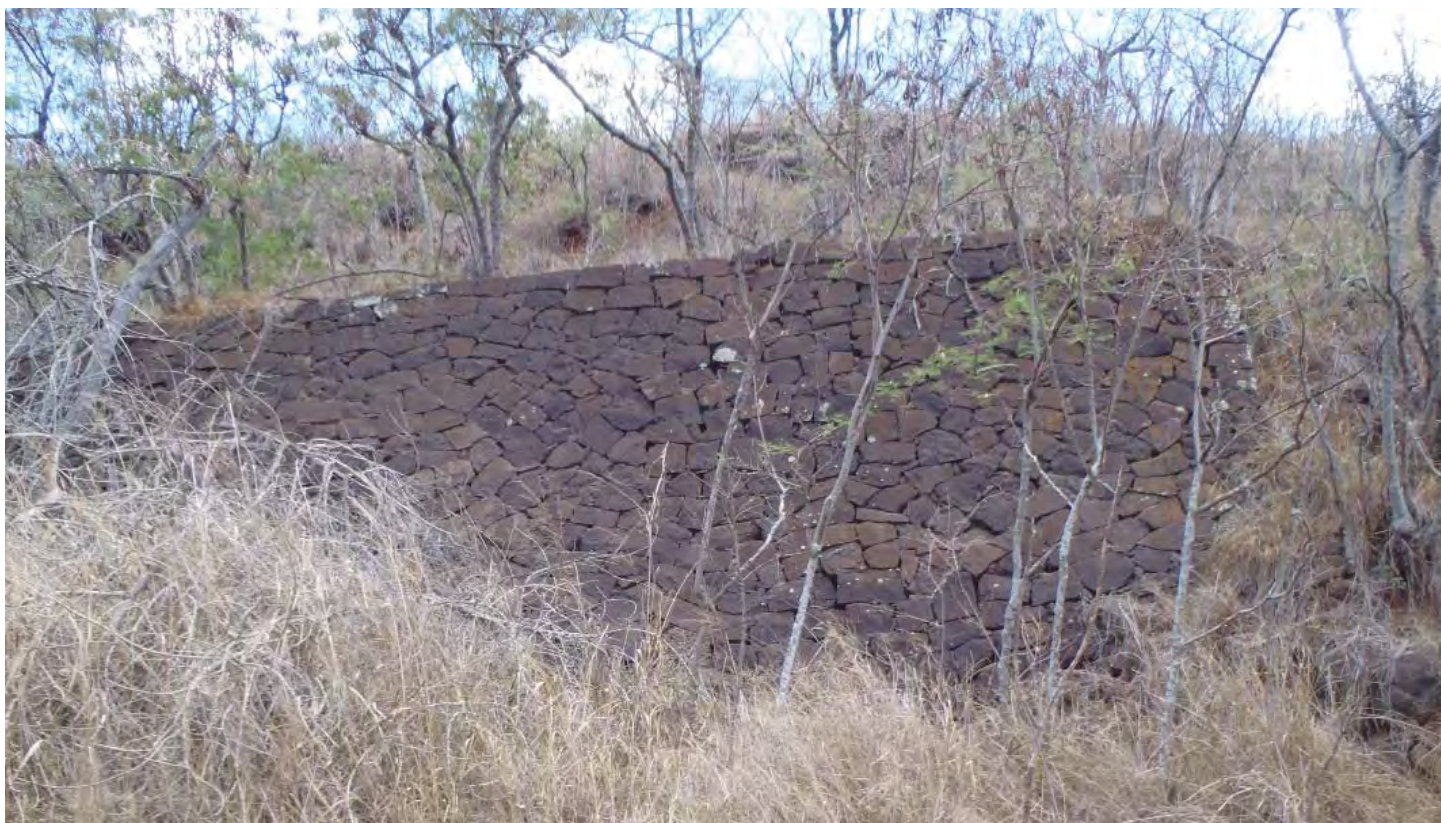
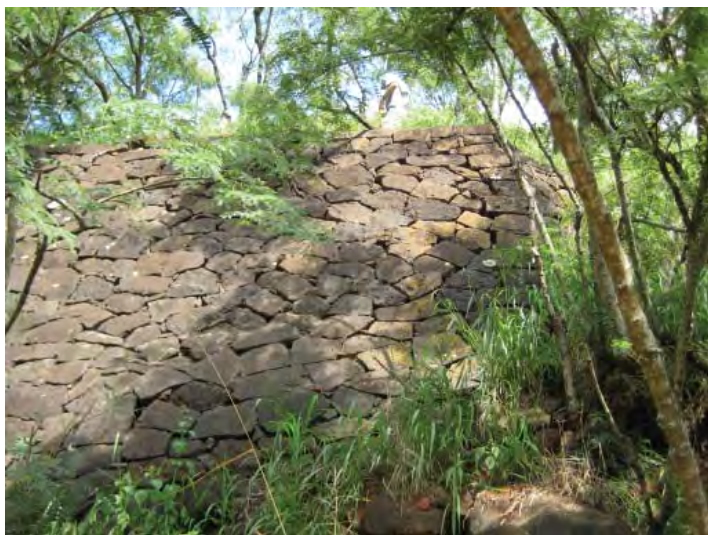
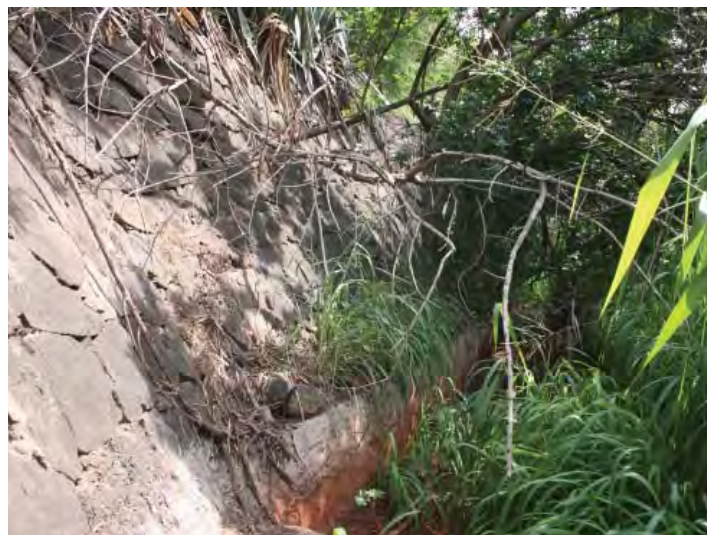
First noted in 2006, Feature L-1g is an uncoursed dry-laid basalt retaining wall for a road (Feature V-16). Above the ditch to the east of the aqueduct, the retaining wall is 157 feet long, up to 21 feet high at its southern end, tapering down to ground level where it curves around toward the entrance road (see Figures 5.544-5.546). The wall slopes back into the hillside, at about a 60-degree angle.

Figure 5.544. Feature L-1g, rock retaining wall (2012).

Figure 5.545. Feature L-1g, rock retaining wall (2008).

Figure 5.546. Feature L-1g, rock retaining wall above concrete ditch (2017).

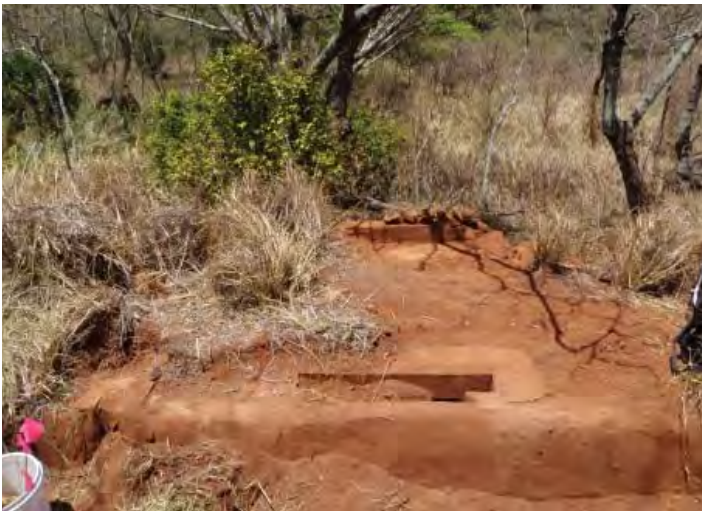
V along the ditch (see Figures 5.547 and 5.548). Both of these features consist of a water discharge gate that has been permanently sealed with concrete, to prevent access from the prison area below. Feature L-1h is near the north edge of Compound V, about 500 feet north of the sealed gate at the guard tower recorded as Feature VI-50. L-1i is about 300 feet further south, or 200 feet north of the guard tower. No dates were observed inscribed in the concrete at either feature, but the seals were probably made at about the same time as the similar seal inscribed January 21, 1943, at the guard

Figure 5.547. Feature L-1h, sealed ditch outlet gate (2010).

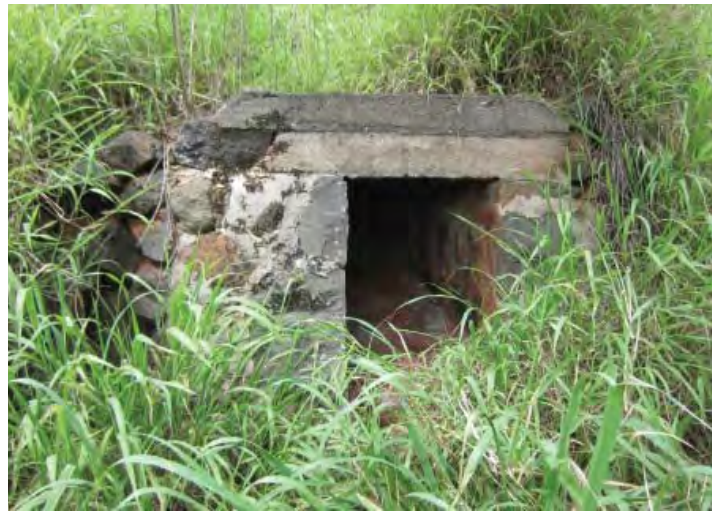
Figure 5.548. Feature L-1i, sealed ditch outlet gate (2014).

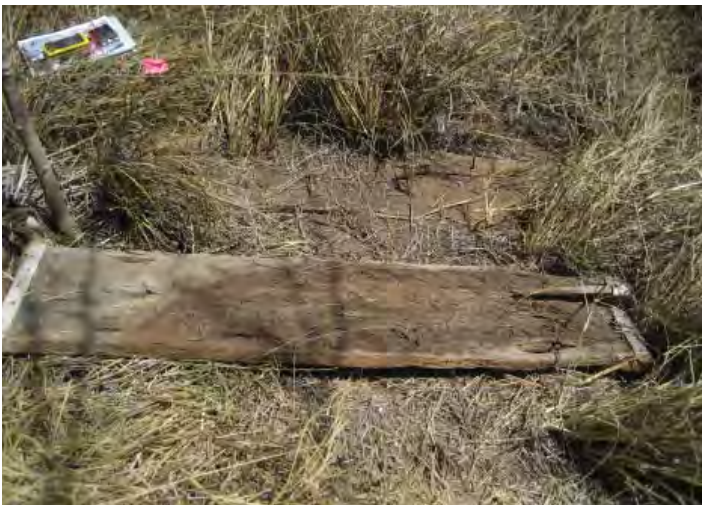
tower foundation (Features VI-50 and L-1d, above). Recorded in 2010, Feature L-1j consists of two boards found on the east side of the aqueduct, near the western boundary of Compound VI, the guard camp area, and about 115 feet south of the guard tower foundation recorded as Feature VI-50 (see Figure 5.549). One board measured 1 inch by 11¾ inches by 52½ inches long, and had a strip of galvanized metal wrapped around and nailed over each end. There are three irregular, elongated holes across the board about 10 inches from each end, which may indicate former

nail holes where cross pieces were attached, but no “shadow” from a cross piece was observed. The other board was thickly entwined with vegetation, and left in place because it appeared too fragile to move without damaging it. About the same dimensions as the other board, it had more holes, and nails still present. The galvanized metal strips suggest the boards functioned as a removable gate for the aqueduct. They may have been recycled for use as a footbridge: what appears to be a small simple footbridge is visible in this general location in historic photographs taken by R.H. Lodge (see Figure 4.16).

Figure 5.549. Feature L-1j, wood board (2010).

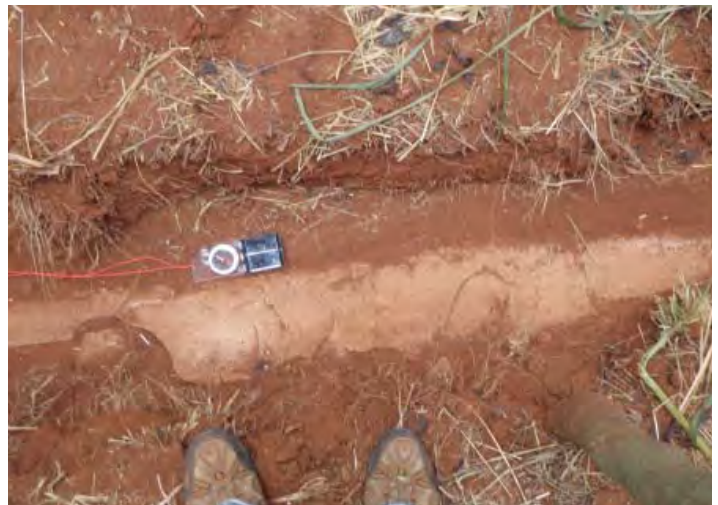
Feature L-1k was discovered during the 2011 removal of a recent landslide; it is a sealed gate along the ditch (see Figure 5.550). Similar to features L-1e, -h, and -i, the seal was likely constructed when the internment camp was constructed, to close off a potential prisoner escape route.

Figure 5.550. Feature L-1k, buried ditch outflow gate (2011).

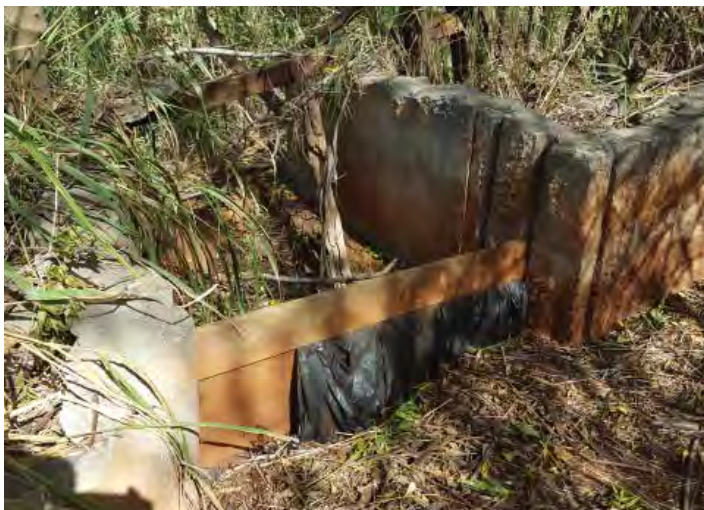
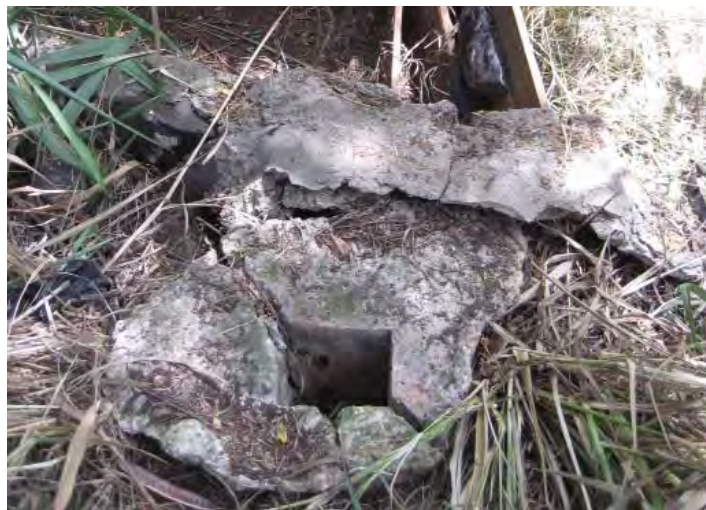
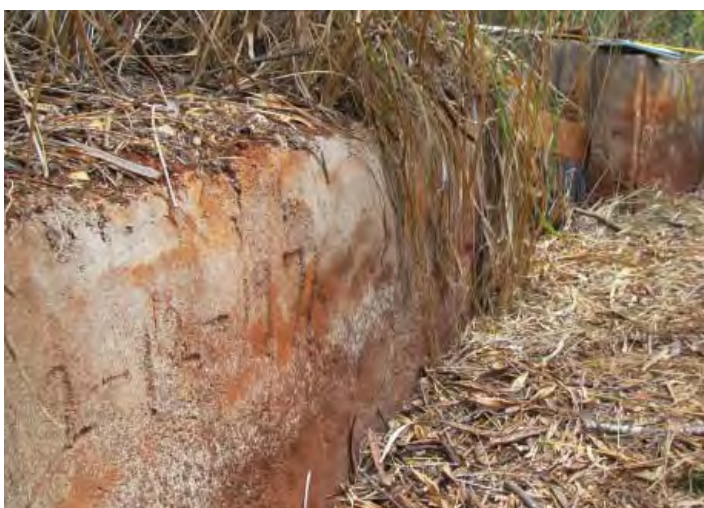
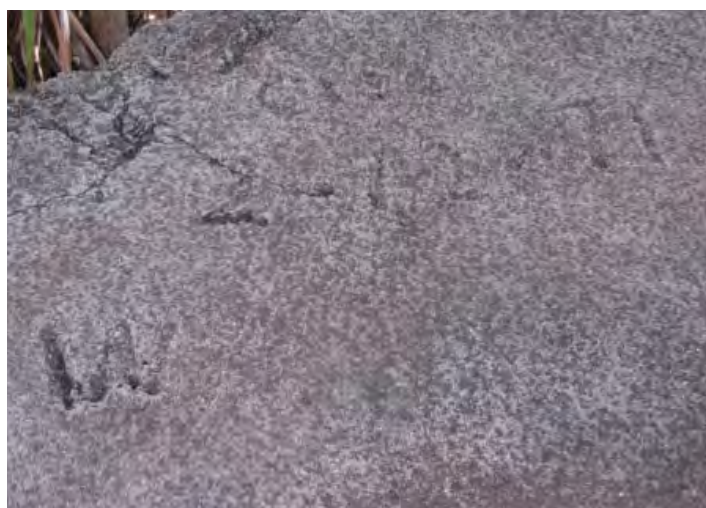
Recorded in 2011 and 2012, Feature 1l is located about 20 feet west of the westernmost pillar of the aqueduct (see Figures 5.551-5.554). The feature is a sluice gate

opening on the north side of the ditch. It is 42 inches wide and 36 inches high, and has slots for two parallel gates that would have controlled the water flow into a concrete-lined channel to the north which measures about 8 feet long. A modern (but not functional) gate in one of the slots consists of four horizontal boards and plastic sheeting, and two other boards nearby were probably used as part of a gate. There is a concrete footing for a four-by-six-inch post near its west end. The footing (and now-missing post) likely relate to the prison camp. Two 1971 dates are inscribed in repairs at the top and side of the ditch.

Figure 5.551. Feature L-1l, ditch outlet gate (2017).

Figure 5.552. Feature L-1l, post hole at ditch outlet gate (2011).

Figure 5.553. Feature L-1l, dated repair at ditch outlet gate (2012).

Figure 5.554. Feature L-1l, 1971 date inscribed in concrete at ditch outlet gate (2012).

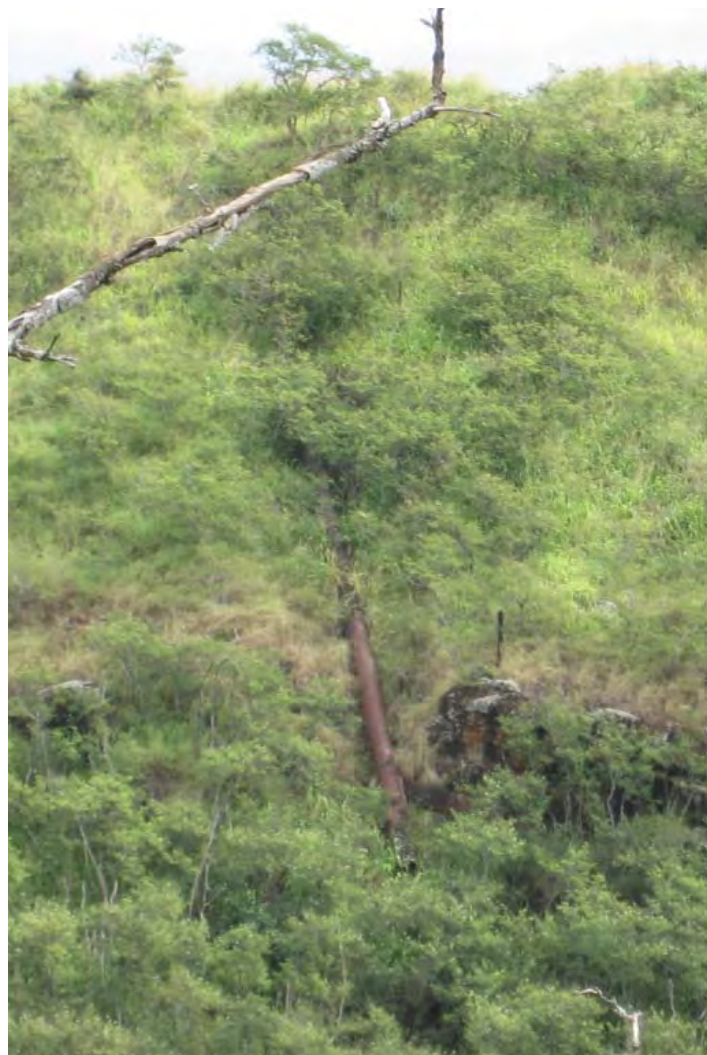
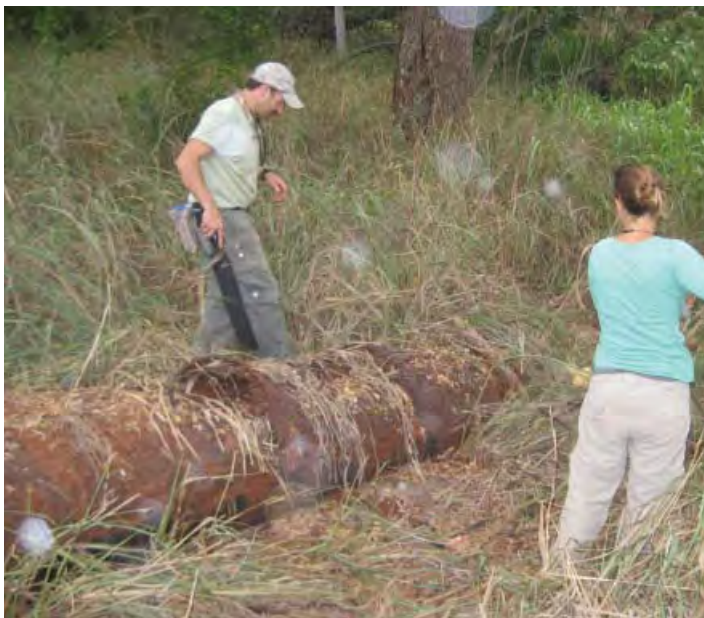
The siphon (Feature L-2a) is 2 feet in diameter, composed of sections of riveted steel pipe (see Figures 5.557-5.558). It was supported at intervals by formed concrete piers measuring roughly 48 inches high. The pipe would have fit into a half-cylindrical hollow in the pier's top, and was held down with a semi-circular heavy-gauge metal clamp with flanges that fit over bolts sunk into the concrete (see Figure 5.559). Near

Figure 5.557. Feature L-2, metal siphon (2009).

Figure 5.558. Feature L-2, siphon (2010).

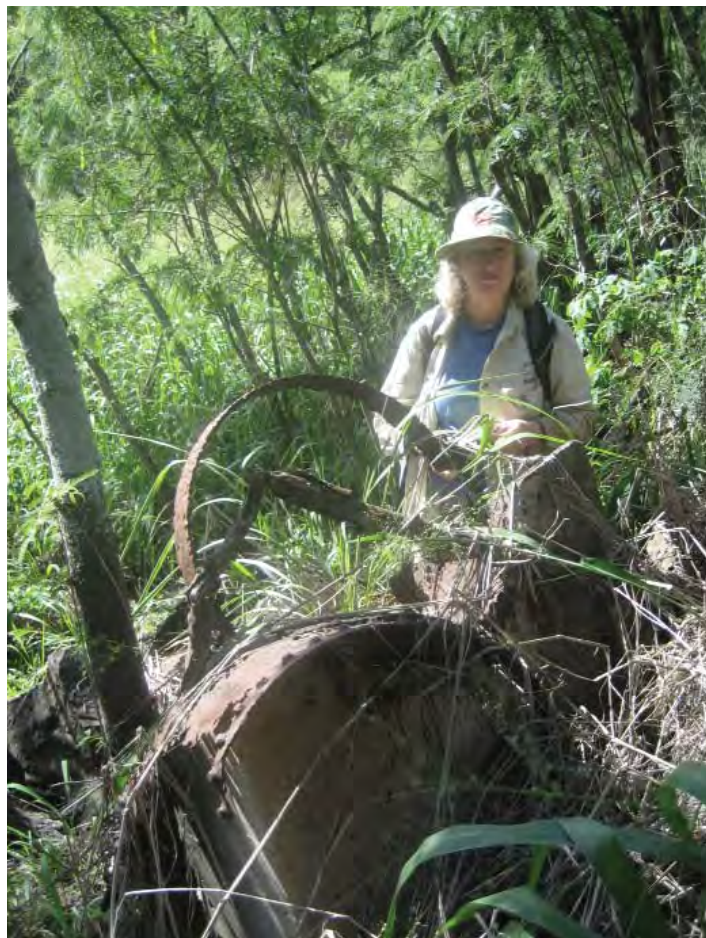
Figure 5.559. Feature L-2a, siphon support (2010).

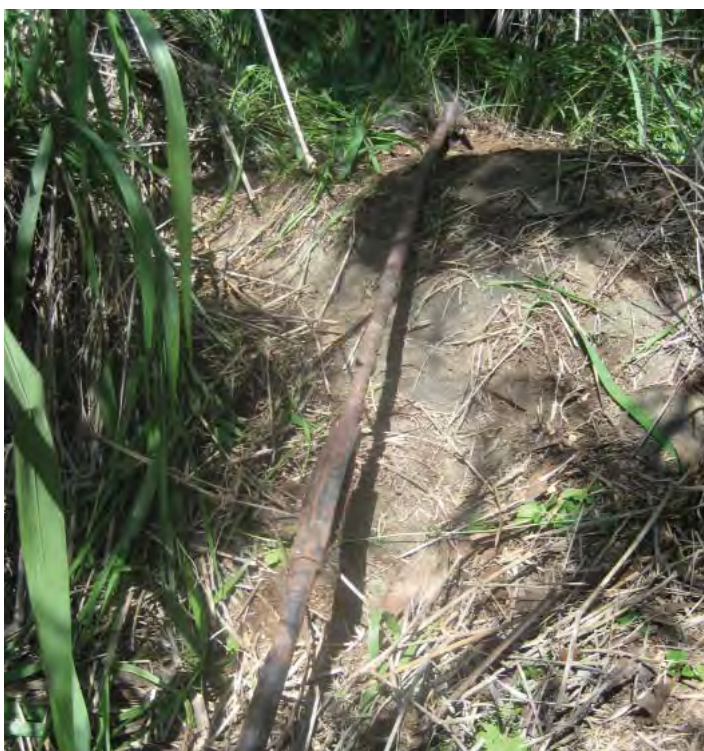
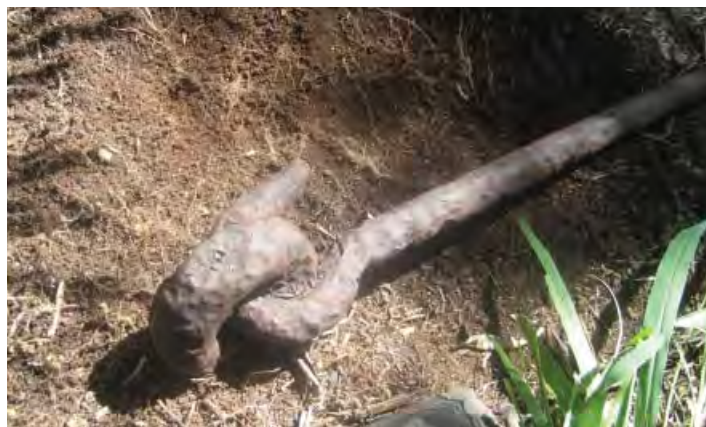
one of the piers is a large iron rod with a turnbuckle in the middle and a hook at the end, which connects to an iron eye loop sunk into a basalt boulder (see Figure 5.560 and 5.561).

Figure 5.560. Feature L-2a, siphon anchor (2010).

Figure 5.561. Feature L-2a, siphon anchor (2010).

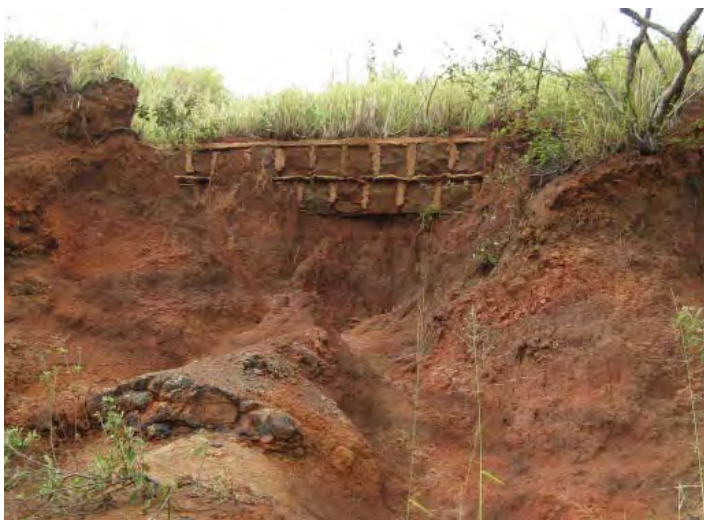
Feature L-2b is a portion of the ditch wall exposed by erosion above the road recorded as L-5 (see below). Because a portion of the cut bank has eroded away, a section of what appears to be a rock wall composed of basalt boulders and mortar is visible (see Figure 5.562). Located where the ditch that debouches from the siphon is shown on historic maps, this “wall” is actually the exterior of the ditch lining. The exposed section is about 10 feet long and 2 feet high; the rocks appear to have been shaped to be roughly 10 or 12 inches square. The concrete rim at the top of the ditch is level and straight; the mortar on the newly exposed face is irregular, suggesting that the rocks were set in the ditch wall to conserve concrete, and plastered over. The ditch itself has been filled with sediment, and is partially

Figure 5.562. Feature L-2b, exposed exterior of ditch (2009).

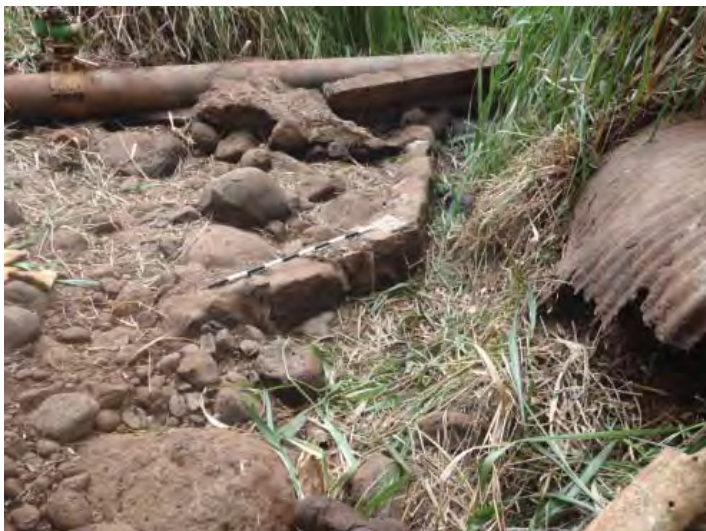
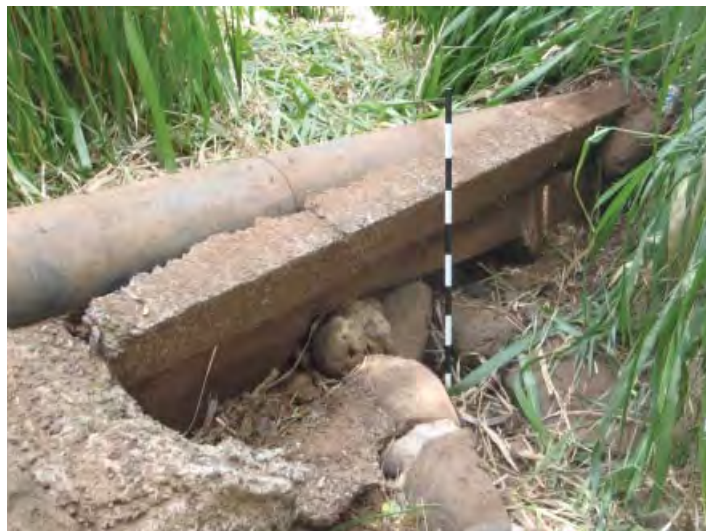
Feature L4a is a creek crossing cleared in 2012 and 2014 (see Figures 5.570 and 5.571). Although there is little sign of the road itself here, a mortared stone wall on the west bank indicates where the bridge once was. A pipe with a valve at the crossing appears to be in place; pieces of concrete and a culvert have been dis-

placed. The crossing is within the monument boundary, but on Monsanto Hawai'i land.

Figure 5.570. Feature L-4a, stream crossing (2012).

Figure 5.571. Feature L-4a, stream crossing (2012).

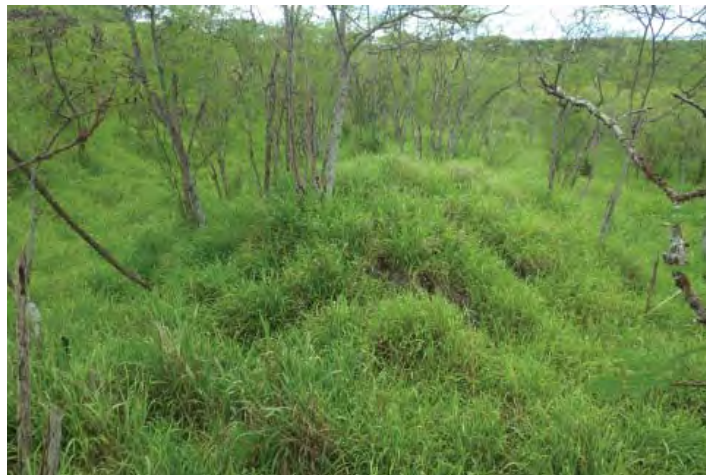
pound VII. Depicted as a “dam” on the 1945 disciplinary compound blueprint, the berm is 6 to 8 feet wide at the top, 12 to 15 feet at the base, up to 8 feet tall, and 310 feet long. It has been breached (or possibly cut?) in the center, with either end of the breach or cut reinforced with broken foundation slabs (Features VII-14 and VII-15, above). Small trees and Guinea grass grow on the berm.

Figure 5.581. Feature L-10, berm (2014).

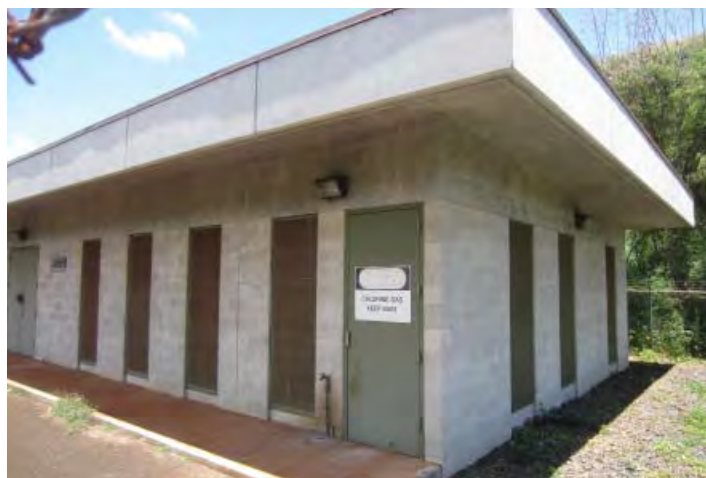
Figure 5.583. Feature M-1, water treatment building (2012).

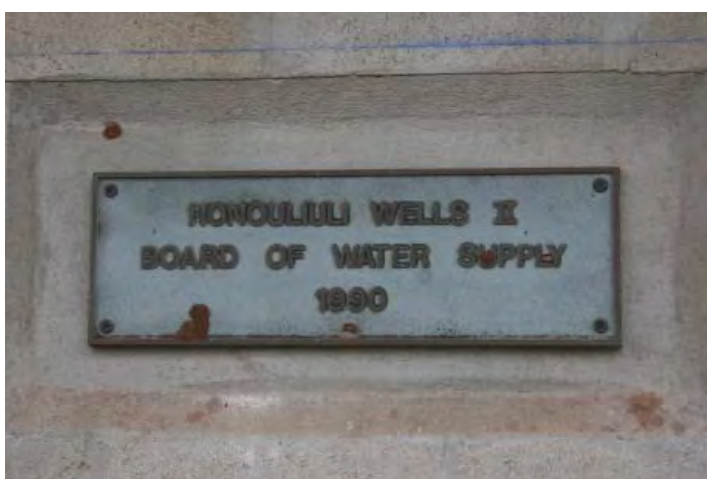
Figure 5.584. Feature M-1, water treatment building (2012).

all enclosed with a tall chain-link fence. The current retaining wall for the platform appears to be fairly recently constructed or recently reinforced with rock and concrete, but portions of the retaining wall at the rear (northeast edges) of the platform are uncoursed dry-laid basalt rocks, possibly part of an older retaining wall constructed for the Compound IV mess hall. A brass plaque on the building reads: “Honouliuli Wells II / Board of Water Supply /1990” (see Figure 5.585).

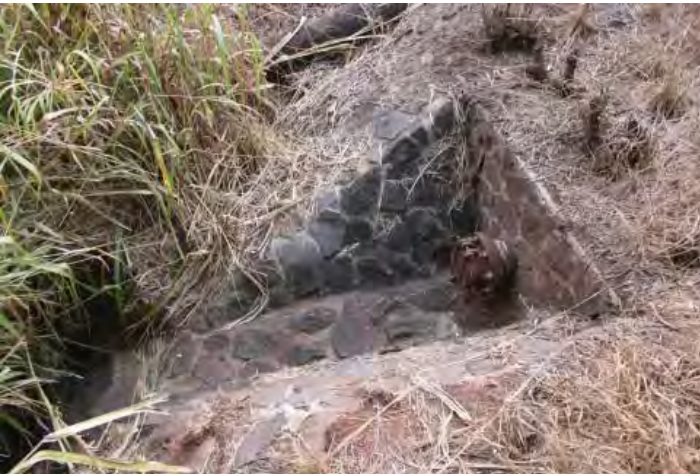
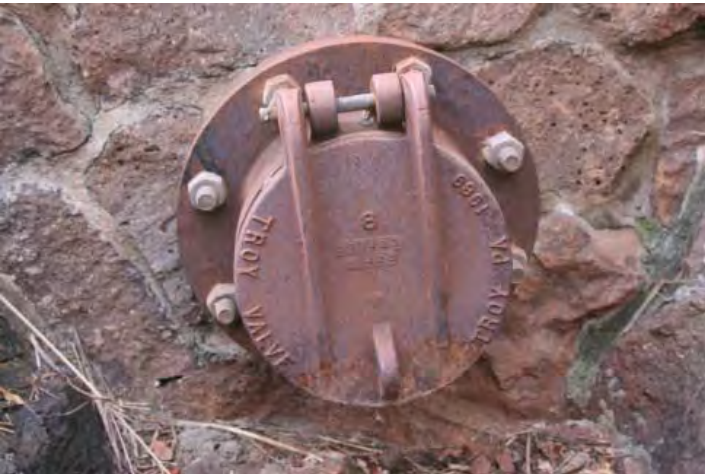
West of the stream and on the north side of the road at the stream crossing, within Compound III, this feature consists of a shutoff valve bolted onto the end of a pipe that is set into a mortared-rock-lined spillway that empties into the stream. The valve reads: “TROY VALVE / TROY PA 1989” around the edge with the numbers “8 / 177423 / -1420” and the letters “BF” in the center (see Figure 5.594). It was recorded in 2008.

Figure 5.593. Feature M-4, rock wall and outlet valve (2008).

Figure 5.594. Feature M-4, detail of outlet valve (2008).

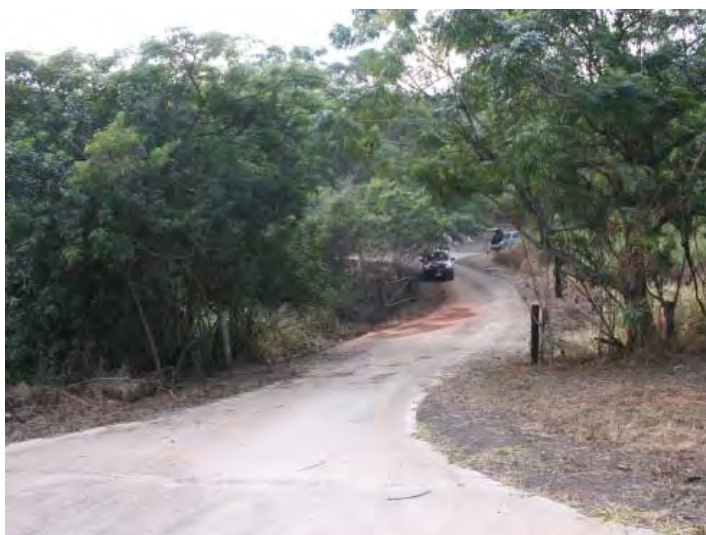
at or near the original boundary between Compounds III and IV (see Figure 5.597). Feature M-5b is a concrete box bridge over the aqueduct ditch (Feature L-1, above), at the original boundary between Compounds IV and V (see Figure 5.598). These features and the road were recorded in 2008.

Figure 5.597. Feature M-5a, stream crossing (2008).

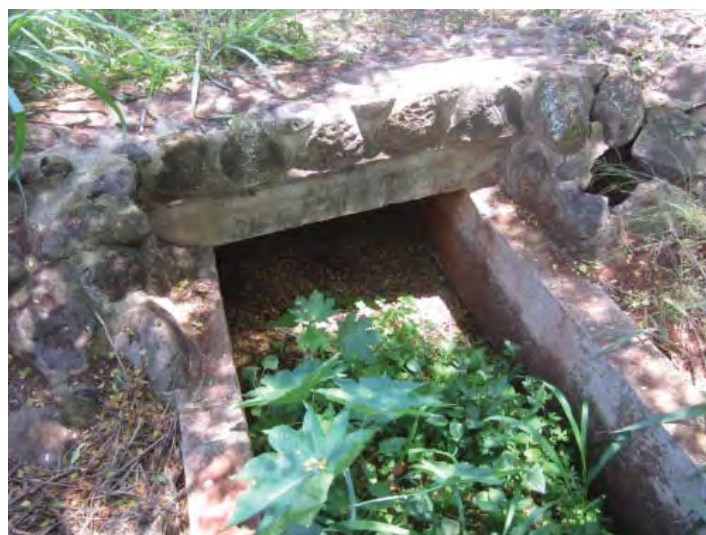
Figure 5.598. Feature M-5b, aqueduct crossing (2017).

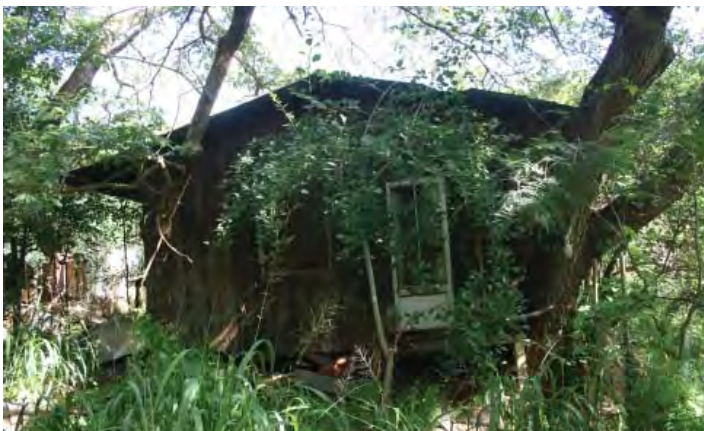
square feet). In precarious condition when we recorded it in 2008, the building has collapsed further since then. The building has a low-pitched gable roof. The south, east, and west facades are sided with vertical tongue-in-groove boards, 5¼ inches wide; the northern facade is sided with wider composite boards. There is a large light fixture on the south end, and knob-and-tube wiring visible above a door and a window. Both openings are screened. The southern half, in the best condition, has a wood floor, and the siding extends from the floor to about 6 feet high. Above the siding is 30 inches of screened area. In 2008, the screen was intact in the east windows. The roof structure is composed of 2-by-6-inch rafters, and the roof is sheathed in corrugated metal.

Figure 5.599. Feature M-6, standing building at chicken farm on concrete foundation of Feature VI-1 (2008).

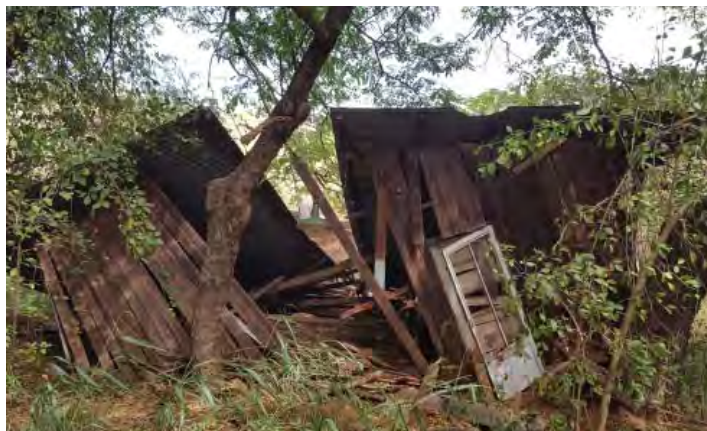
Figure 5.600. Feature M-6, same building at chicken farm, now collapsed (2017).

It was apparently last used for storage, and contained rolled asphalt roofing, corrugated roofing, lumber, and mattresses. The far north part of the structure may have been left open, as for a lanai or porch. A large bougainvillea engulfed the front (north) end of the building (see Figure 5.607), and the building is on the verge of complete collapse (see Figure 5.600).

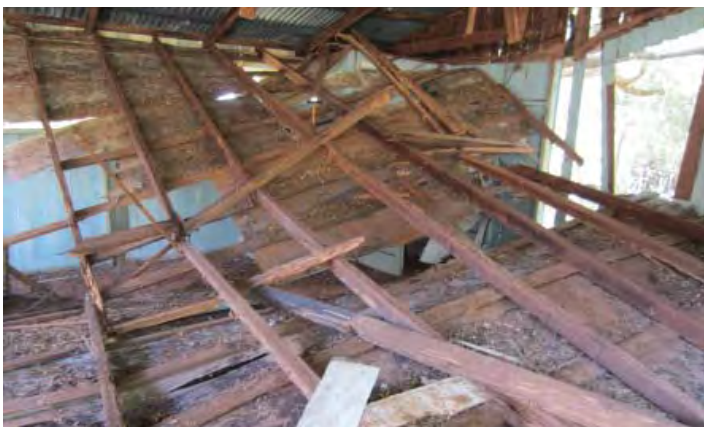
Most of the interior and exterior doors are wood with five horizontal panels; one is half wood and half screened, with the screening replacing the top three panels. The northern room, on the raised concrete foundation, was more dilapidated when initially observed in 2006, and the roof was partially collapsed.

Figure 5.603. Feature M-6, collapsed ceiling of standing building on concrete foundation of Feature VI-1 at chicken farm (2012).

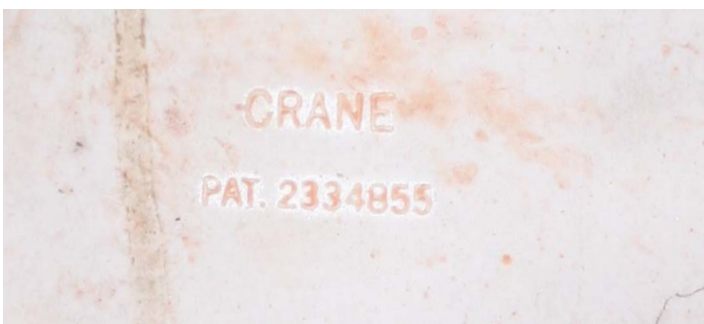
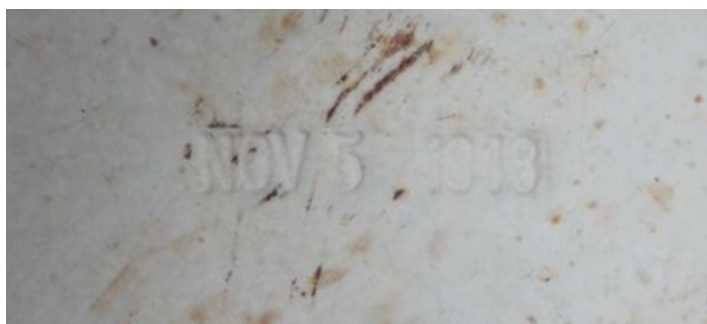
corner; the toilet tank lid has a 1948 date stamp and manufacturer information: “CRANE / PAT. 2334855 / J 2 / TRADE MARK REC. / NOV 5 1948” (see Figures 5.605 and 5.606). Plumbing pipes for the bathroom are on the exterior of the south wall. Because of the 1948 date on the toilet tank lid, we assumed the bathroom was a later addition to the structure. Minatoishi’s conclusion (2010:46) that the bathroom was an original part of the structure jibes with the evidence that the building was constructed between 1951 and 1960.

Figure 5.605. Feature M-6, manufacturer's mark on toilet tank lid interior (2008).

Figure 5.606. Feature M-6, 1946 date on toilet tank lid interior (2012).

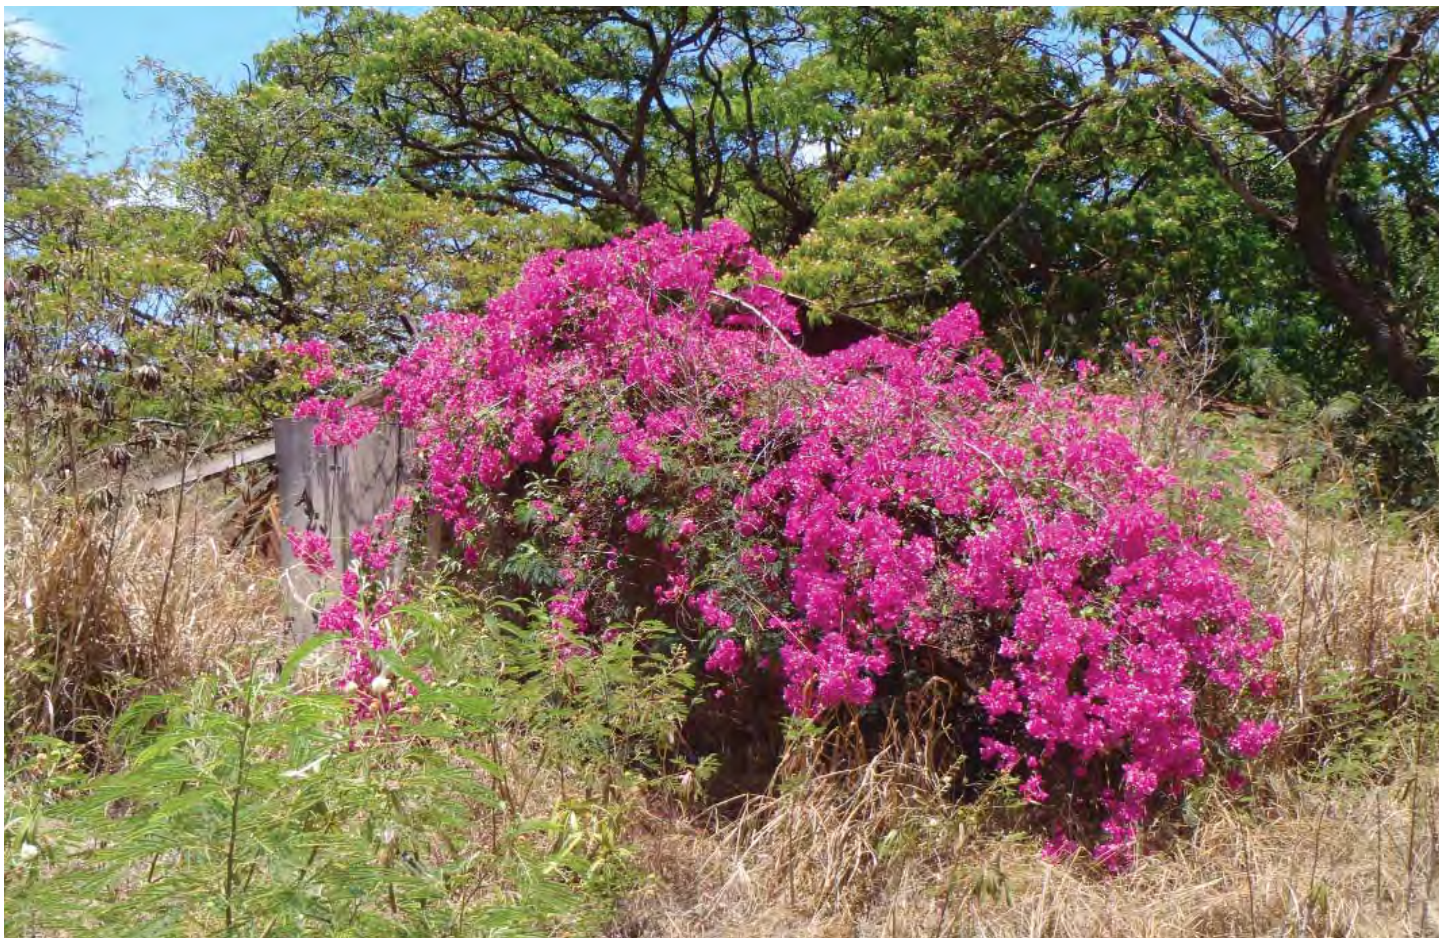
Figure 5.607. Feature M-6, standing building at chicken farm on concrete slab VI-1 (2012).
