Honouliuli POW and Internment Camp

Archaeological Investigations at *Jigoku-Dani*
2006-2017

Mary M. Farrell

December 2017

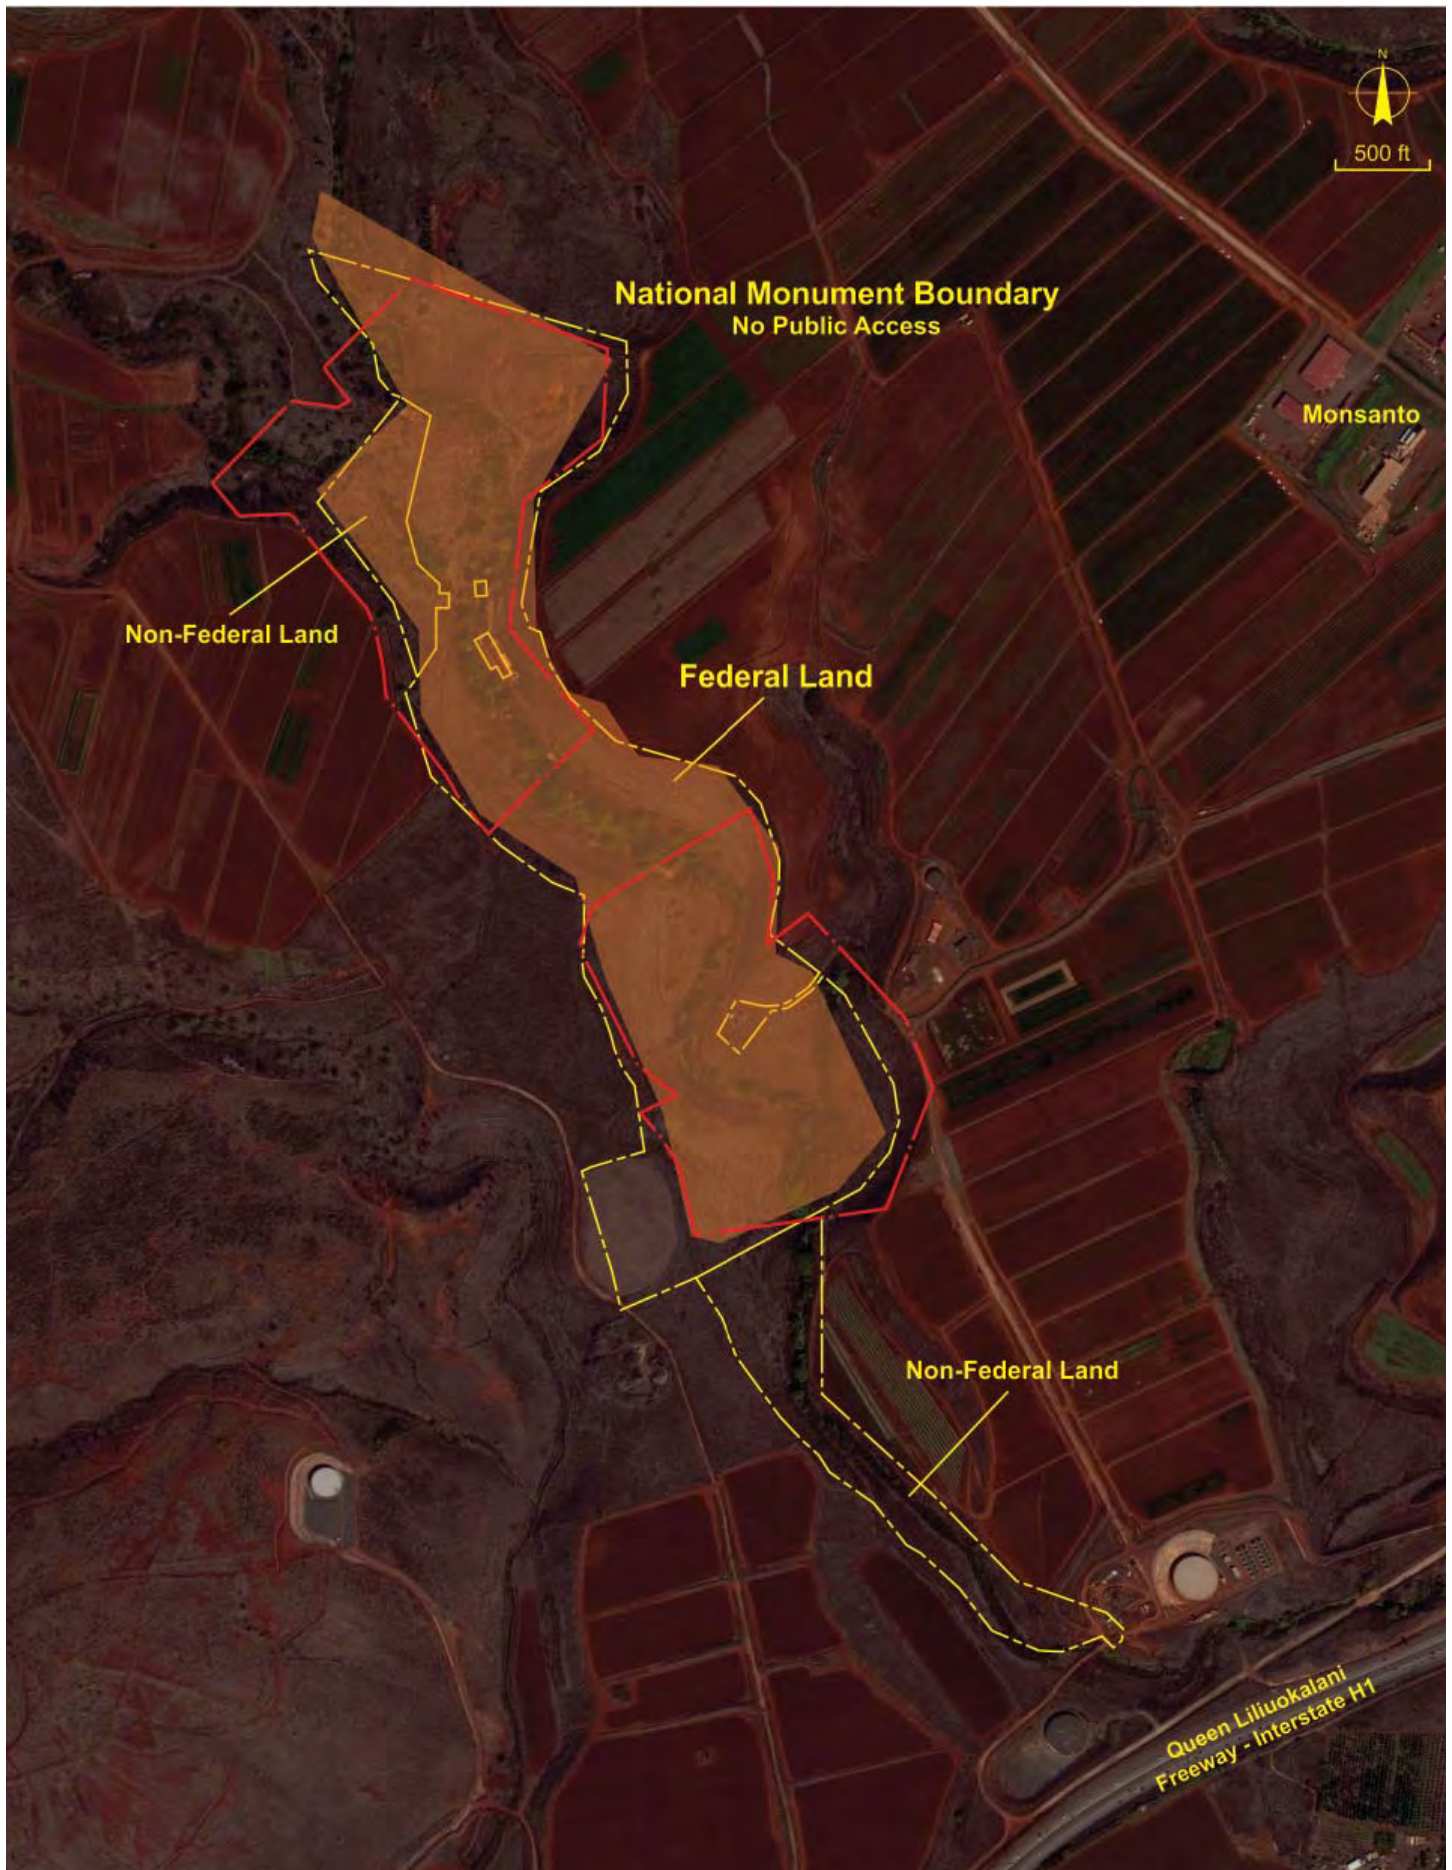
The archaeological survey was able to define, and refine, the boundaries of the site, especially as compared with the generalized map initially available in *Waipahu at War*. The most accurate site boundary is that contained in the National Register nomination (Burton and Farrell 2011b; Figure 6.1). The boundary is based on the 116 acres depicted as a military installation in Lodge (1949) plus an additional 6.5 acres identified on U.S. Army blueprints where prison-camp facilities have been confirmed by archaeological survey. The archaeological work was also used to justify the boundary used in the land exchange and the National Monument designation (Figure 6.2). However, it is important to stress that the National Monument boundary is not the site boundary. Some site features are still located on Monsanto Hawai'i land, even though they had been recorded at the time the exchange boundaries were drawn. Conversely, some areas within the National Monument boundary have not yet been subject to even cursory archaeological survey.

Figure 6.1. Honouliuli National Monument boundary (yellow dashed line), National Register of Historic Places boundary (shaded yellow), and camp perimeter fences depicted on 1943 military terrain map (red lines).

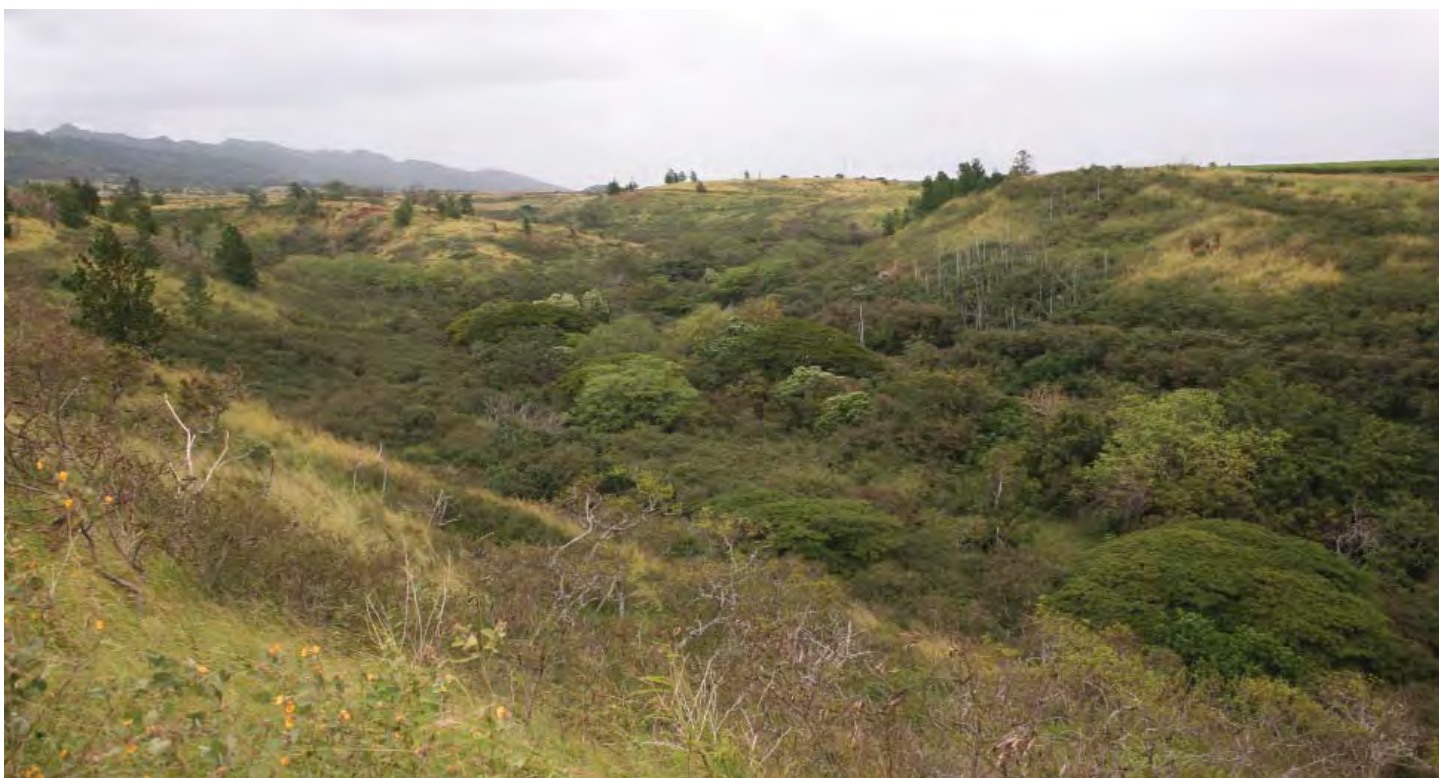
Figure 6.3. Overview of Honouliuli gulch, view to north (2009).

With the current vegetation cover, smaller features pose tripping hazards. The dense vegetation in the gulch also presents challenges for long-term preservation (Figures 6.3 and 6.4). Tree roots have damaged some concrete features (for example, small slabs at Features VI-17 and VI-18 and the latrine and shower foundation and sidewalk at VI-32). Trees are growing

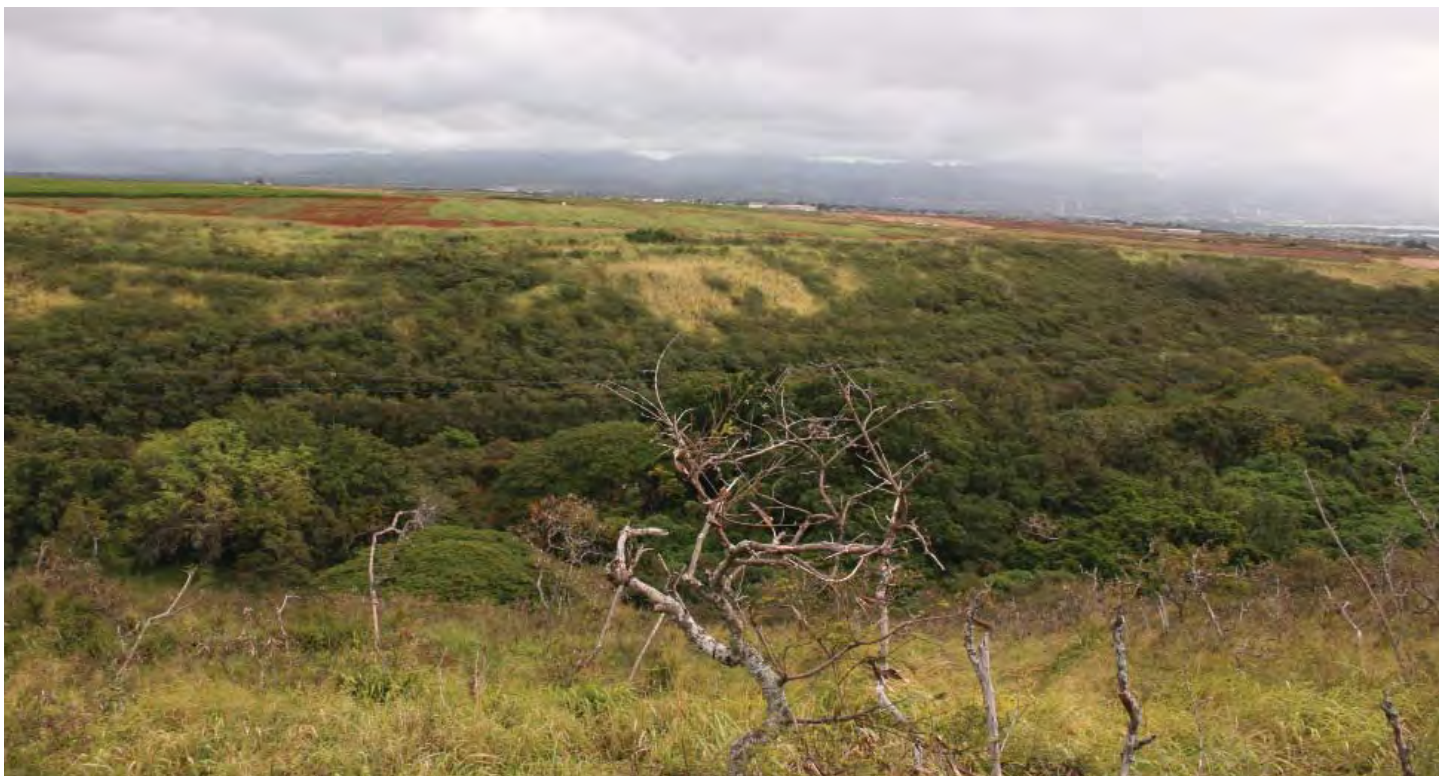
Figure 6.4. Overview of Honouliuli gulch, view to southeast (2009).

in cracks in others (for example, Feature V-1, the internee mess hall). A bougainvillea appears to have contributed to the collapse of the chicken farm building at Feature M-6. And yet the vegetation is not sufficient to hold flooding and erosion in check. For example, there was a small landslide between 2008 and 2011 that covered up over 100 feet of the lower ditch, near Feature IV-2. Erosion continues to create channels in Feature L-5, the road up the west side of the gulch, and has exposed the underside of a section of the upper ditch (Feature L-2b). Other long-term preservation issues include moisture build-up behind the retaining walls: Feature V-15, the distinctive wall that appears in historic photographs, has cracked, and a stone from the rock veneer has spalled off.

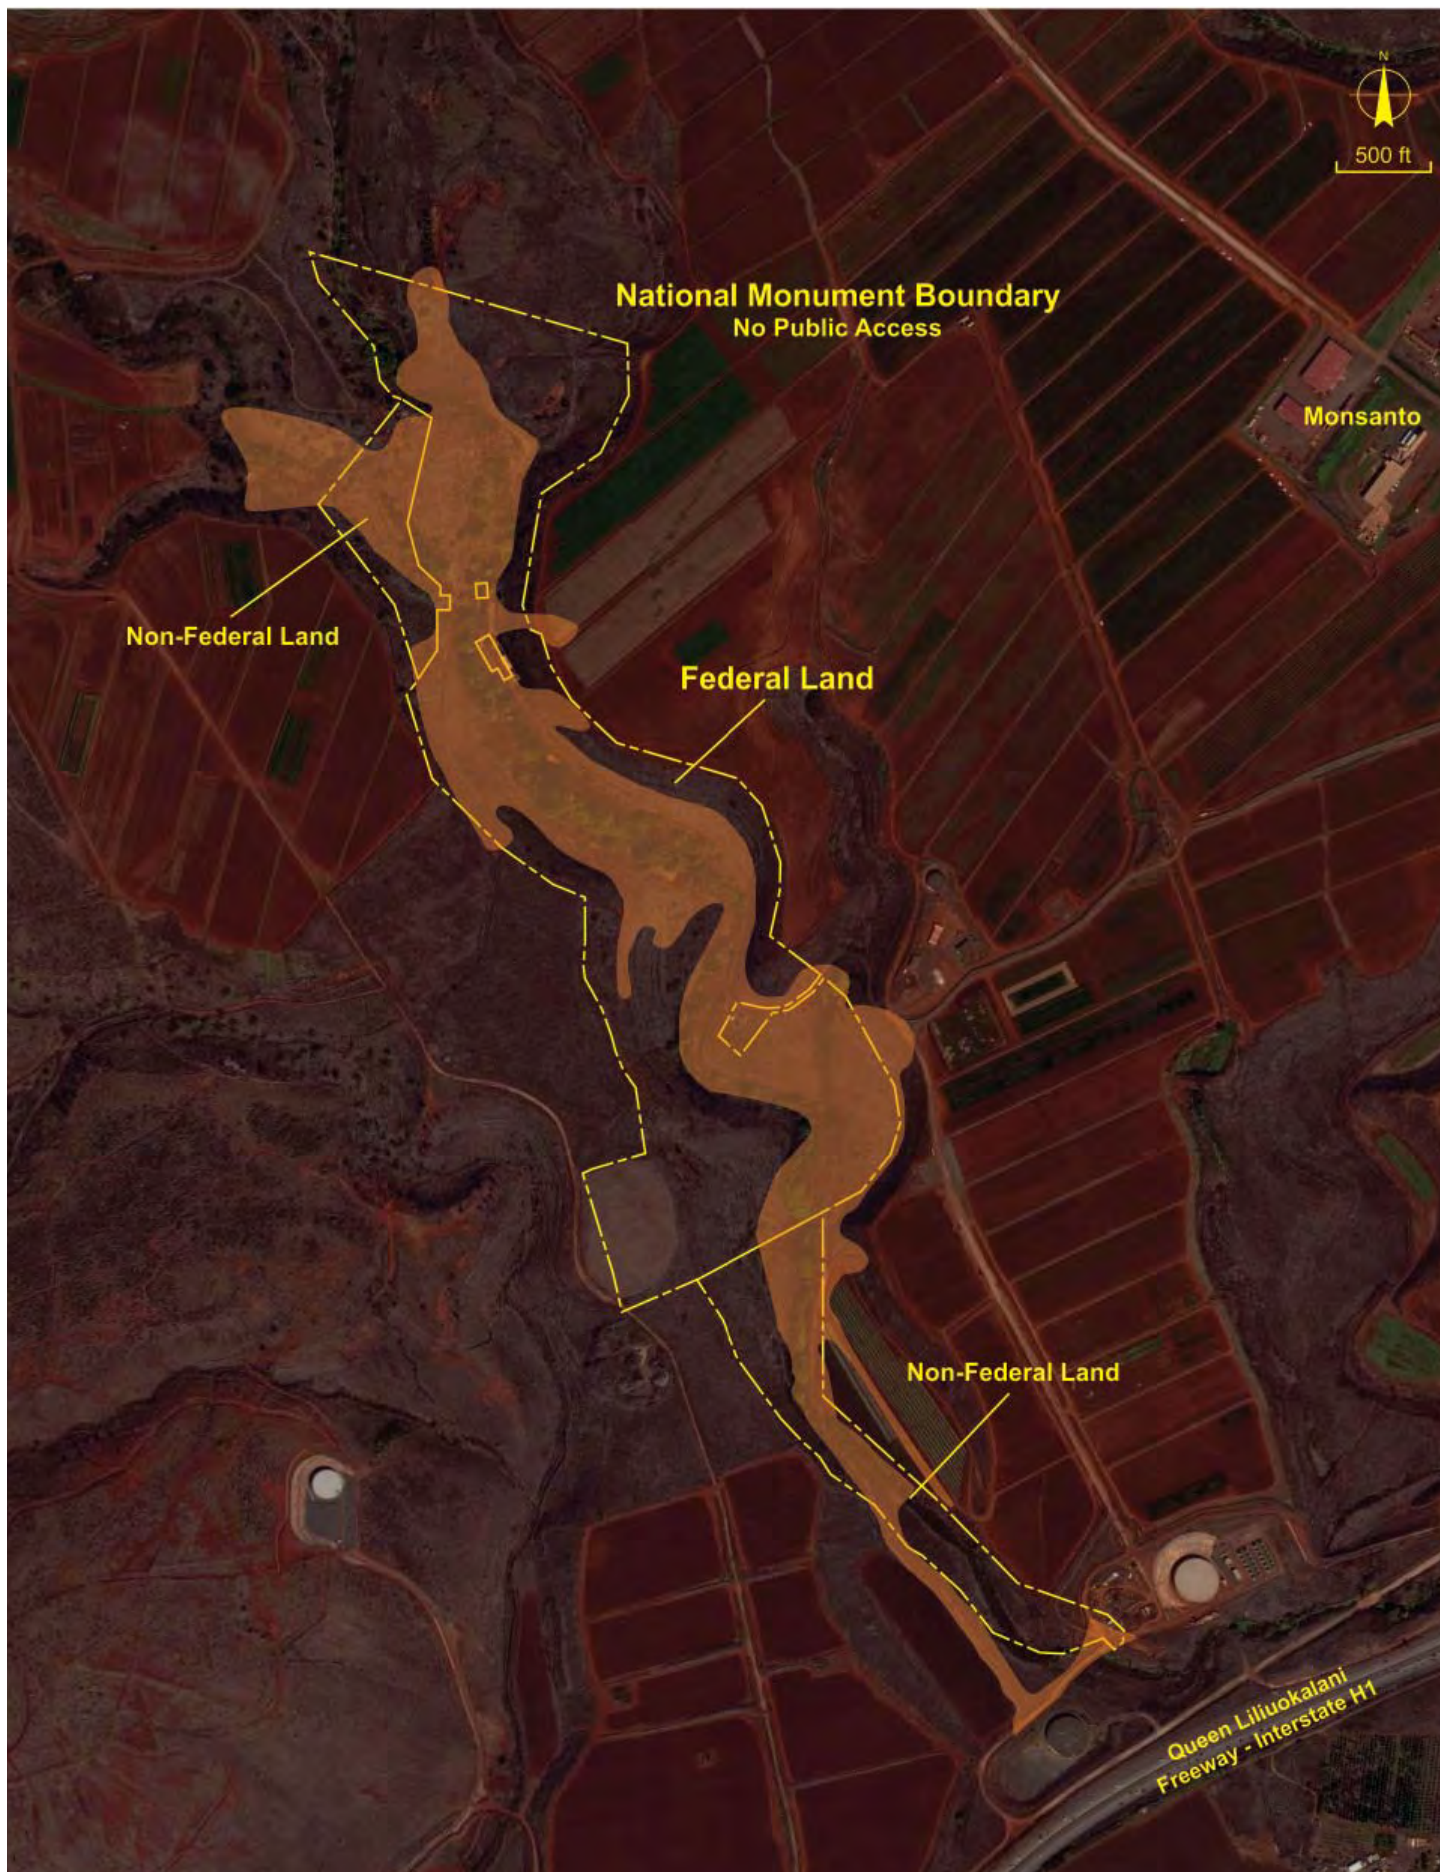
Figure 6.5 illustrates the areas within and adjacent to the Honouliuli National Monument that were subjected to archaeological reconnaissance between 2006 and 2014. Some areas within the monument have yet to be examined, and even in those areas we did examine, the survey needs to be considered cursory and preliminary, because vegetation impeded visibility of the ground surface. Nevertheless, the documentation of features and artifacts, in a relatively intact setting,

Figure 6.5. Honouliuli National Monument boundary (yellow dashed line) and areas that were cursorily surveyed between 2006 and 2014 (shaded yellow).

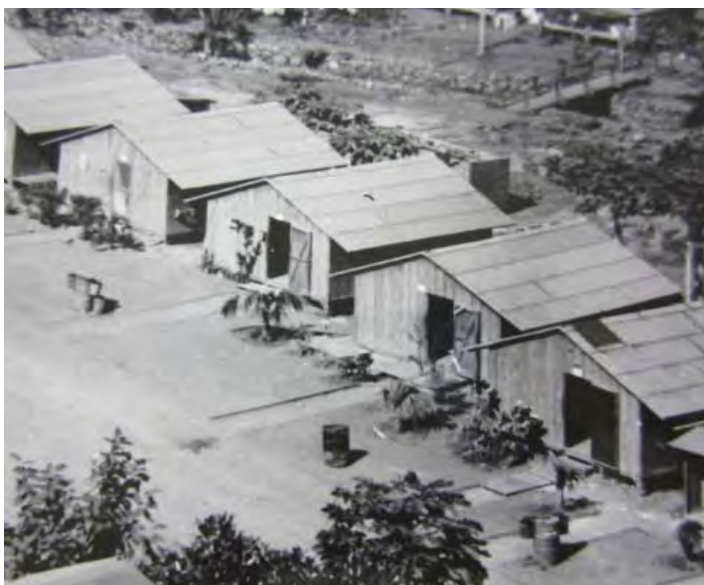
The three excavation units completed in Compound V in 2014 suggest the layer of white coral gravels that formed the World-War-II-era ground surface is intact, at least in some areas. Because the coral was put down by the military, it provides an easily identifiable "occupation surface" for the camp (Figure 6.6). Although most commonly used on roads, at Honouliuli white coral may have been more widespread, as suggested by its presence in Excavation Unit 3, near a barracks, and on the northwest side of the laundry, adjacent to the exterior wall. Dan Nishikawa's drawing of Compound V's barracks shows no break between the road and the paths that led to each barracks, indicating white coral was likely placed on paths, as well. In addition,

Figure 6.6. Paths to barracks surfaced with white coral gravel, ca. 1945 (detail of R.H. Lodge photograph).

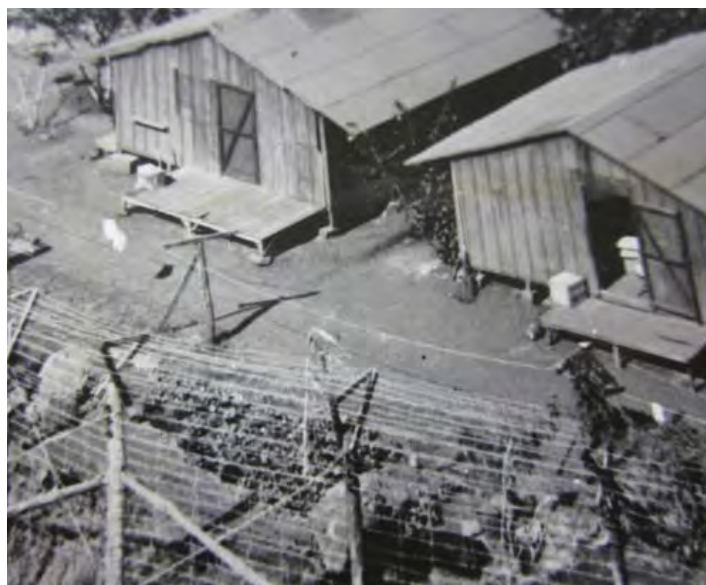
in Excavation Unit 1 a rock alignment not visible on the surface was discovered. Close examination of the R.H. Lodge photographs will suggest additional areas to look for archaeological features, such as the posthole for a clothesline pole (?) and stone and concrete barracks foundation piers visible in Figure 6.7.

Figure 6.7. Barracks in compound V ca. 1945, suggesting archaeological features that might be found (detail of R.H. Lodge photograph).

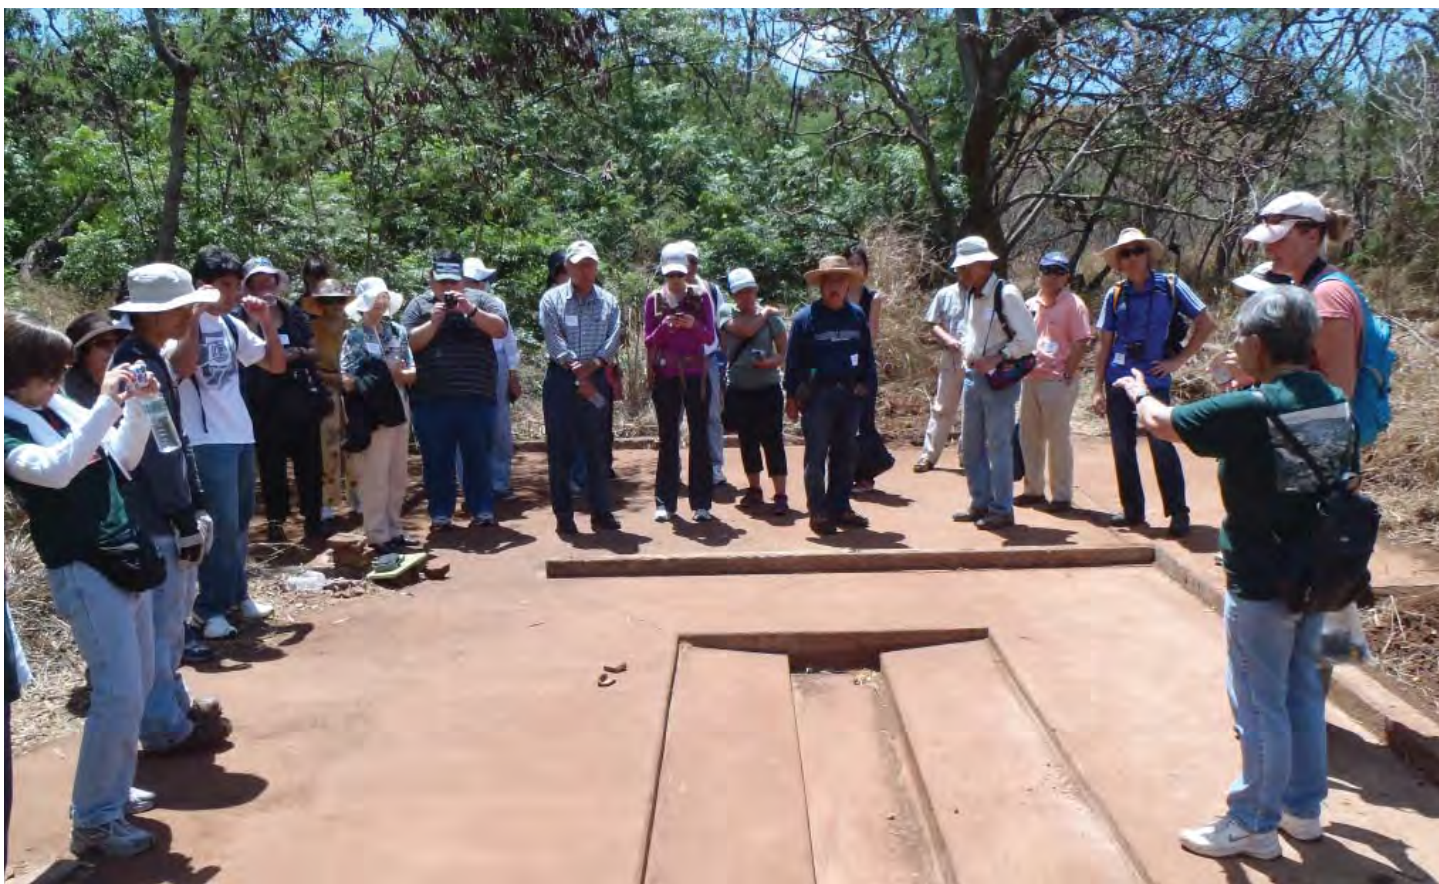
Figure 6.15. Tour group listening to Jane Kurahara at the laundry building foundation in 2012.

- Uncover the rest of the laundry building to allow an analysis of the laundry operations, facilitate maintenance, and serve as a destination point for visitor tours. Its large size gives an impression of the scale of the war development at the camp, and its location at the end of Compound VI would provide a good overview of the camp as a whole (Figure 6.15).

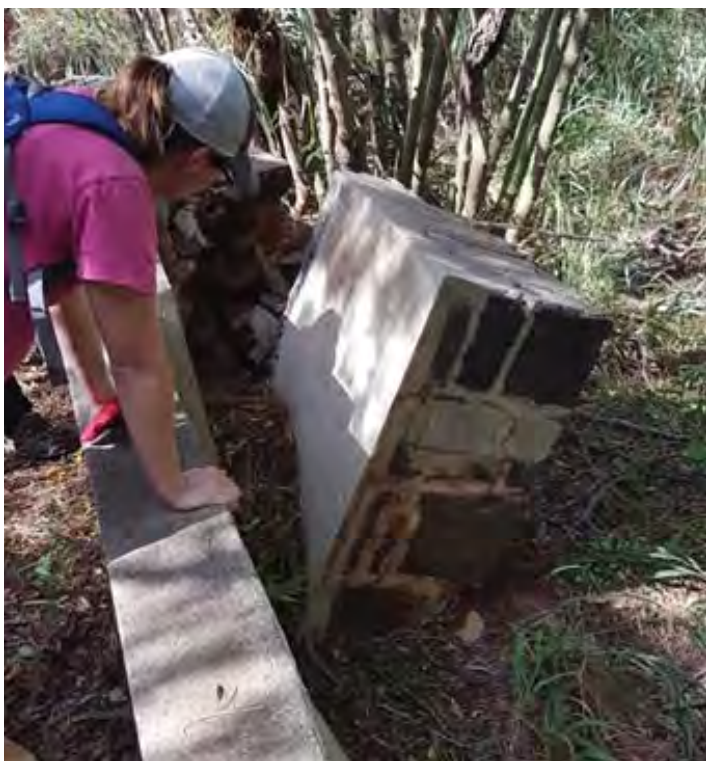
wall for the lower ditch (Figures 6.19 and 6.20). Other actions recommended to help preserve the site include:

Figure 6.19. Tilted pier of the aqueduct (Feature L-1b) in 2017.

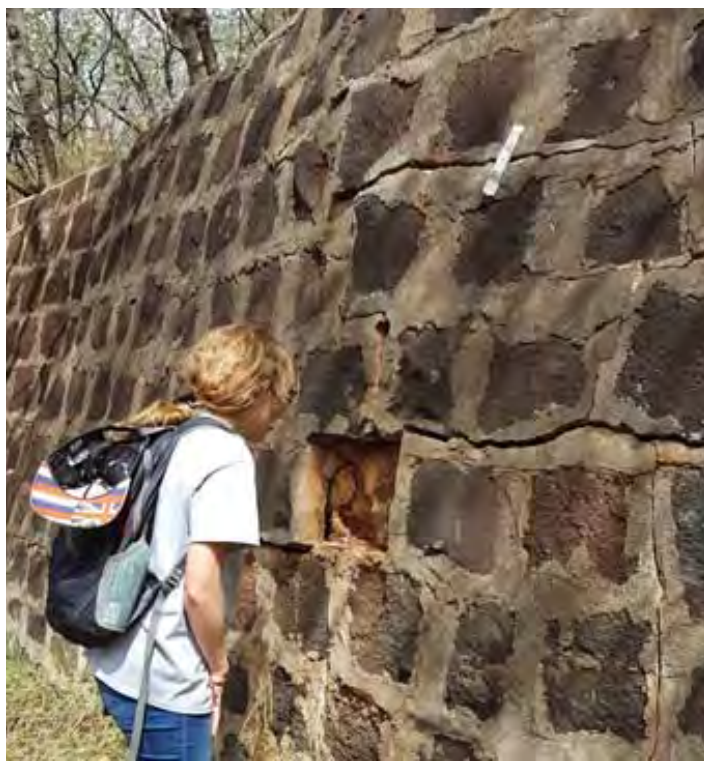
Figure 6.20. Spalling rock wall (Feature V-15) in 2017.
