ARCHEOLOGICAL FEATURE ASSESSMENT AT HONOULIULI NATIONAL HISTORIC
SITE: APPENDIX B – THE 2018 UNIVERSITY OF HAWAI‘I WEST O‘AHU
ARCHEOLOGICAL FIELD SCHOOL

WILLIAM R. BELCHER

15 JULY 2019

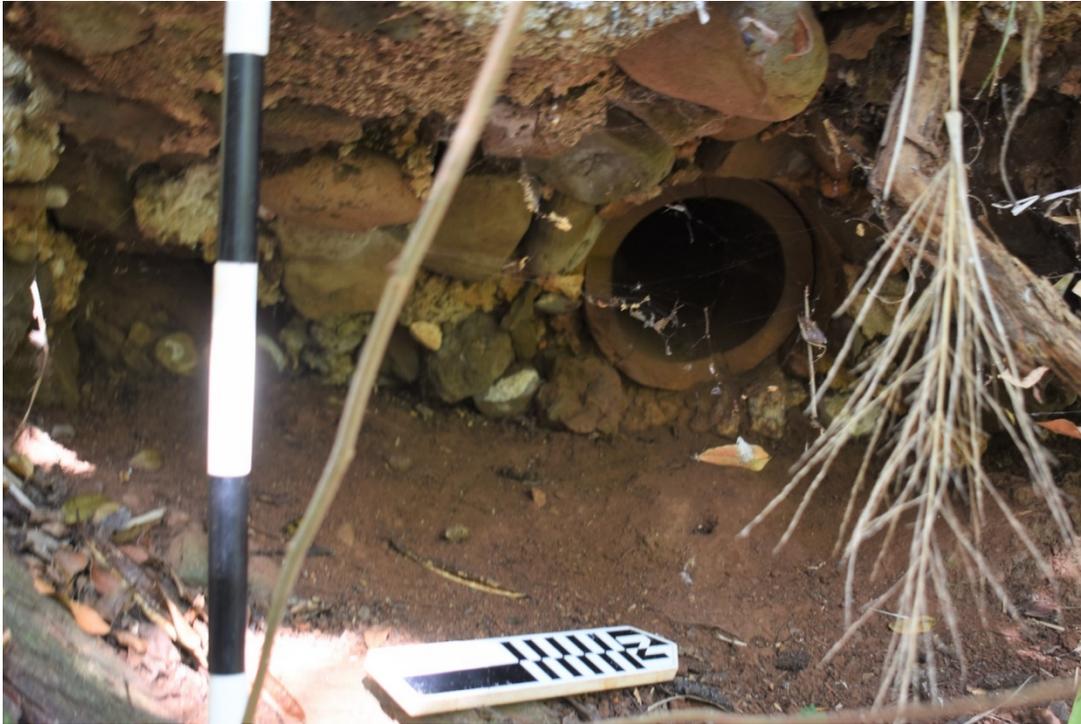
Figure 9. Feature I-1, Sewer Pipe.

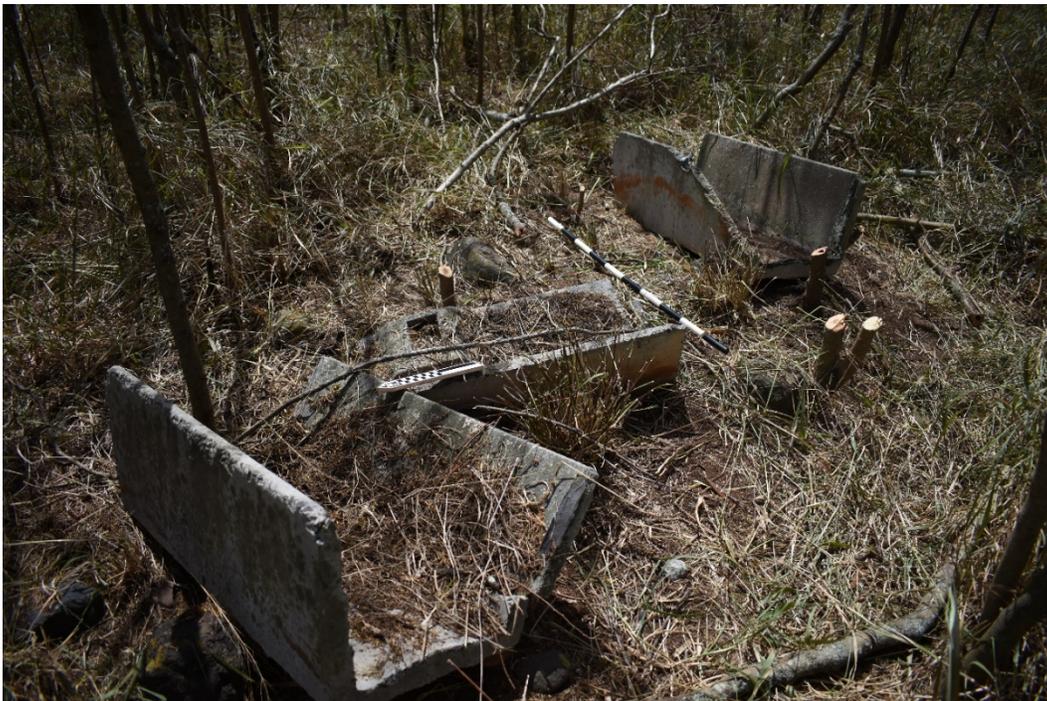
Figure 10. Representative sample of debris related to irrigation flumes, Feature I-4.

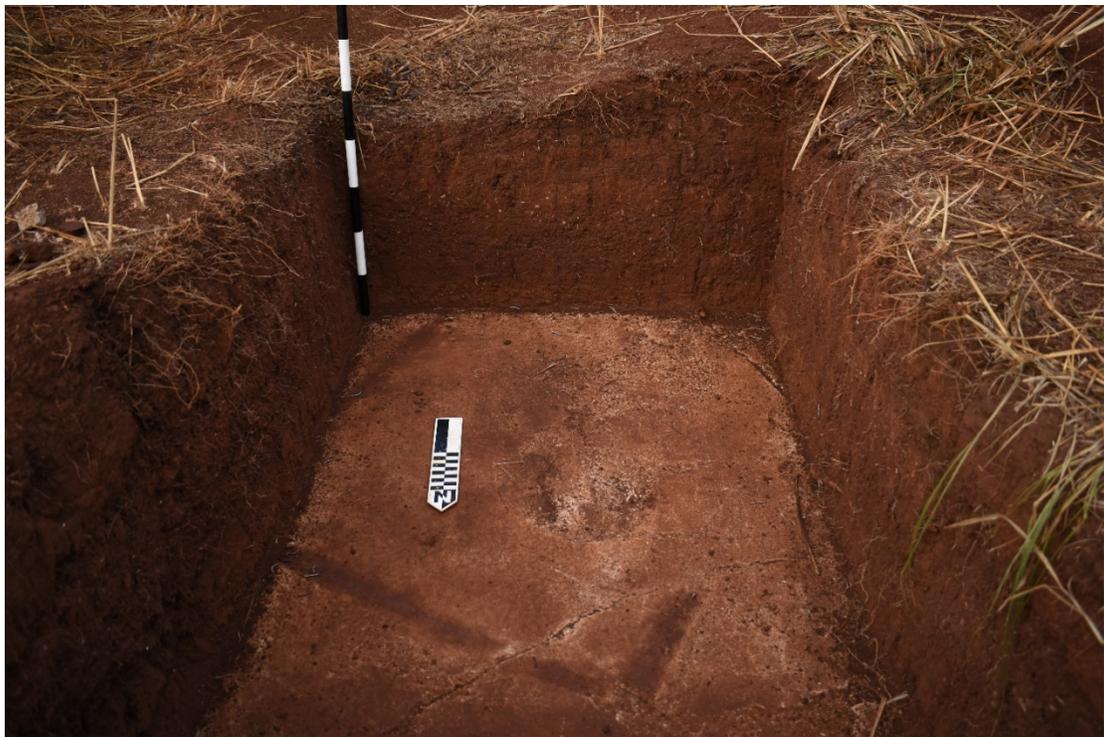
Figure 15. Feature I-7, TP-H, south wall with floor “shadow”; view is south.

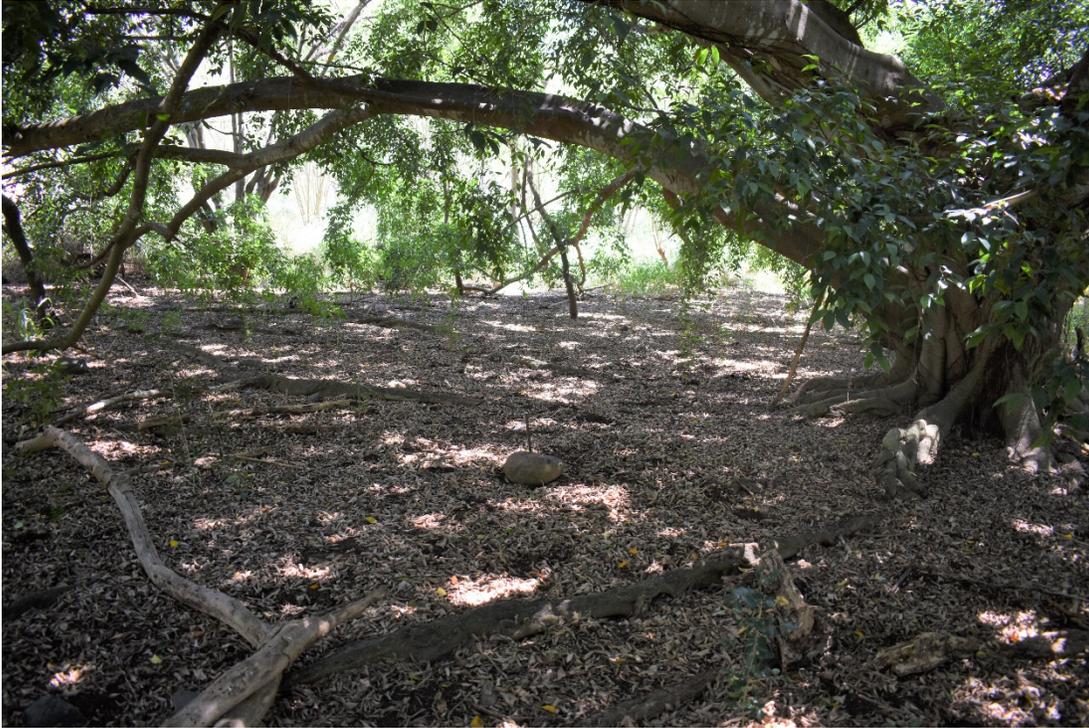
Figure 22. Feature II-8, Structural Debris and Artifacts, overview under *Ficus* tree; facing southeast.

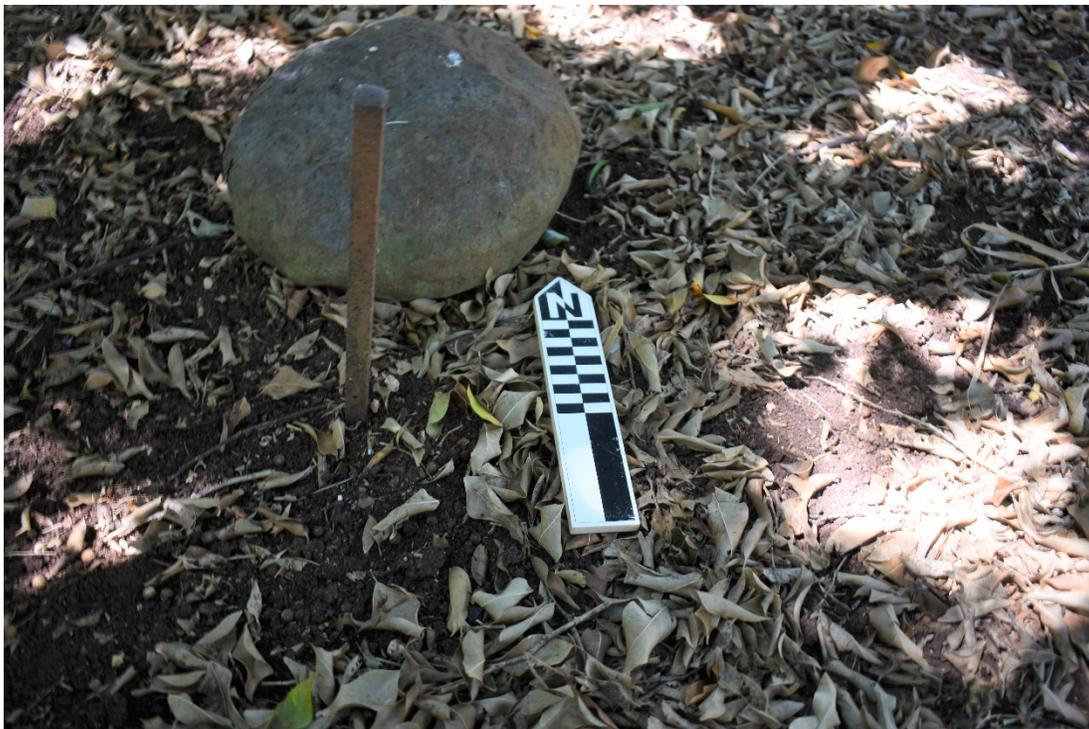
Figure 23. Feature II-8, Vertical Stake.

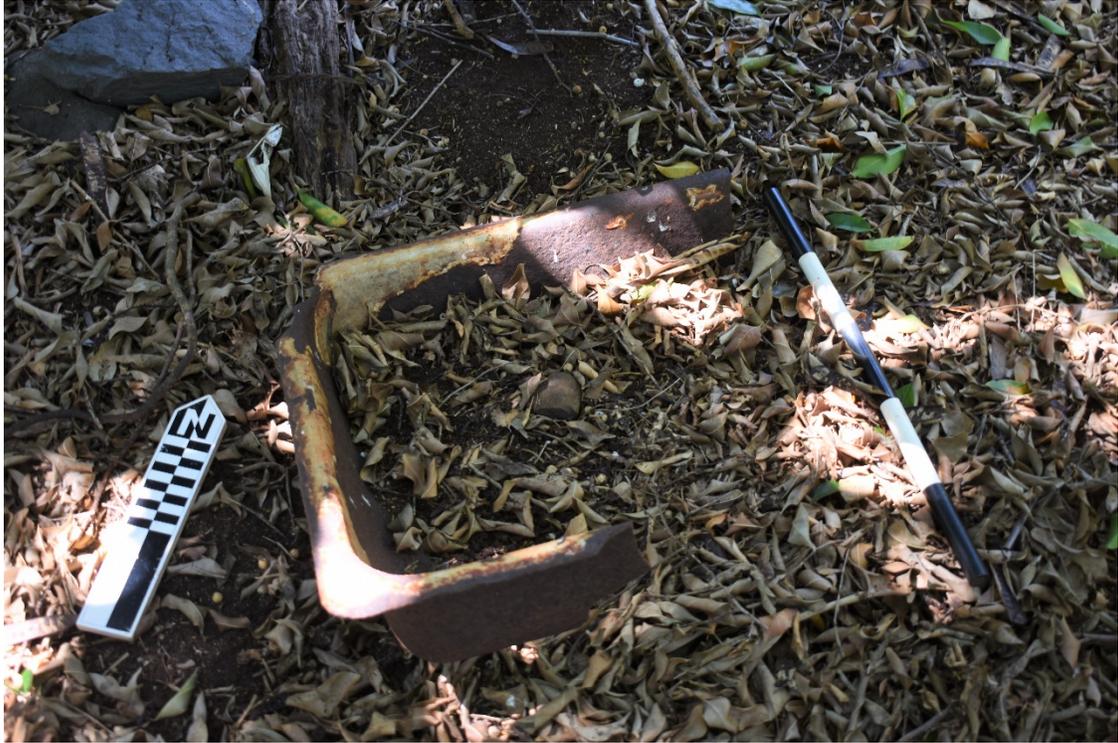
Figure 24. Feature II-8, Sink Debris.

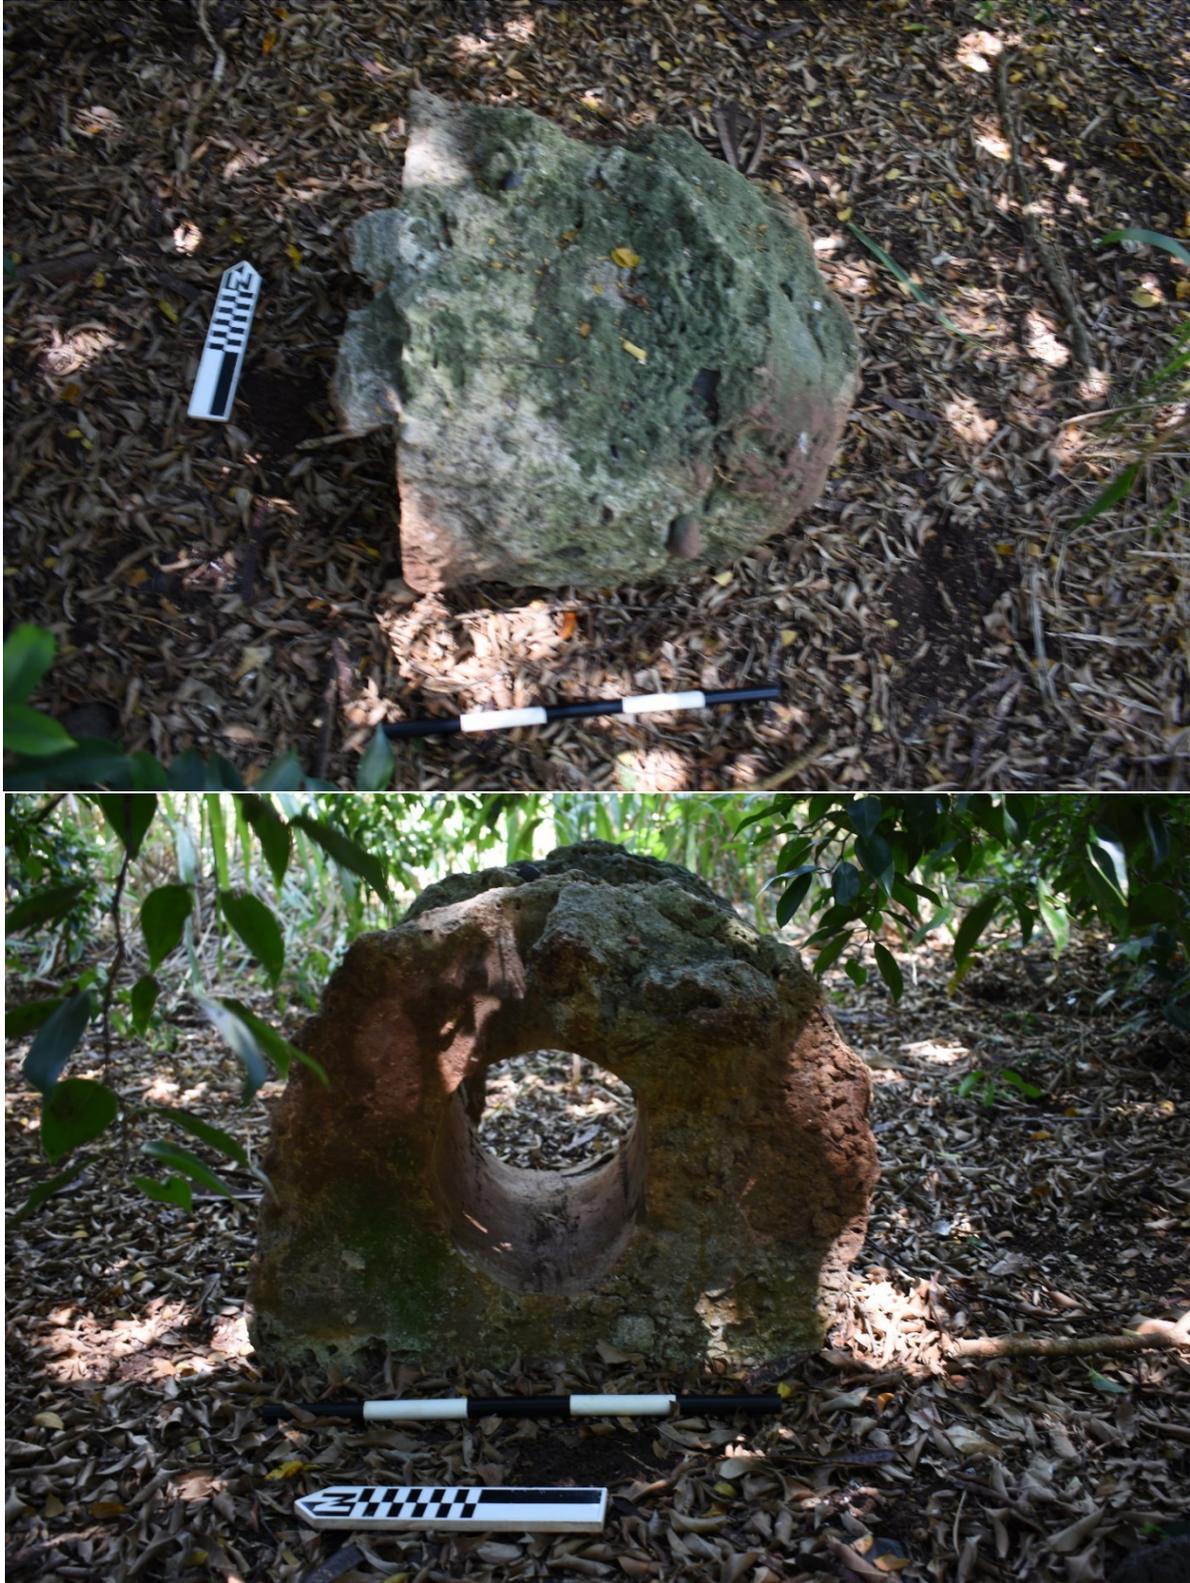
Figure 25. Feature II-8, Concrete Pipe (?) (top vertical view; bottom “side” view).

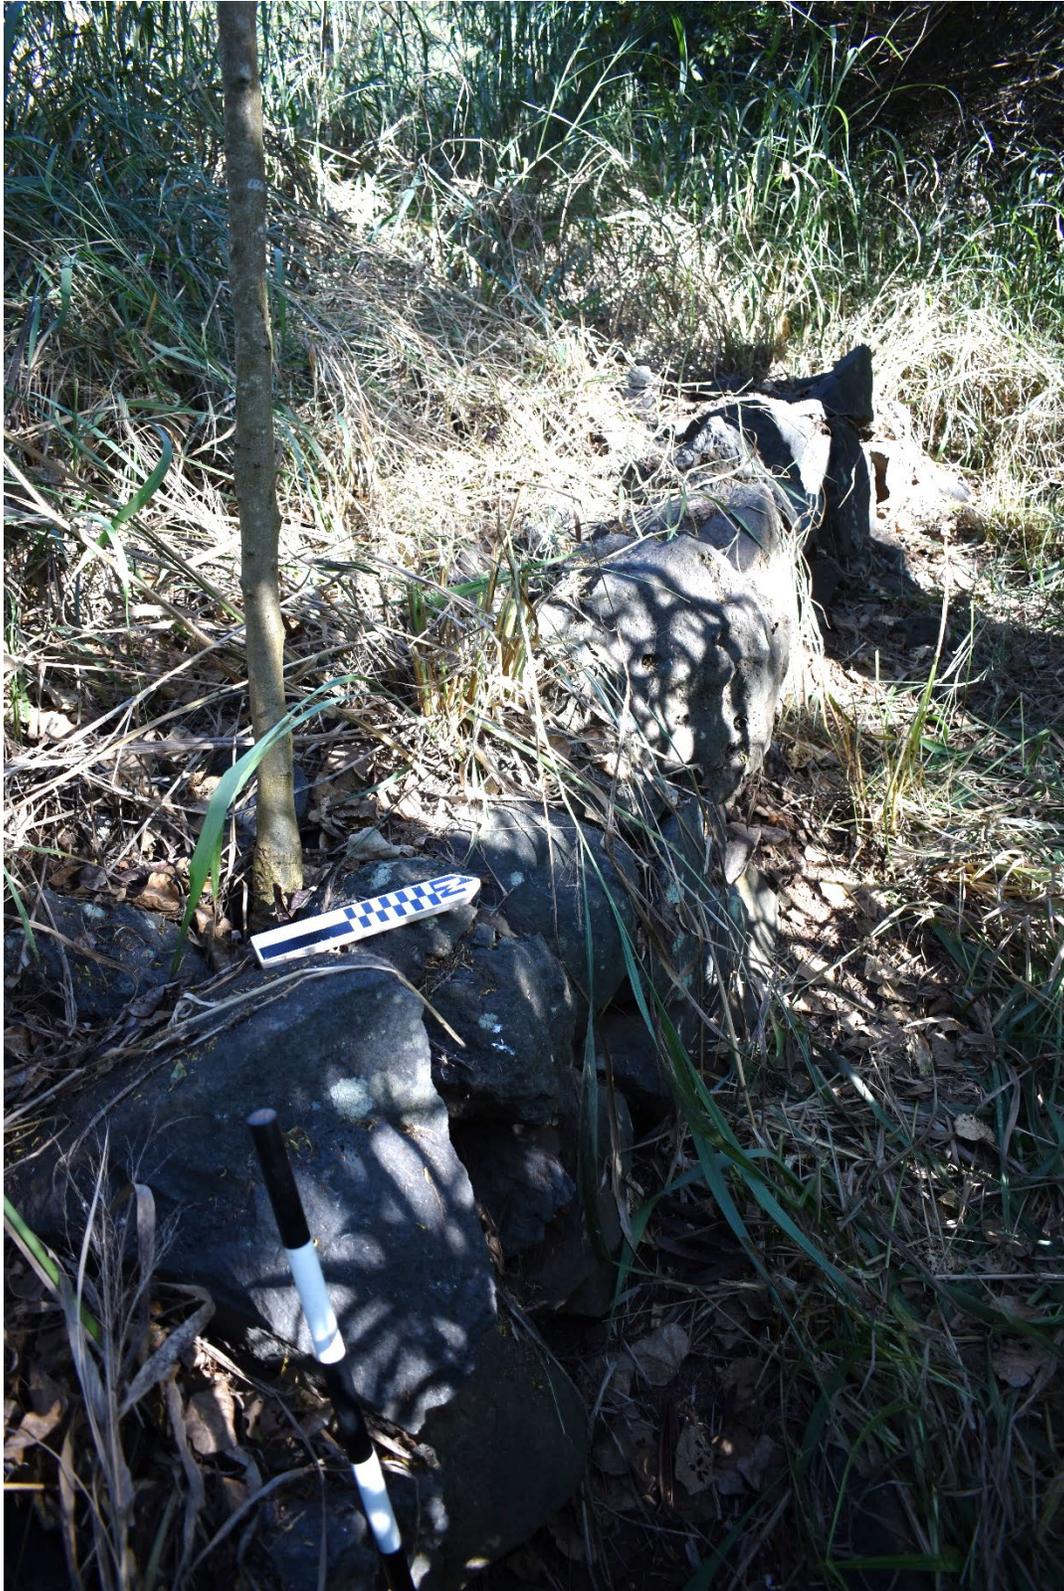
Figure 26. Feature II-11, Rock Wall.

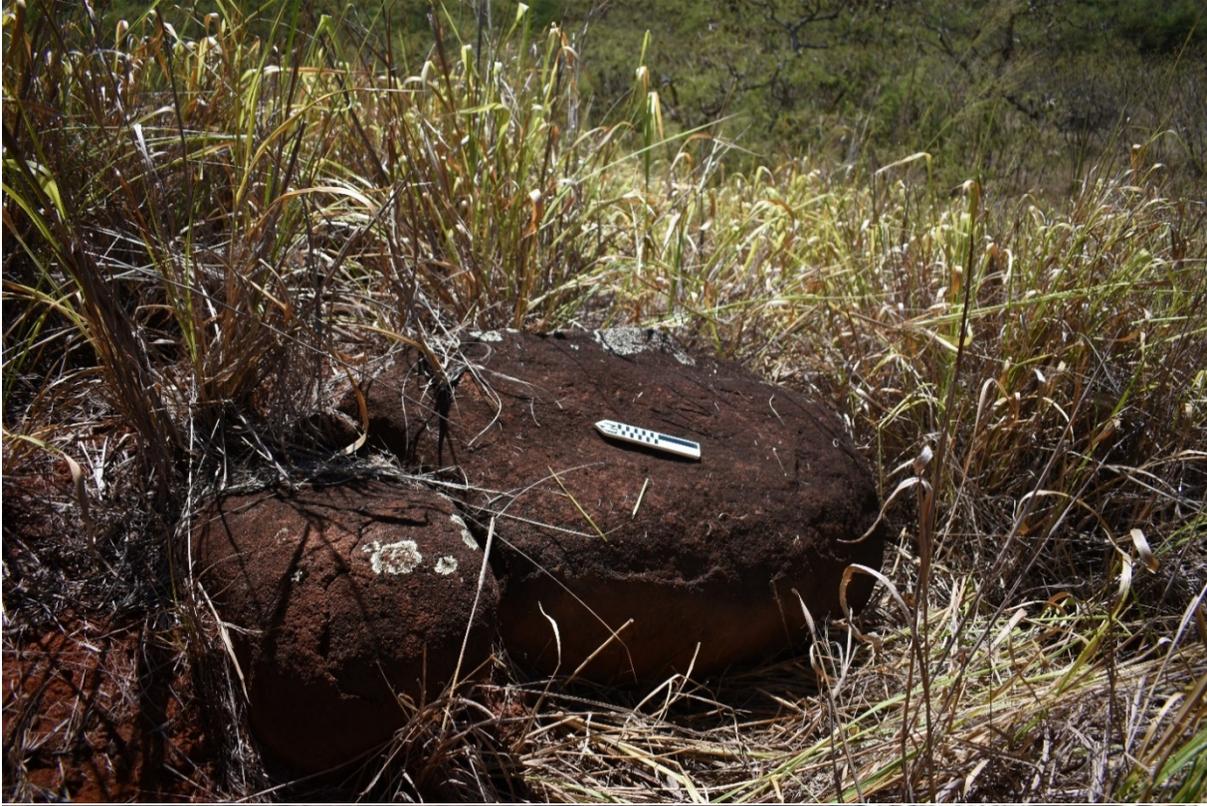
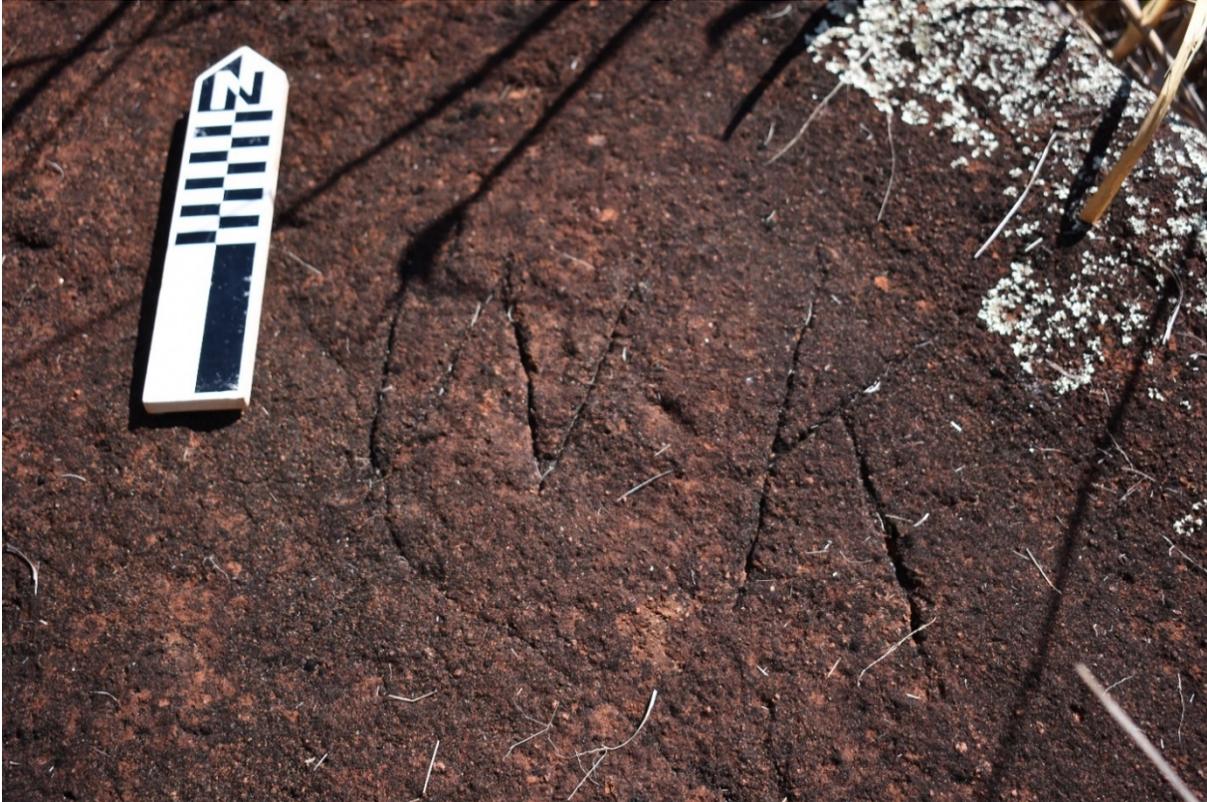
Figure 27. Feature II-14, Inscription “WK”.

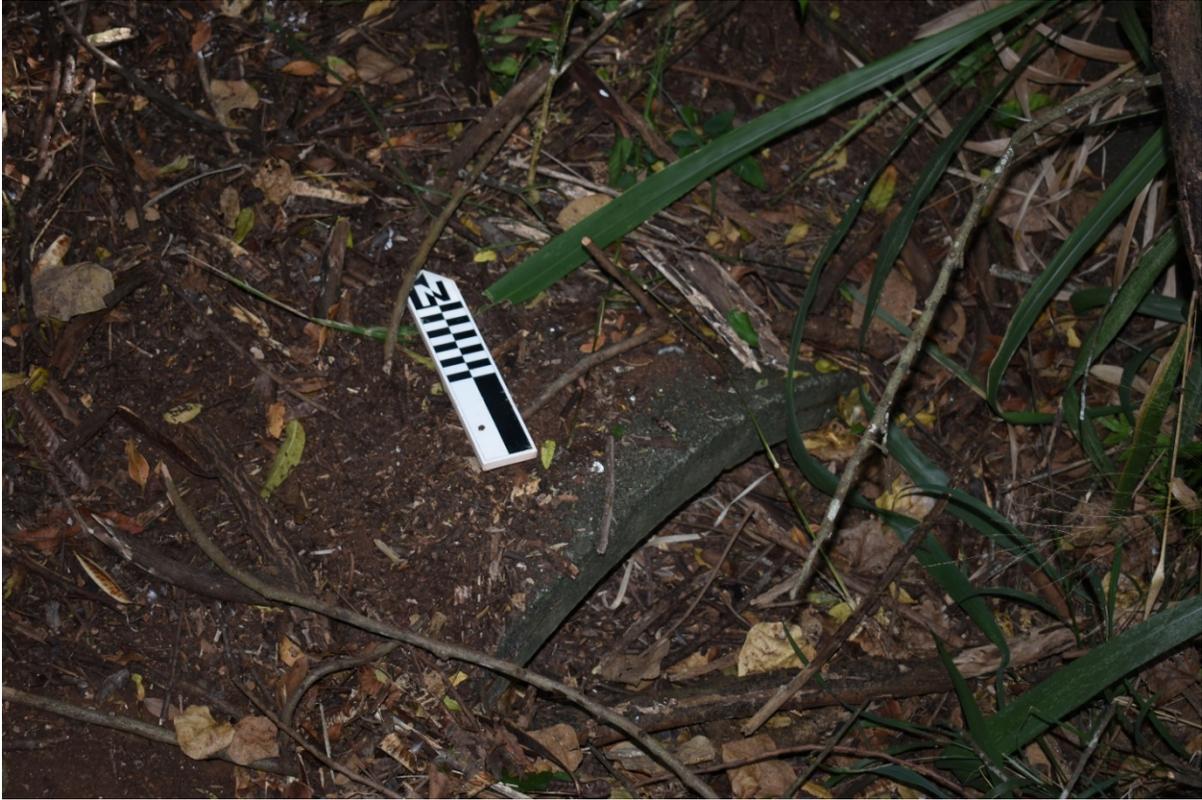
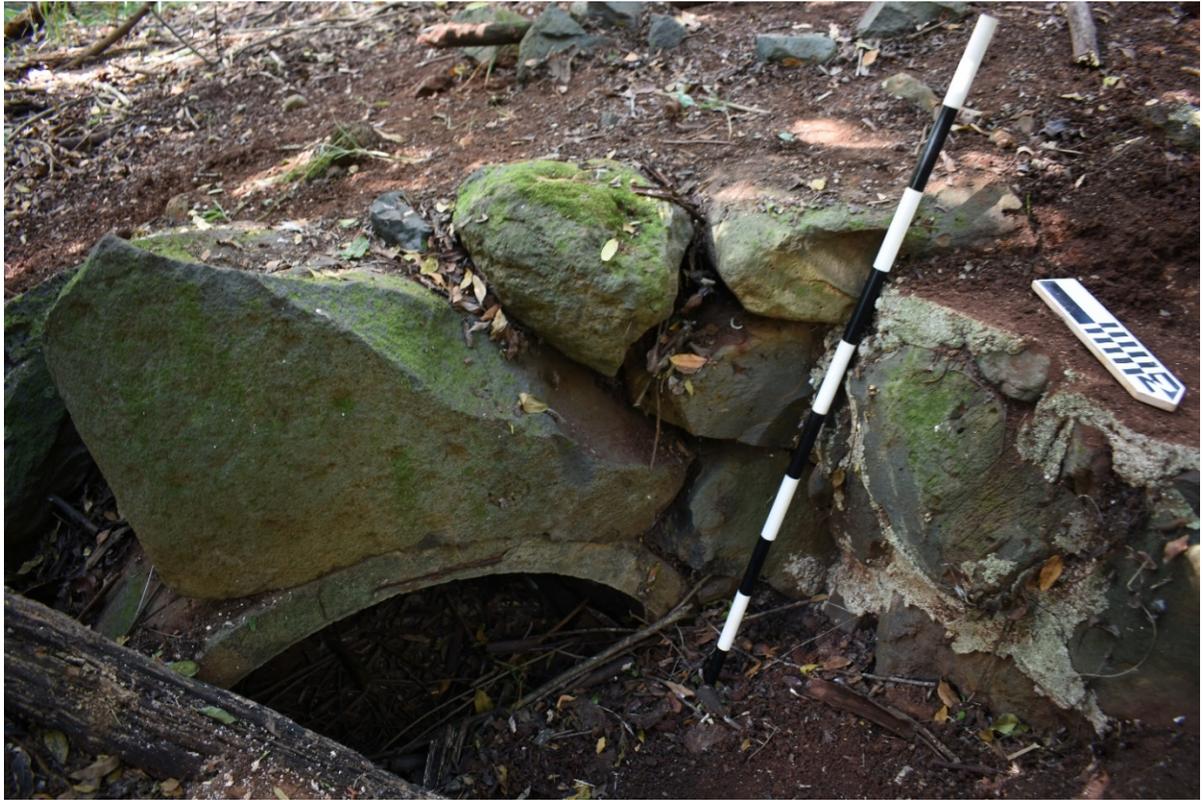
Figure 28. Feature II-22, Culverts (top, south end; bottom, north end).

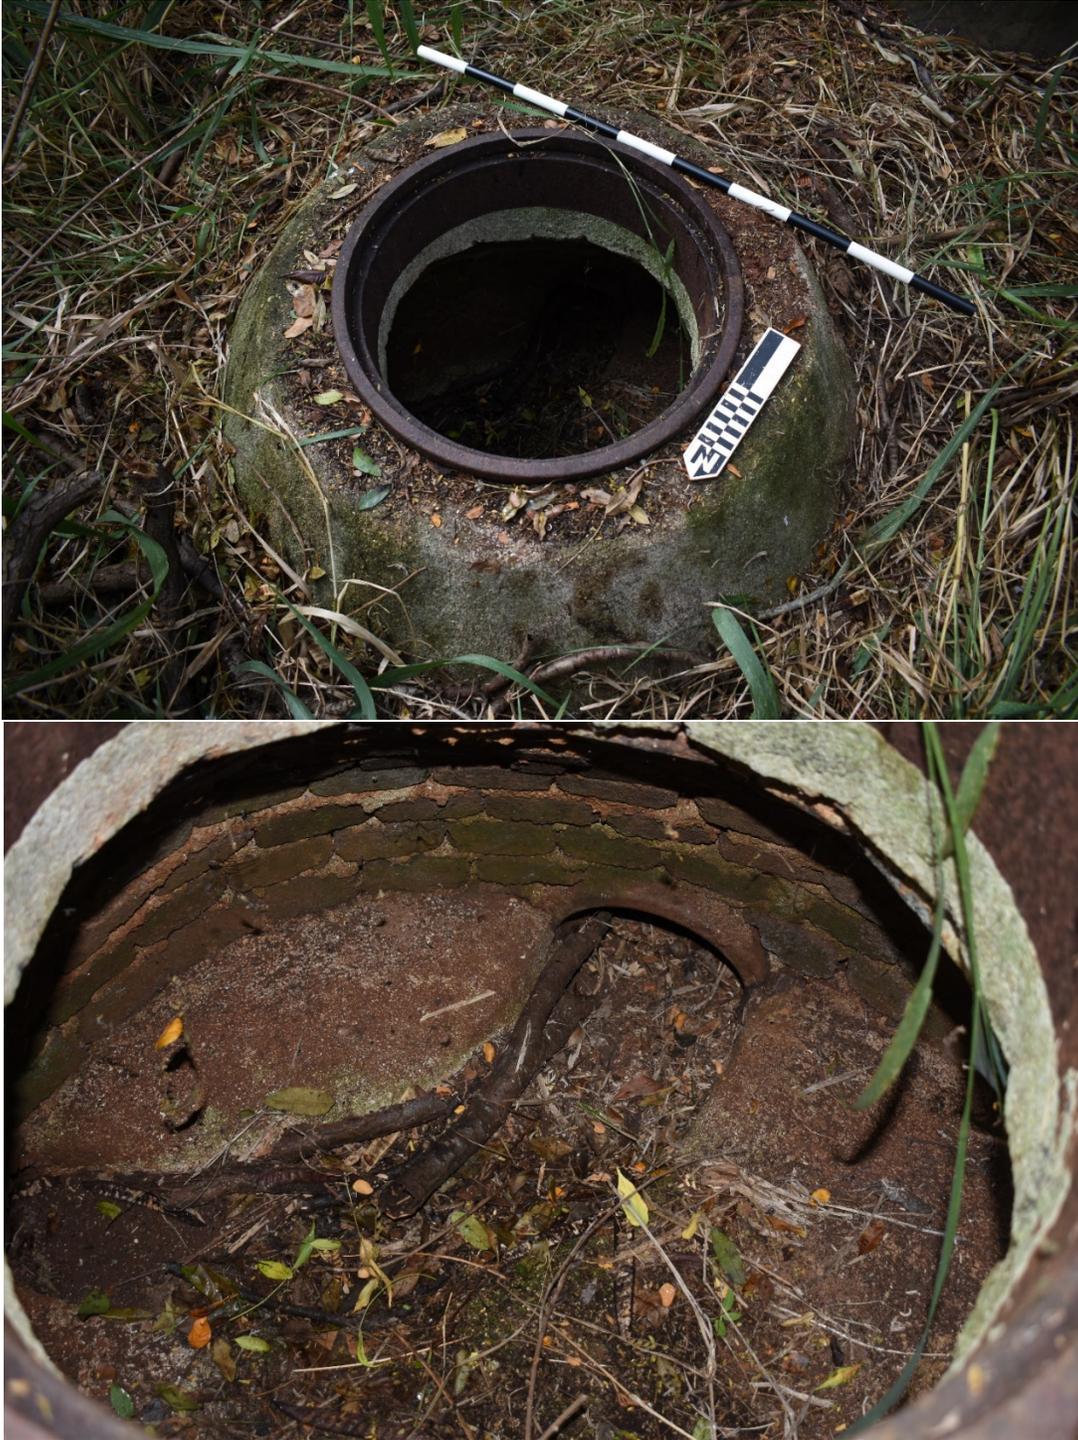
Figure 36. Feature VI-1, Manhole Exterior (top) and interior (bottom) showing pipes and concrete floor and troughs.

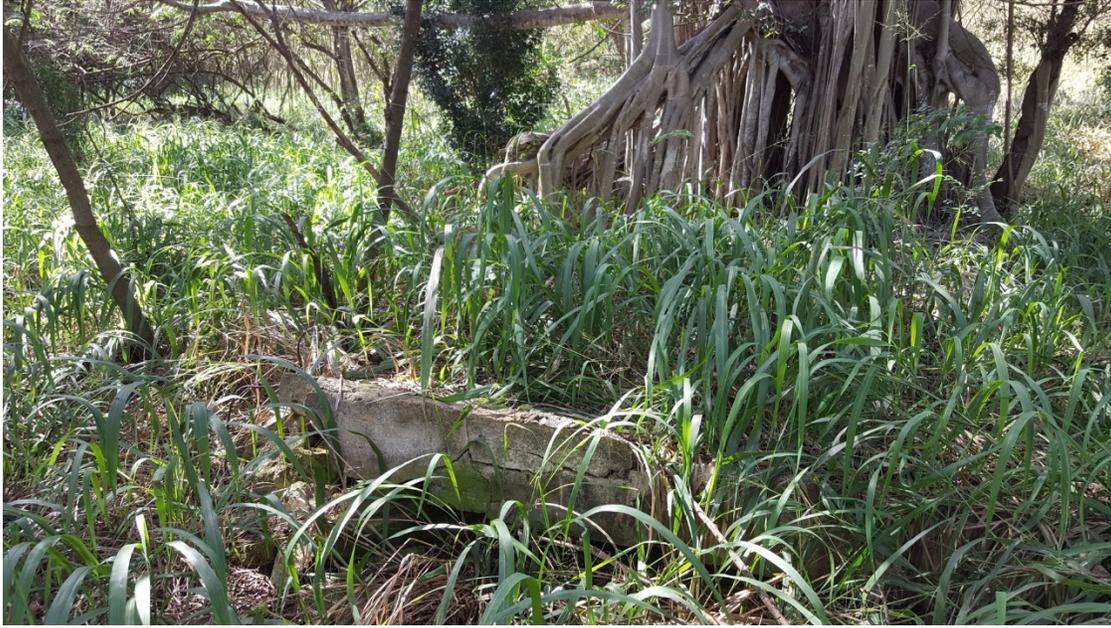
Figure 39. Feature V-2, Structural Debris.

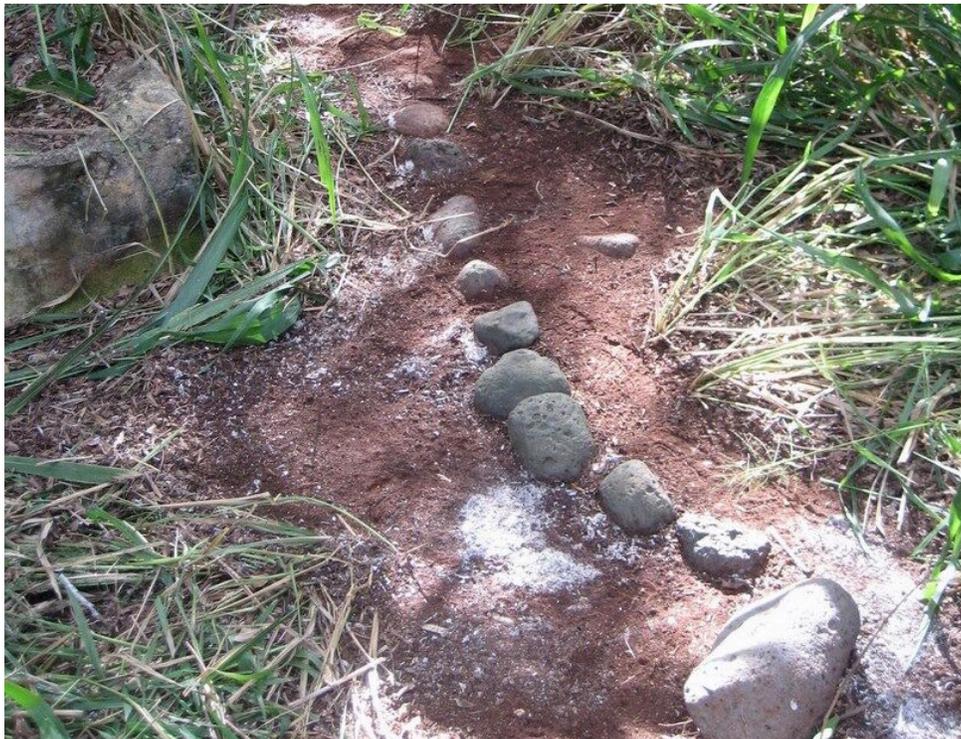
Feature V-4: Rock Alignment (Figure 40). This rock alignment is approximately 15 feet long and composed at least 18 rocks; it appears to form a straight line for about 9 feet perpendicular to the main road and then curves north for another 6 feet. These rocks may have lined a path near a possible building (concrete slab fragments are present nearby). The feature appeared stable in 2018, but since this is an ephemeral surface feature, it is very sensitive to disturbance.

Figure 40. Feature V-4, Rock Alignment.

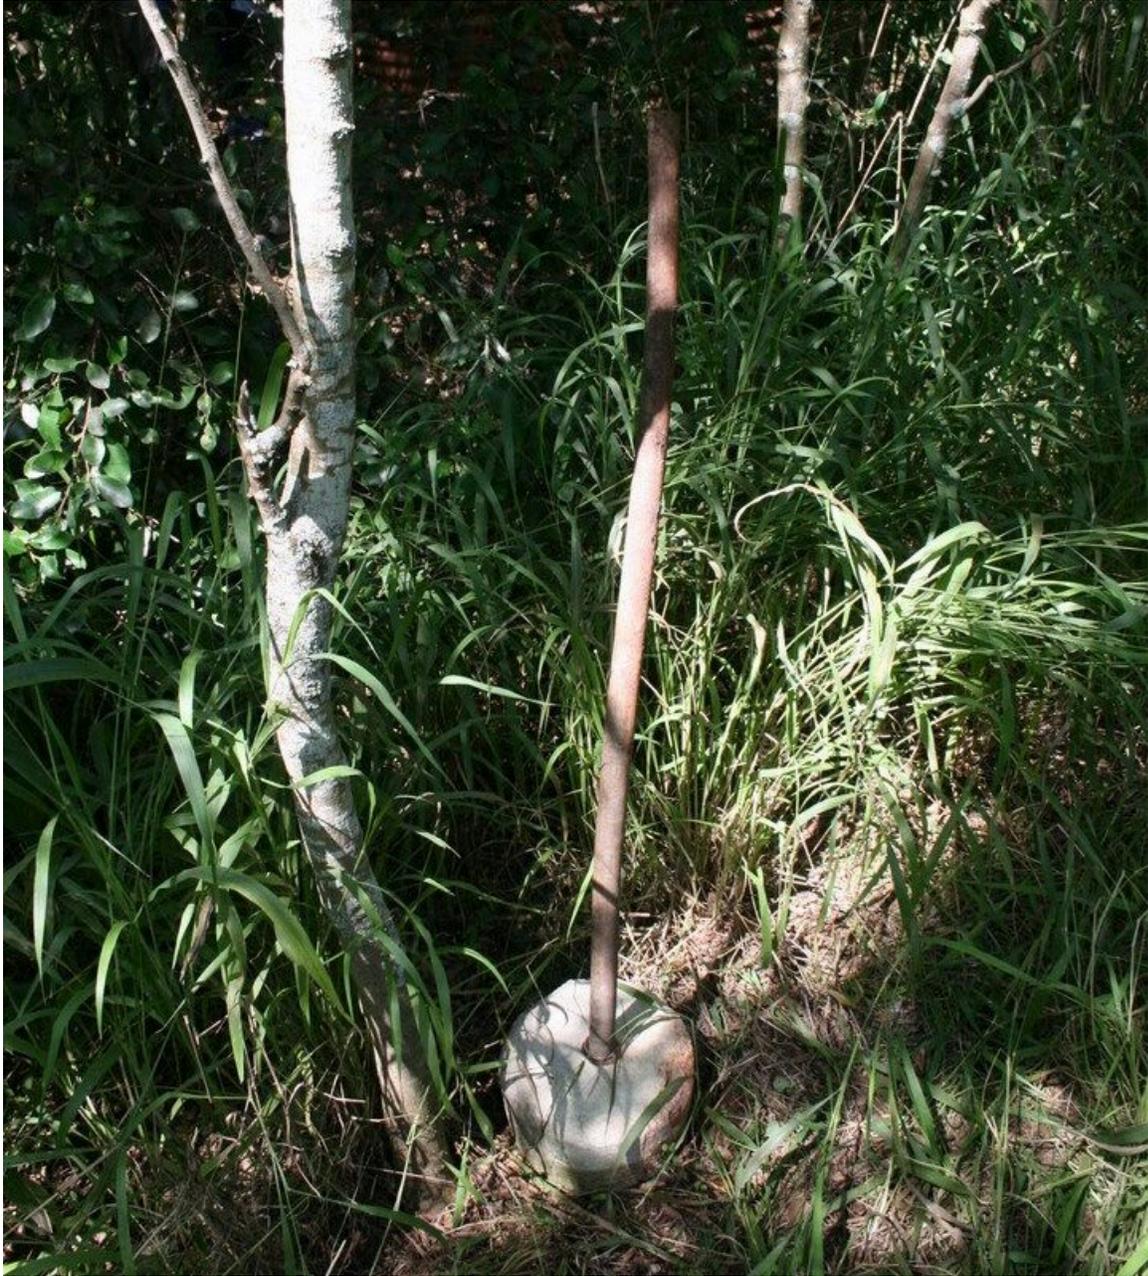
Feature V-5: Metal Pole with Concrete Plug (Figure 41). This is a “mobile” feature in that it is not fixed to the ground and appears to have been moved since initially documented. It consists of a bent, hollow metal pole, approximately 4 feet, 3 inches long; the concrete plug is 6 inches in length and approximately one foot in diameter. Burton and Farrell (2012:19) suggest that this may be a post-camp, ranch era feature.

Figure 41. Feature V-5, Metal pole with concrete plug.

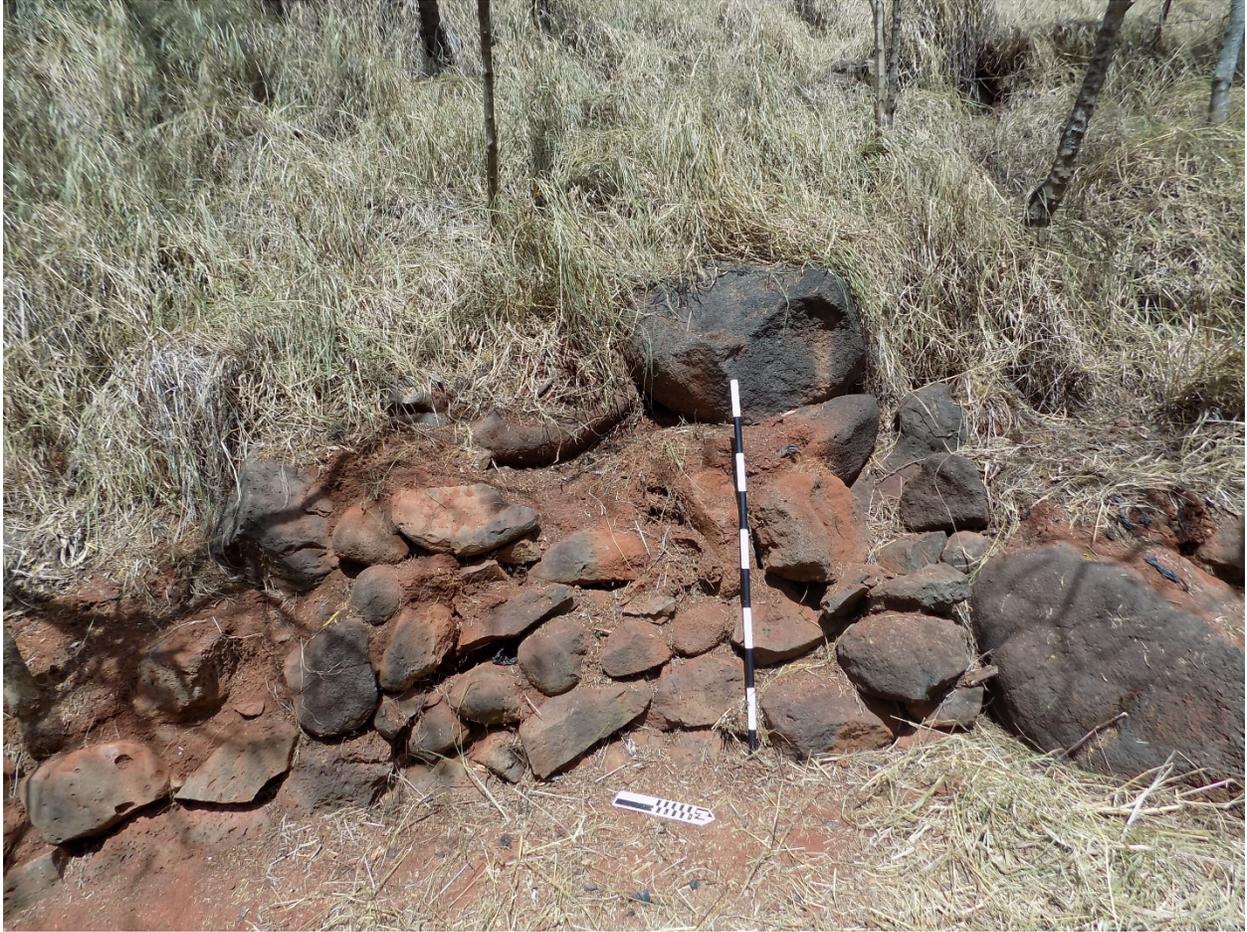
Feature V-28 Rock Wall (Figure 45). This feature was not recorded as part of the NRHP nomination form. The dry-stack wall is approximately 29 feet long and has an irregular height of

Figure 45. Feature V-28, Rock Wall.

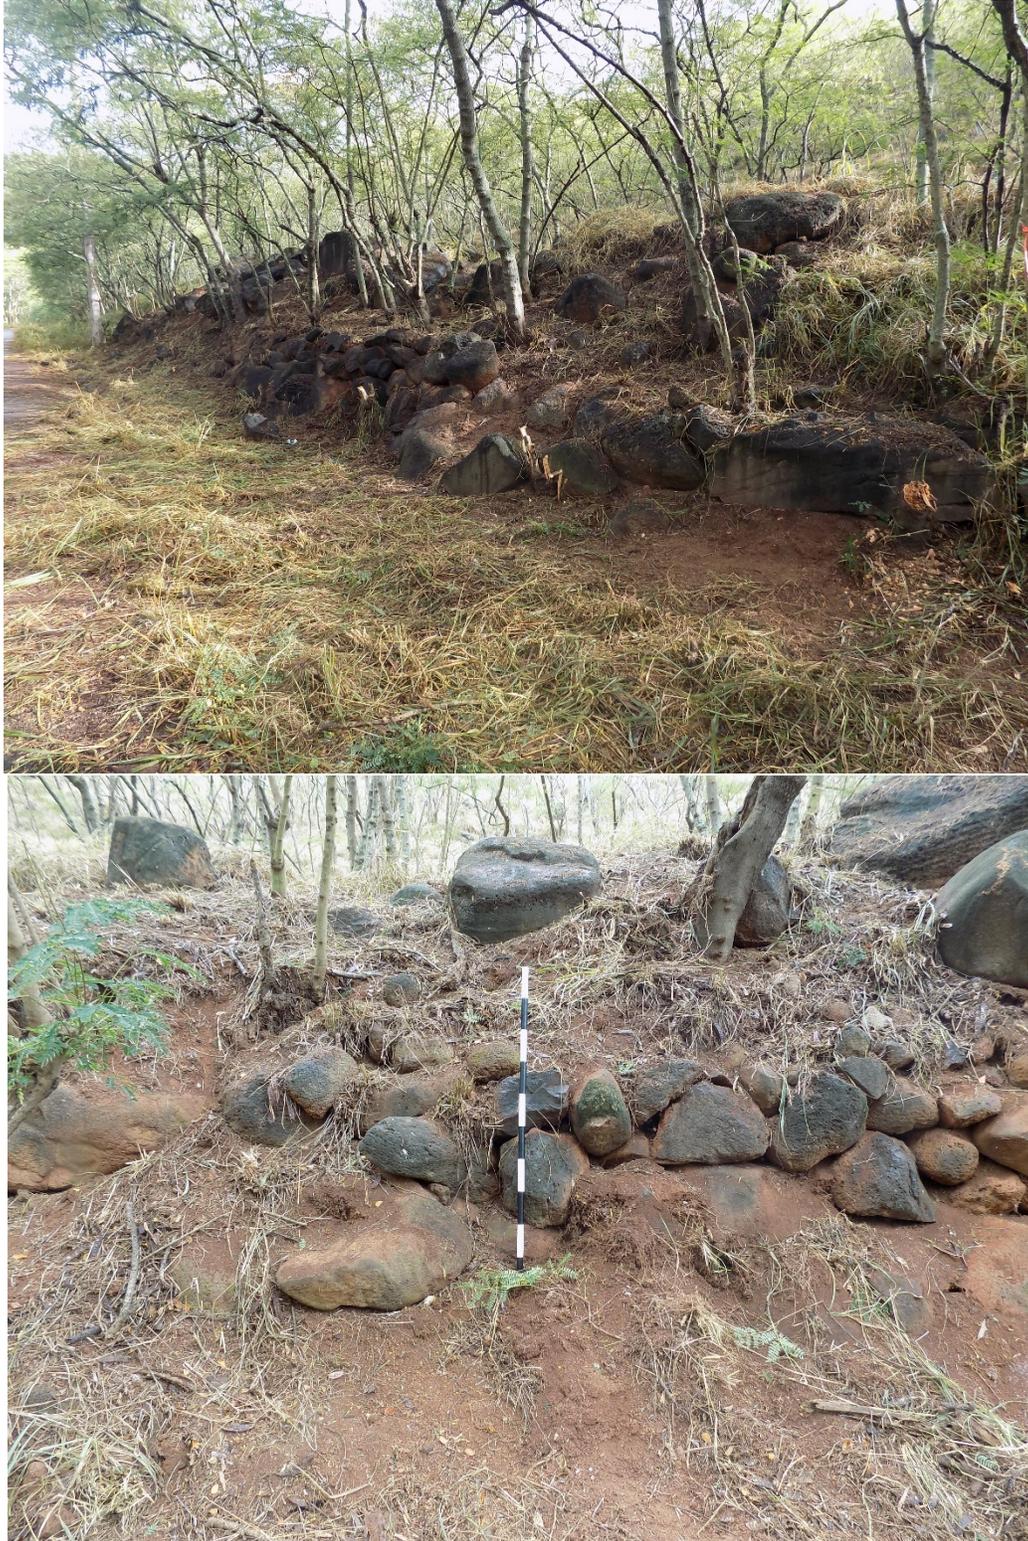
Feature VI-13: Rock Wall (Figure 48). This feature is located along the east side of the entrance road and is approximately 150 feet long and ranges from 1 to 3 feet high. It is constructed of undressed, dry-stacked basalt rocks. This wall is in poor shape and is actively collapsing. Burton and Farrell (2012:24) suggest that concrete fragments on its northern end may represent the remains of steps.

Figure 48. Feature VI-13, Rock Wall (top, general shot, facing northeast; bottom, detail of lava rock tiers, facing east).

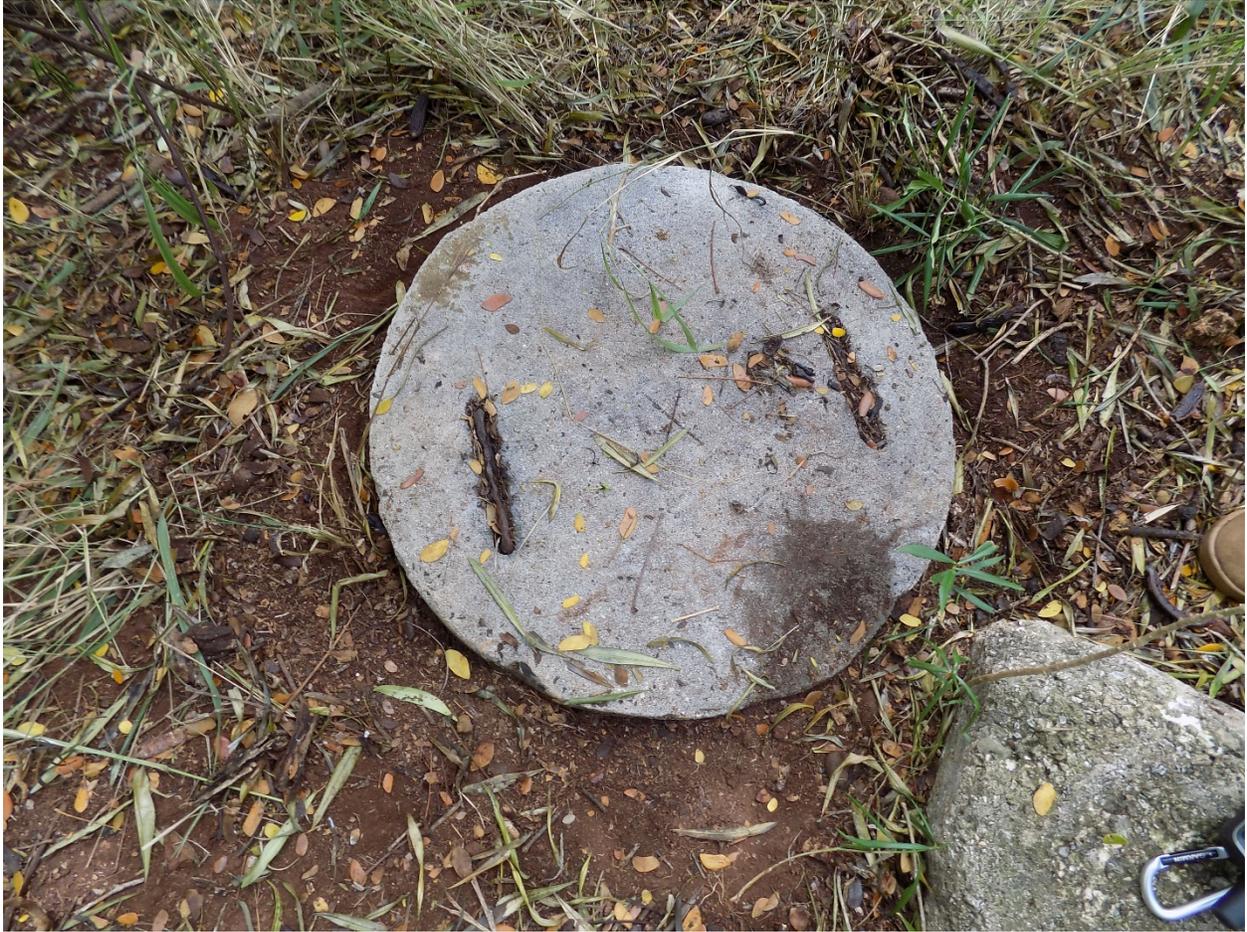
Feature VI-37: Manhole Lid (Figure 49). This manhole lid may be associated with Feature VI-36 but is located approximately 75 feet away. It is approximately 2 feet in diameter with two rebar handles.

Figure 49. Feature VI-37, Manhole Lid.

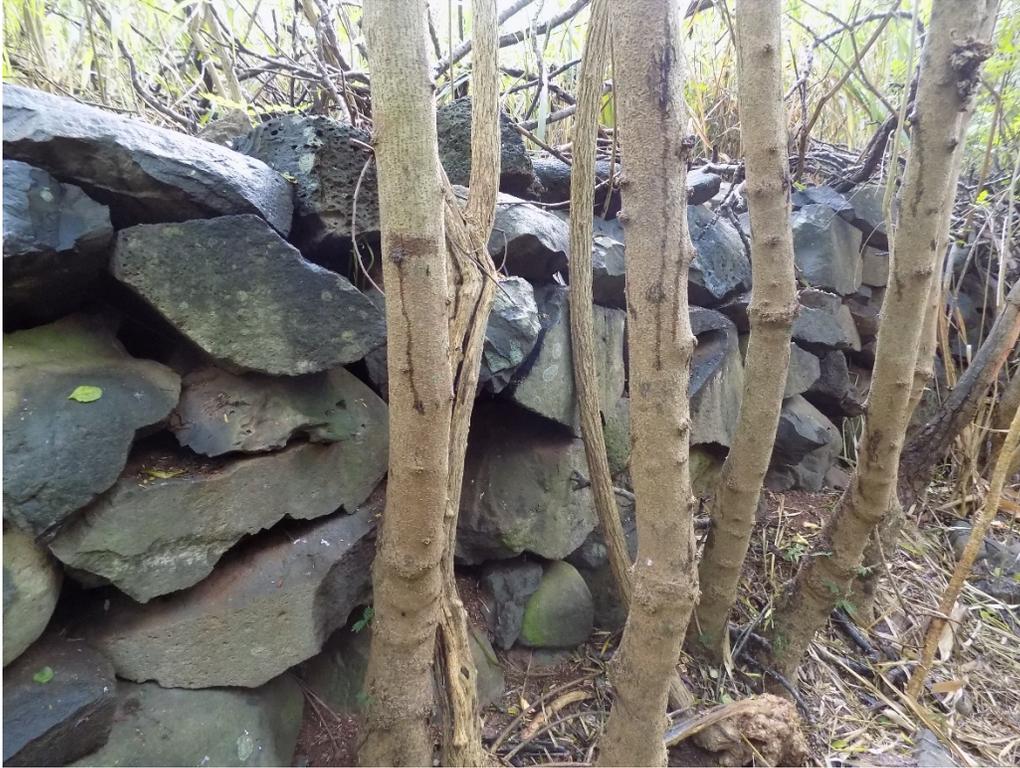
Feature VI-48: Foundation (?) (Figure 50). This feature is a mound of basalt rocks between a ditch (Feature VI-47) and Honouliuli Stream. Burton and Farrell (2012:28) suggest that this may represent a foundation for a building that is seen in historic photographs.

Figure 50. Feature VI-48, Rock Wall, Possible Foundation (?); facing south.

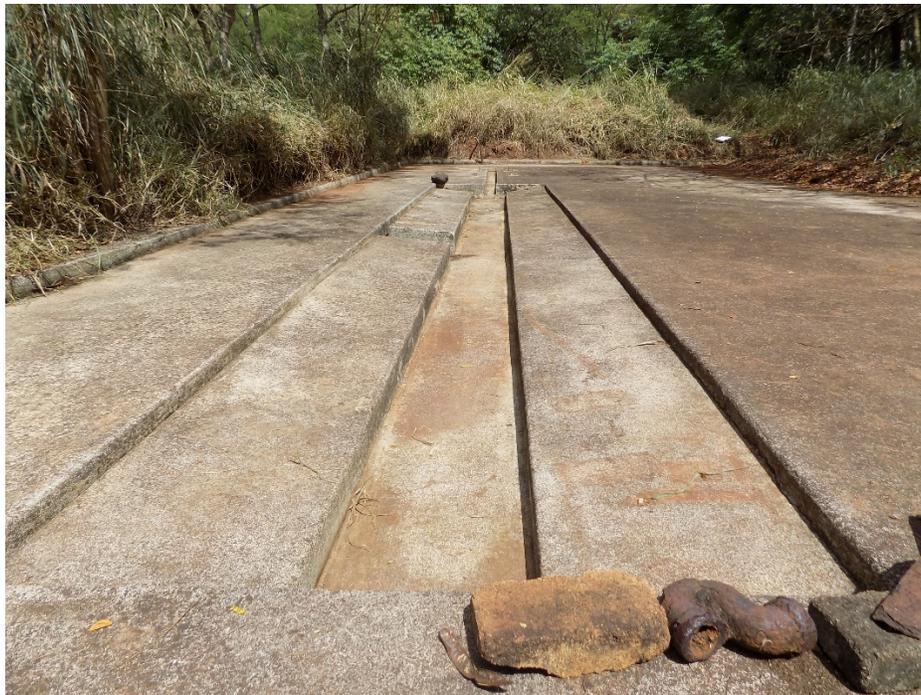
Feature VI-49: Laundry Building Foundation (Figure 51). This building is one of the largest buildings at Honouliuli National Historic Site. It measures approximately 60 feet by 55 feet. The southern side of the concrete slab is still covered in approximately one foot of sediment. Considerable effort will be required to uncover this (as well as other similar features throughout Honouliuli National Historic Site. Several beer bottles were mentioned in the 2012 NRHP

Figure 51. Feature VI-49, Laundry Building Foundation.
