ARCHEOLOGICAL FEATURE ASSESSMENT AT HONOULIULI NATIONAL HISTORIC
SITE: APPENDIX B – THE 2018 UNIVERSITY OF HAWAI‘I WEST O‘AHU
ARCHEOLOGICAL FIELD SCHOOL

WILLIAM R. BELCHER

15 JULY 2019

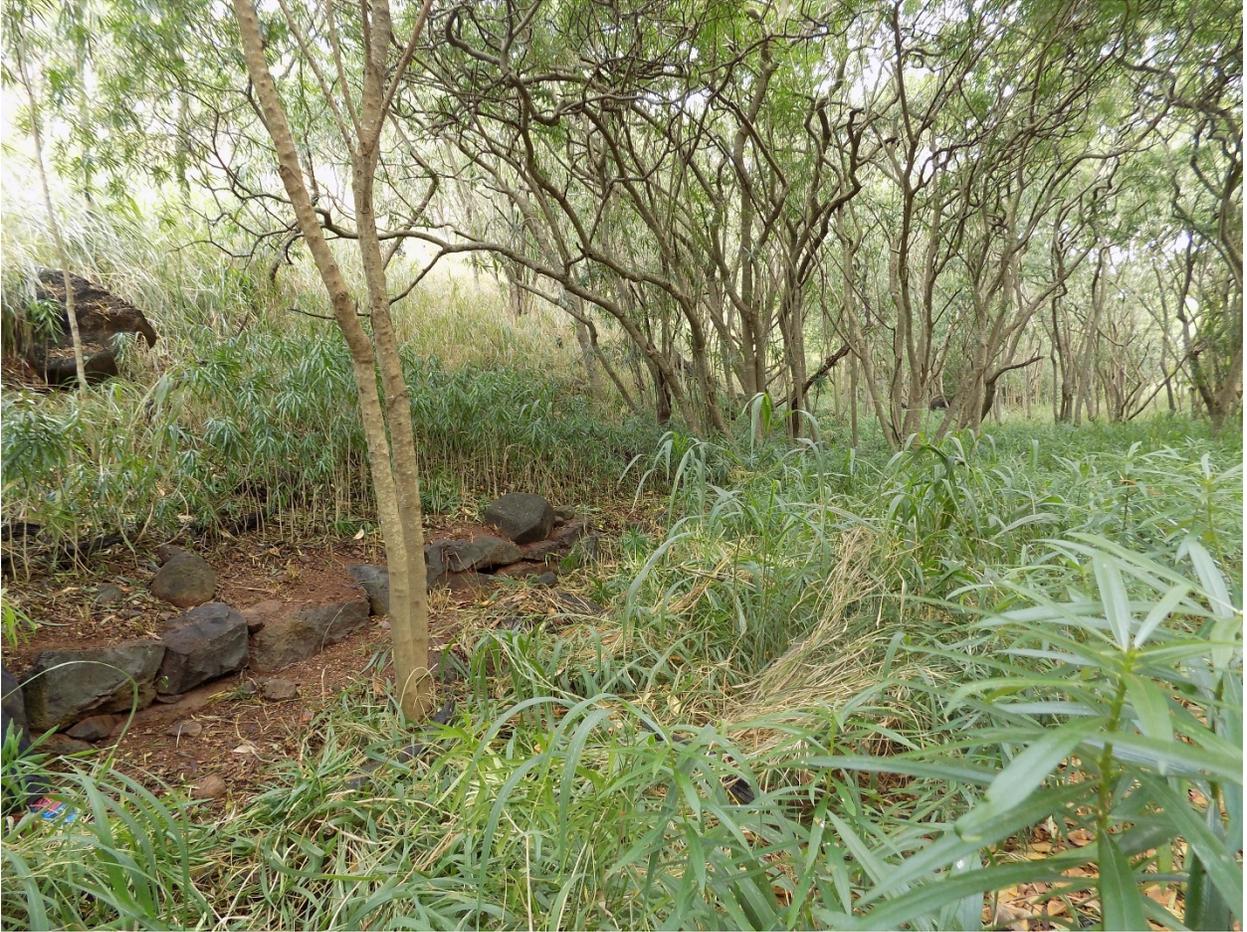
Feature VI-55: Rock Wall (Figure 53). This rock wall is a dry-stack wall that is composed of cobble to boulder-sized basalt rocks. This wall is approximately one to two feet high and approximately 150 feet long. It is actively collapsing downslope.

Figure 53. Figure VI-55. Rock Wall.

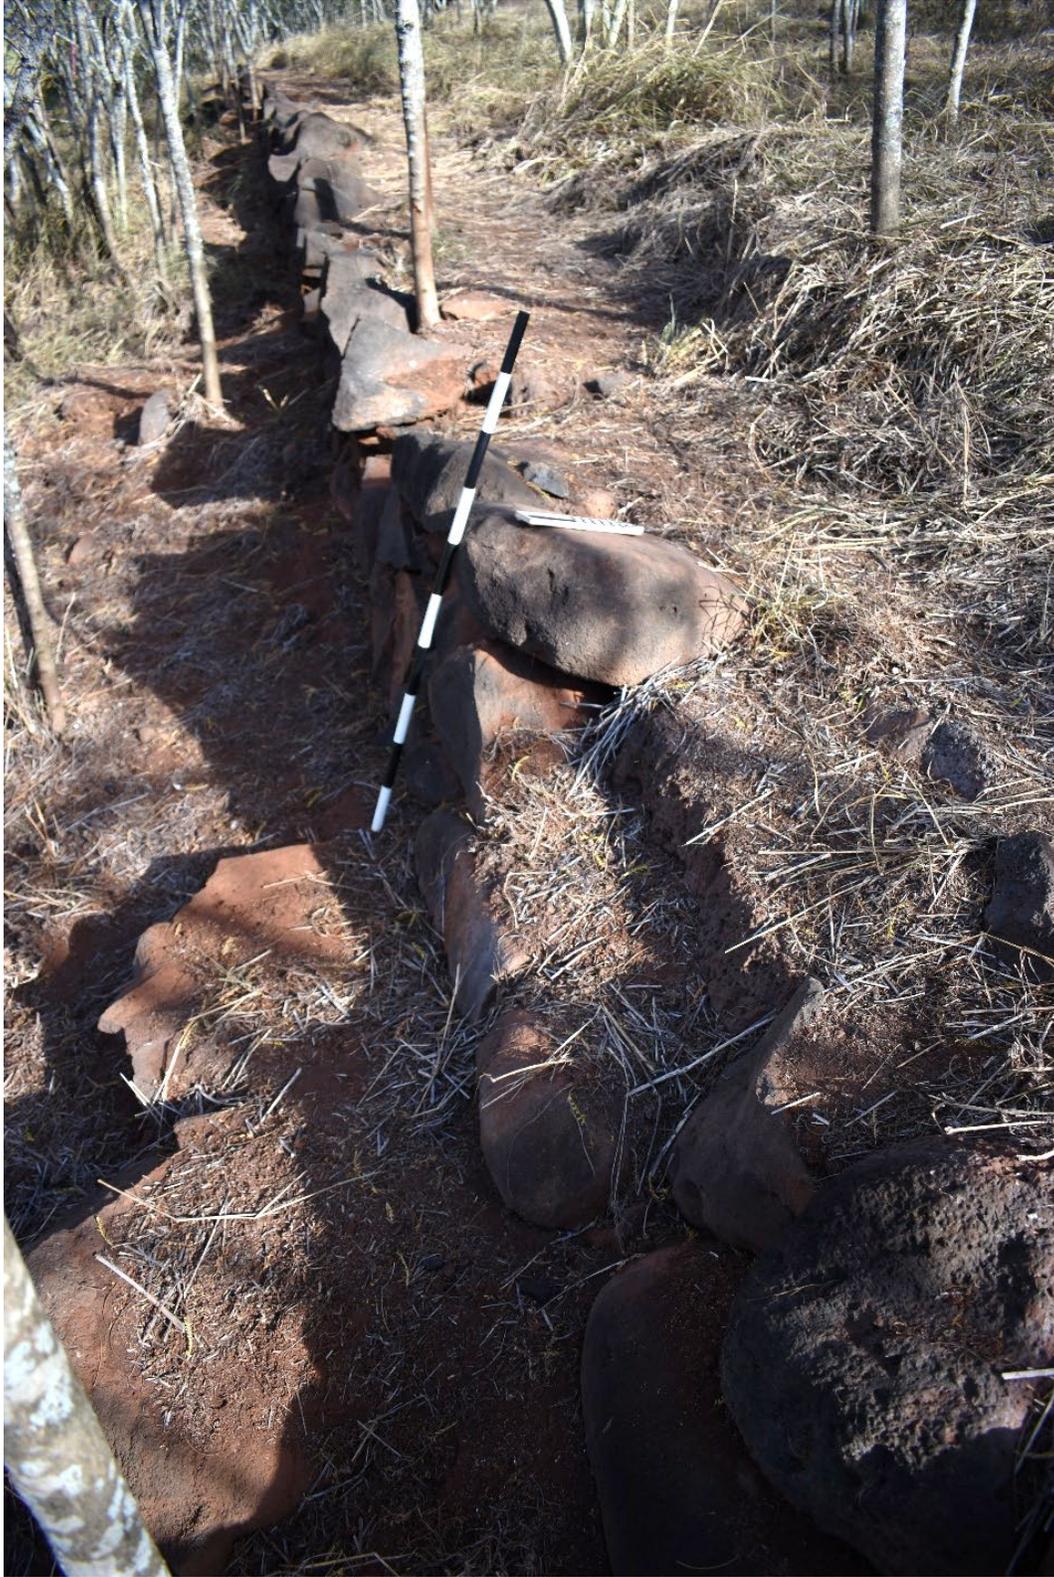
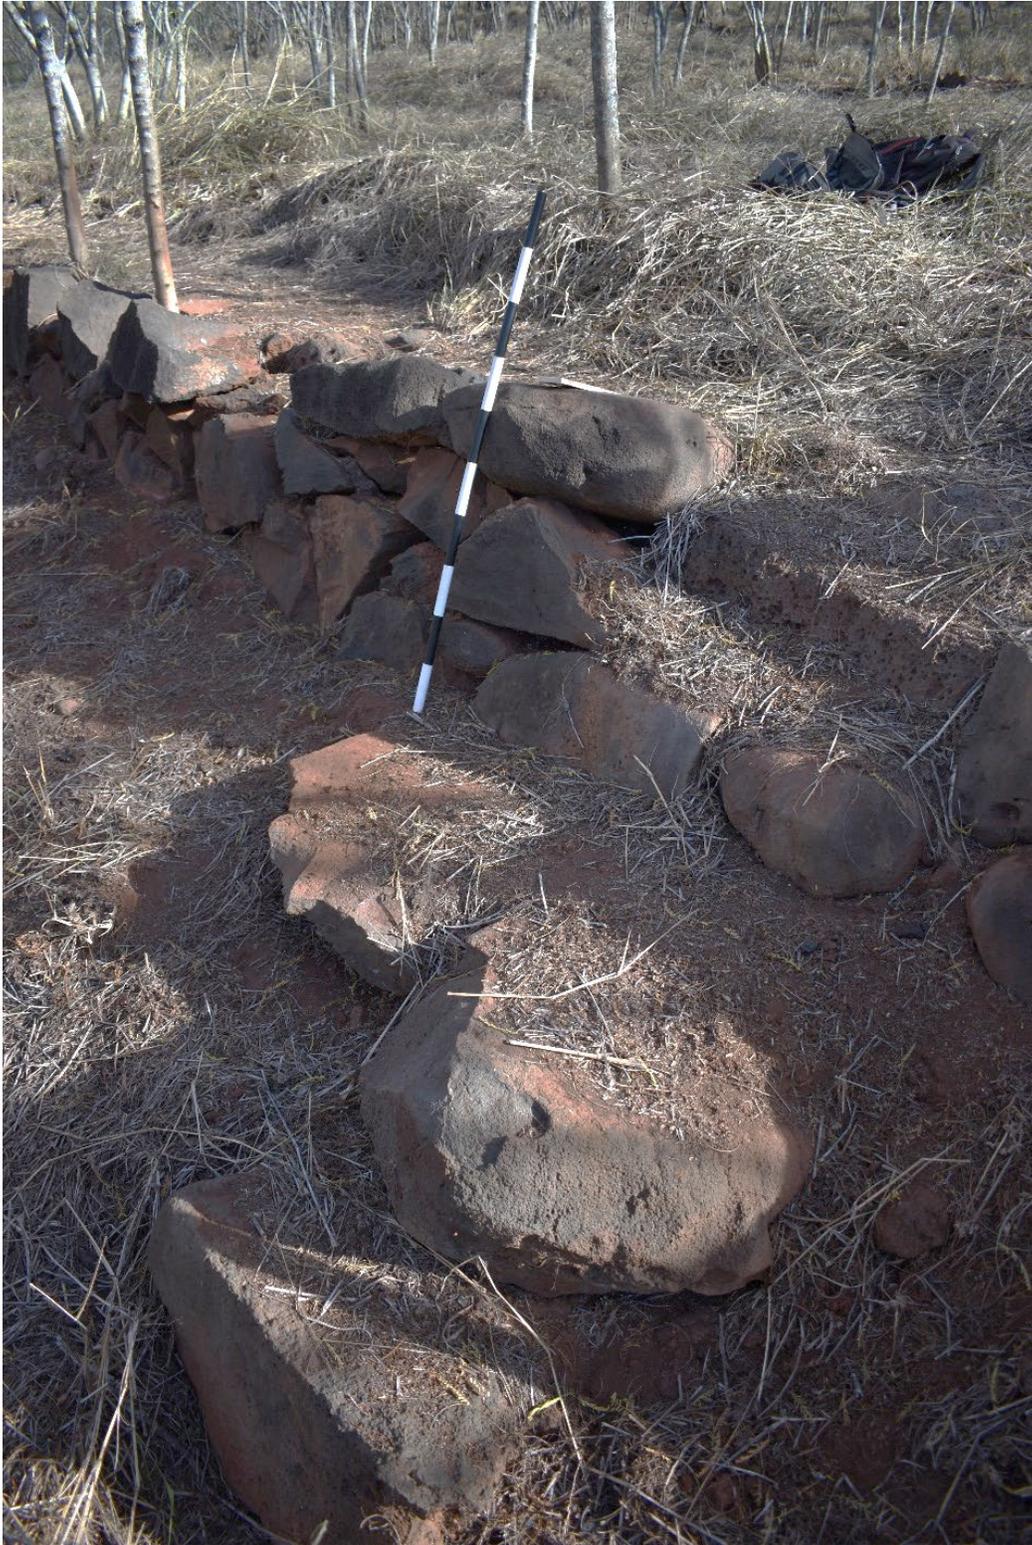
Feature VI-60 (new): Linear Basalt Rock Wall (Figures 54 and 55). This feature is a very well-constructed dry-stack terrace wall. It is composed of cobble to boulder-sized basalt rocks and is approximately 182 feet long with a width of 1 to 2 feet and a height of one to three feet. It is composed of two to three tiers of rocks, except where large boulders are present, it is only a single tier. Features VI-60a and 60b are two distinct areas that are composed of two-tiers of dressed stones forming spaces (3 feet wide) in the wall. Feature VI-60b appears to form a series of two stone steps. Both Features VI-60 and VI-61 become very irregular along the southern end to appear to be a series of scattered cobbles.

Figure 54. Feature VI-60 Rock Wall.

Figure 55. Feature VI-60 Rock Wall detail (mid-wall stairs).

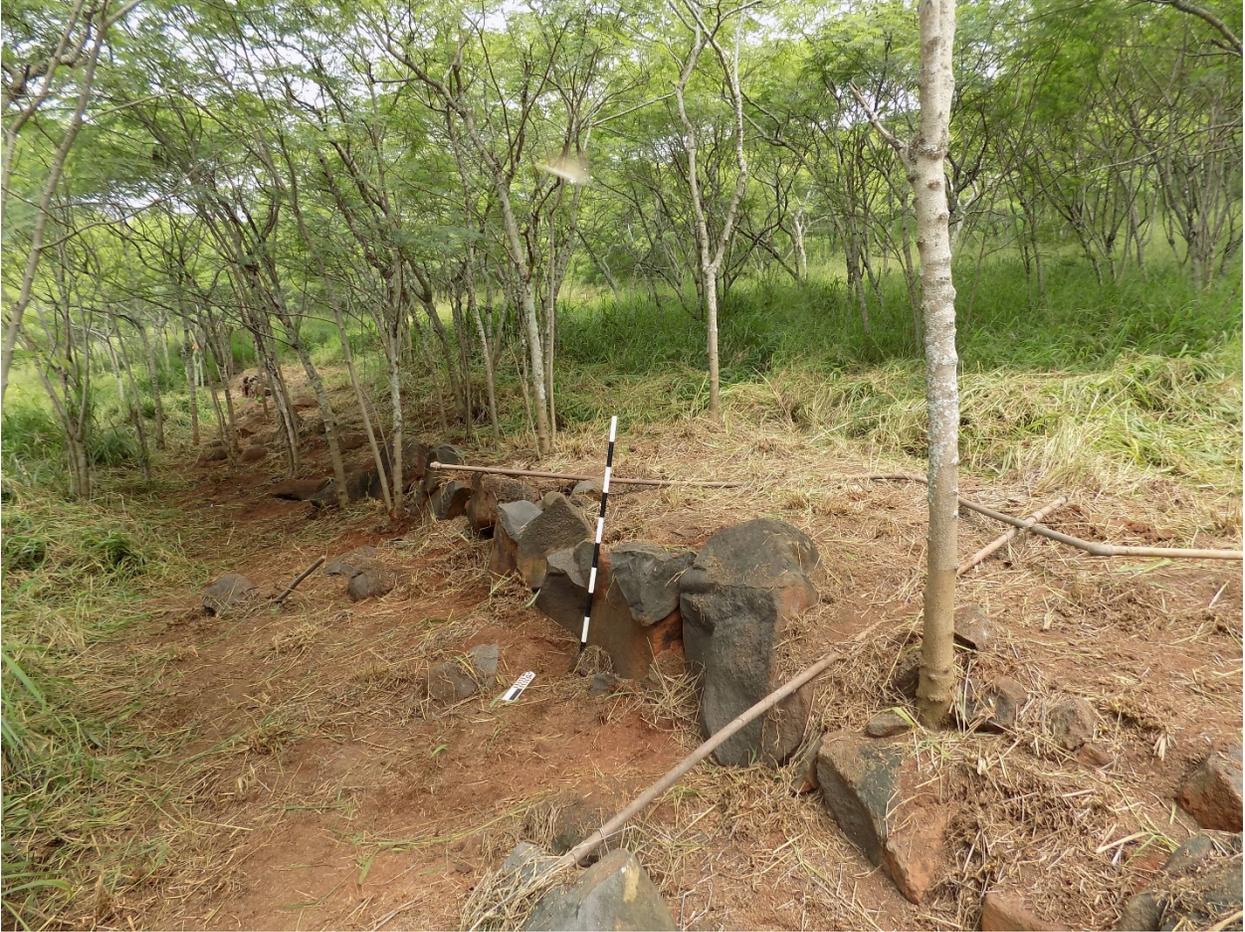
Figure 56. Feature VI-61 Rock Wall.

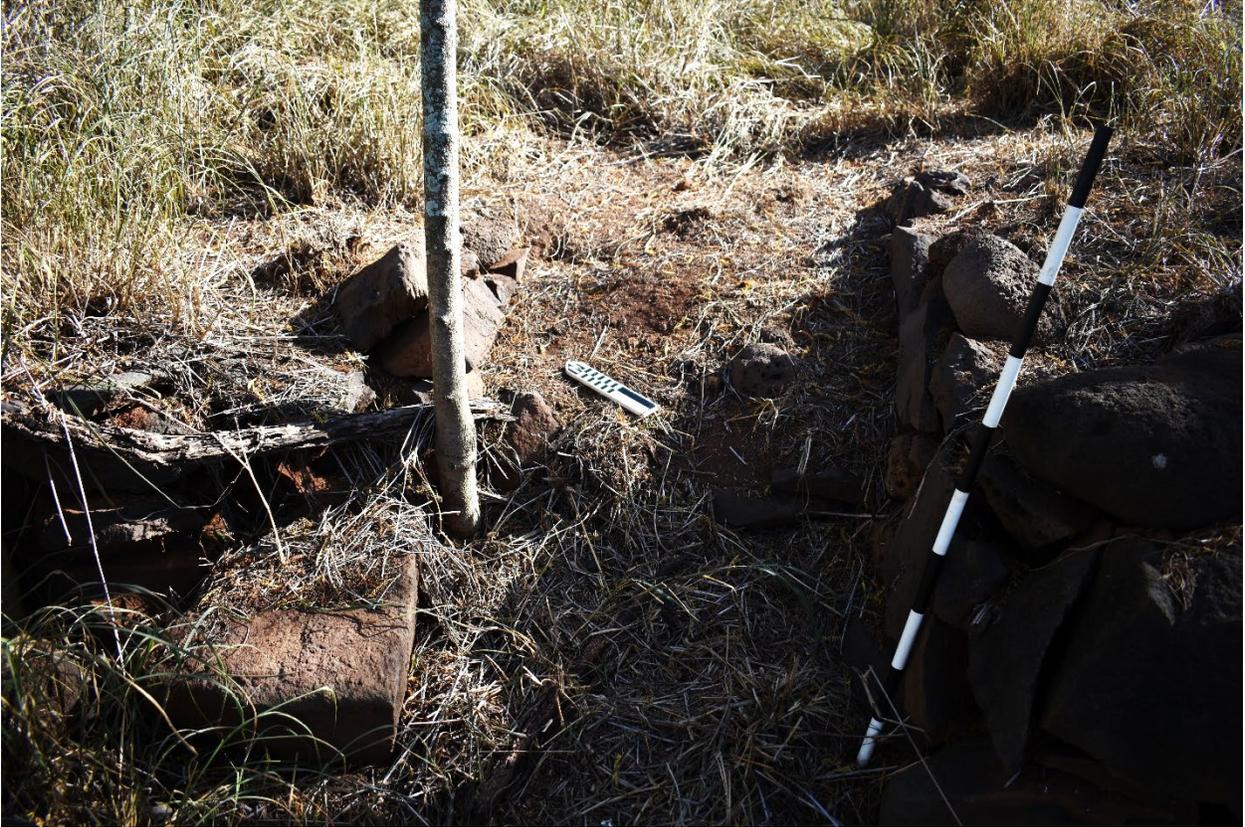
Figure 57. Feature VI-61, Rock Wall detail (gap/opening).

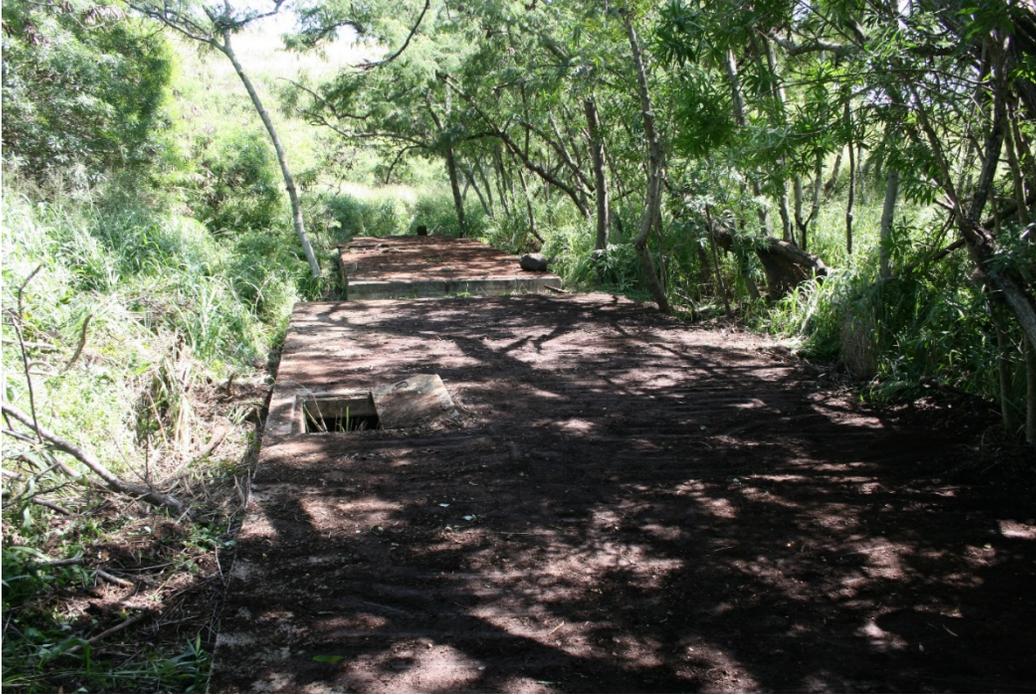
Figure 59. Features VII-1 (background) and VII-2 (foreground), Septic Tank, facing south.

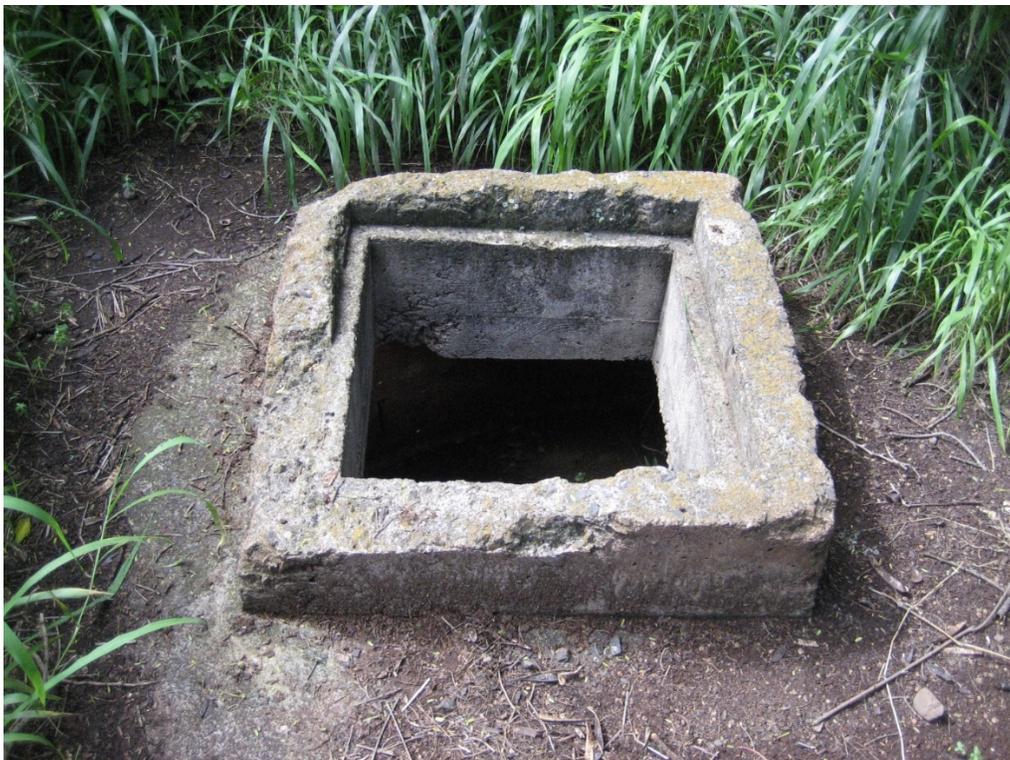
Figure 60. Feature VII-3, Septic Tank/Concrete Structure.

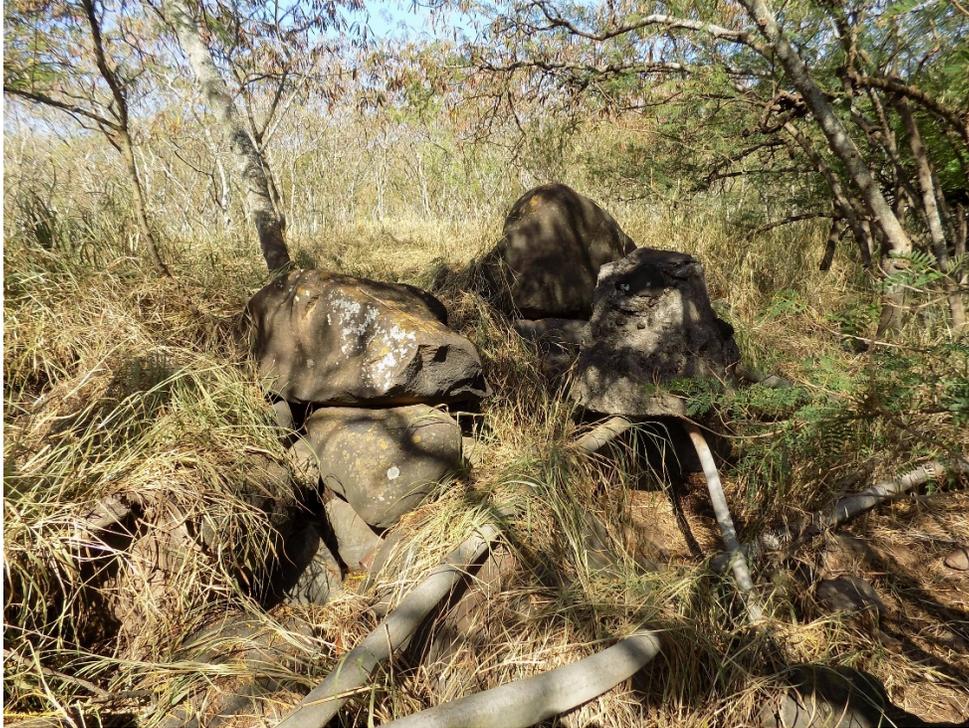
Figure 61. Feature VII-4, Fence Remnants.

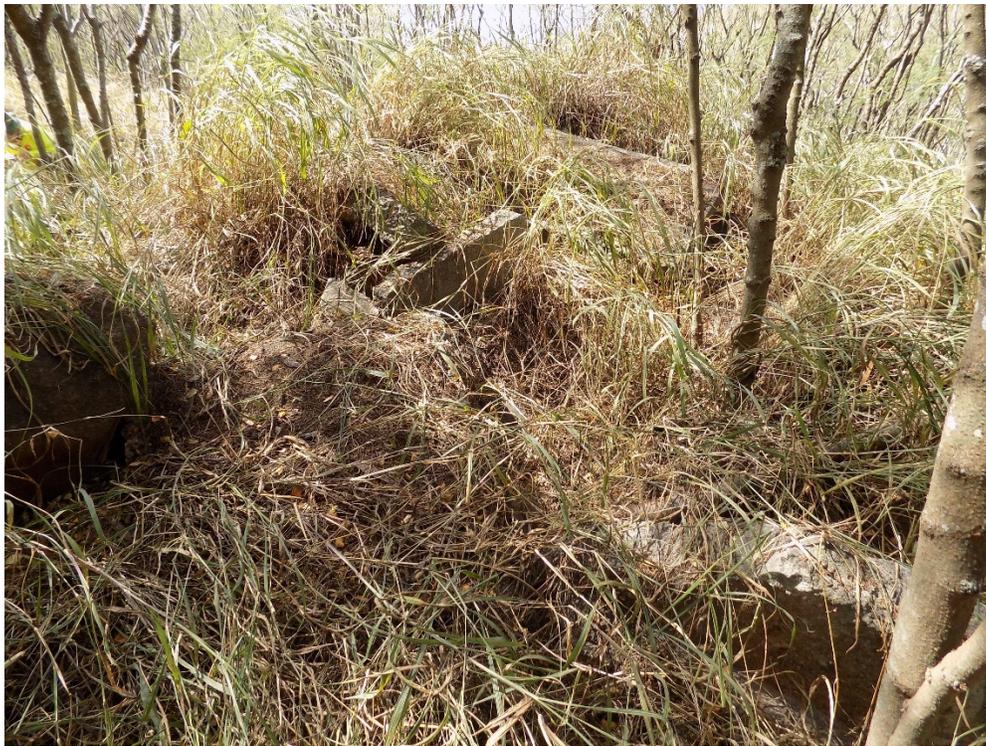
Figure 62. Feature VII-6, Structural Debris (Irrigation Flumes)

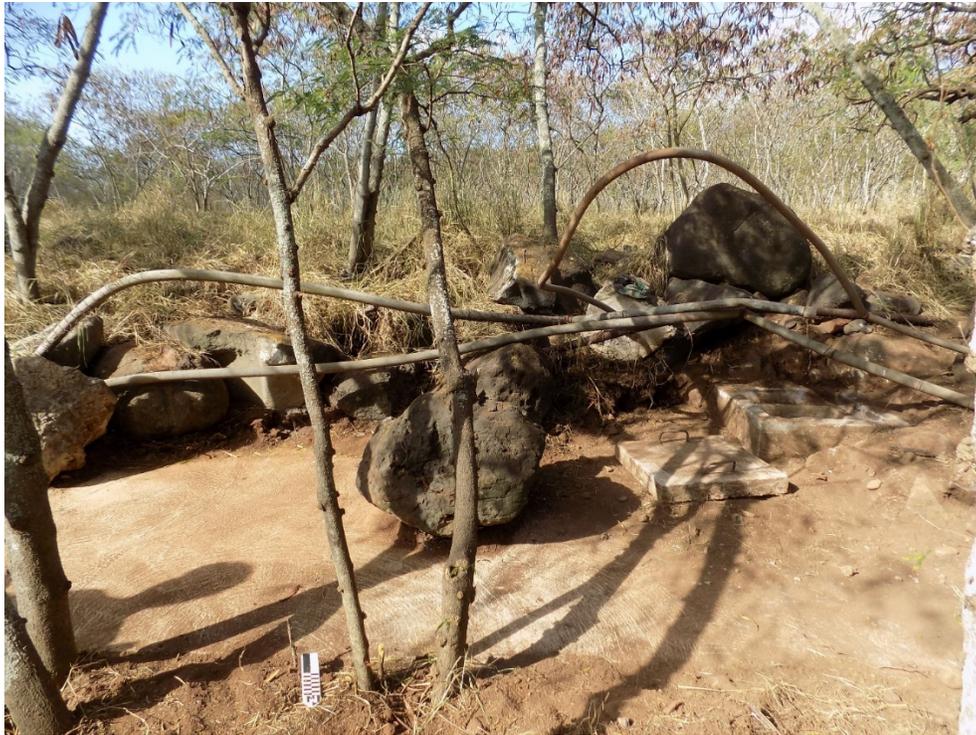
Figure 64. Figure VII-22 (new), Septic Tank.

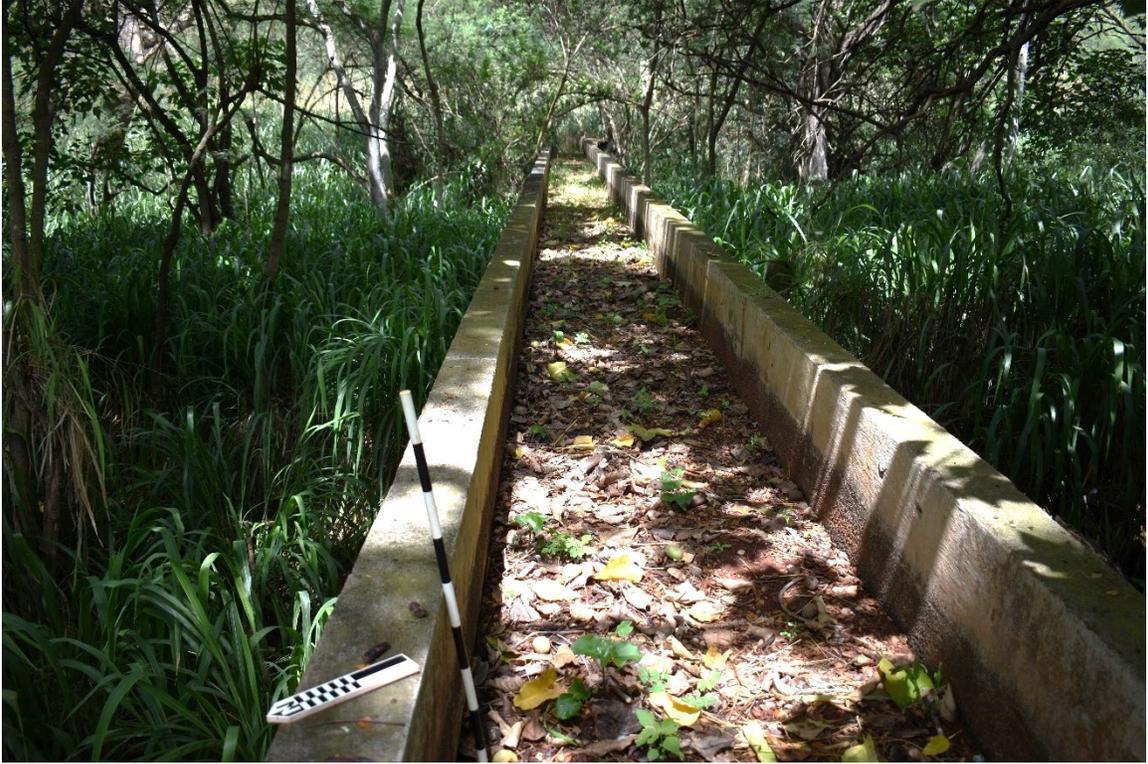
Feature L-1a Main Aqueduct (Figure 66). The aqueduct is a large rectangular concrete structure that sits on eight dressed basalt rock and concrete mortar piers. The six piers over Honouliuli Stream are straight on the downstream end and pointed on the upstream/leading edge, spaced approximately 16 feet apart. The aqueduct is approximately 170 feet long and is approximately 5 feet, 4 inches wide with a depth of about 4 feet (however, much of the aqueduct floor is filled with sediment). While one of the piers on the northwestern side of the concrete flume has partially collapsed (see below, Feature L-1b), it doesn’t appear to have a support function. This feature appears stable; however, there are several cracks in the aqueduct itself; clearing of the sediment will help relieve some of the constant stress and may help alleviate the damage from continuing.

Figure 66. Feature L-1a, Main Aqueduct.

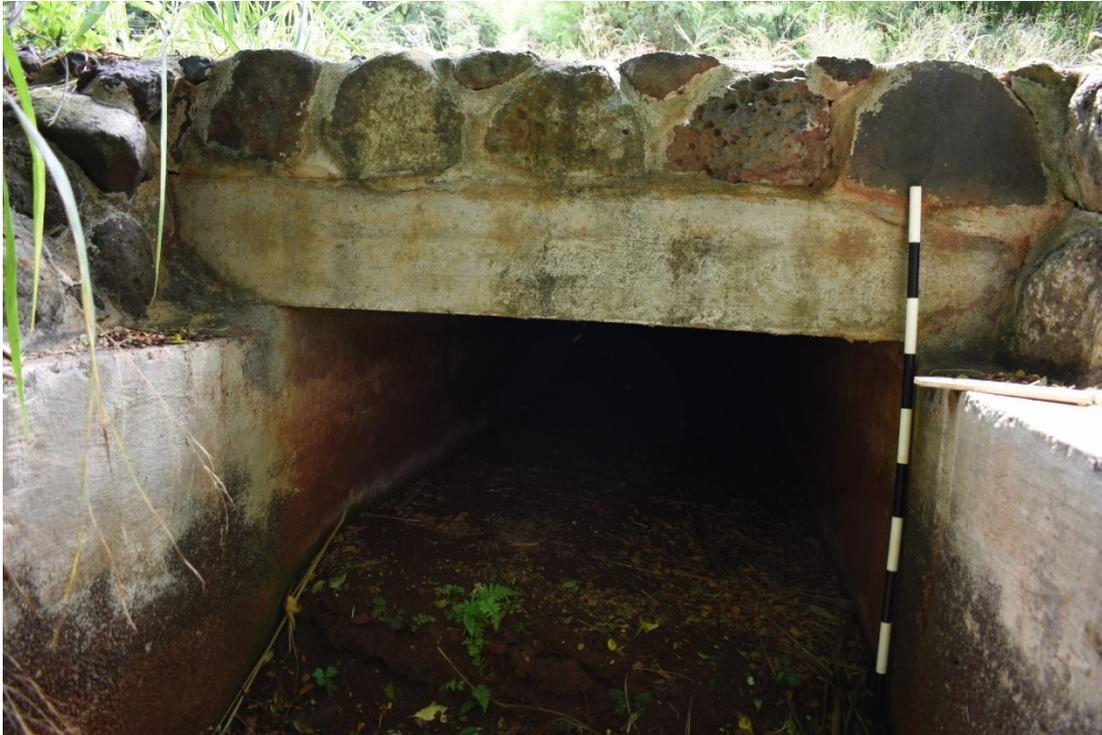
Feature L-1c Concrete Pipe (Figure 68): Just east of the main aqueduct, is a concrete drainpipe. It appears relatively stable.

Figure 68. Feature L-1c, Concrete Pipe, leading to Aqueduct, L-1a.

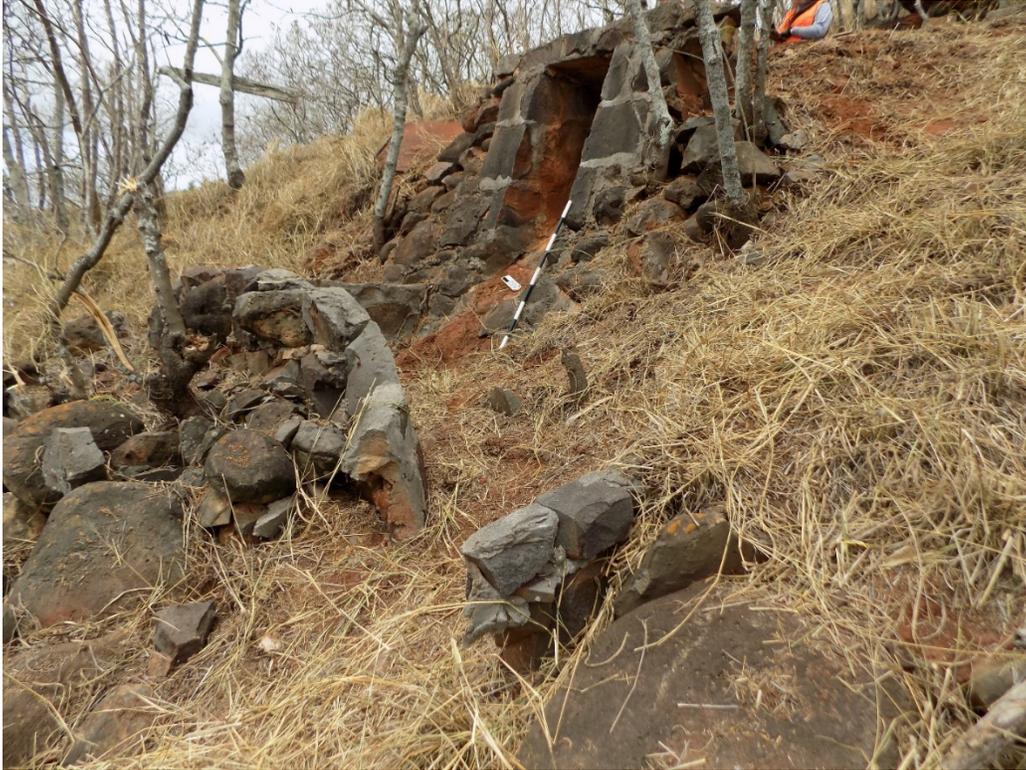
Feature L-1e Sealed Gate (Figure 70). This feature is another sealed gate like Feature L-1d. This lies within the Guard Camp Compound VI.

Figure 70. Feature L-1e, Sealed Gate, facing south.

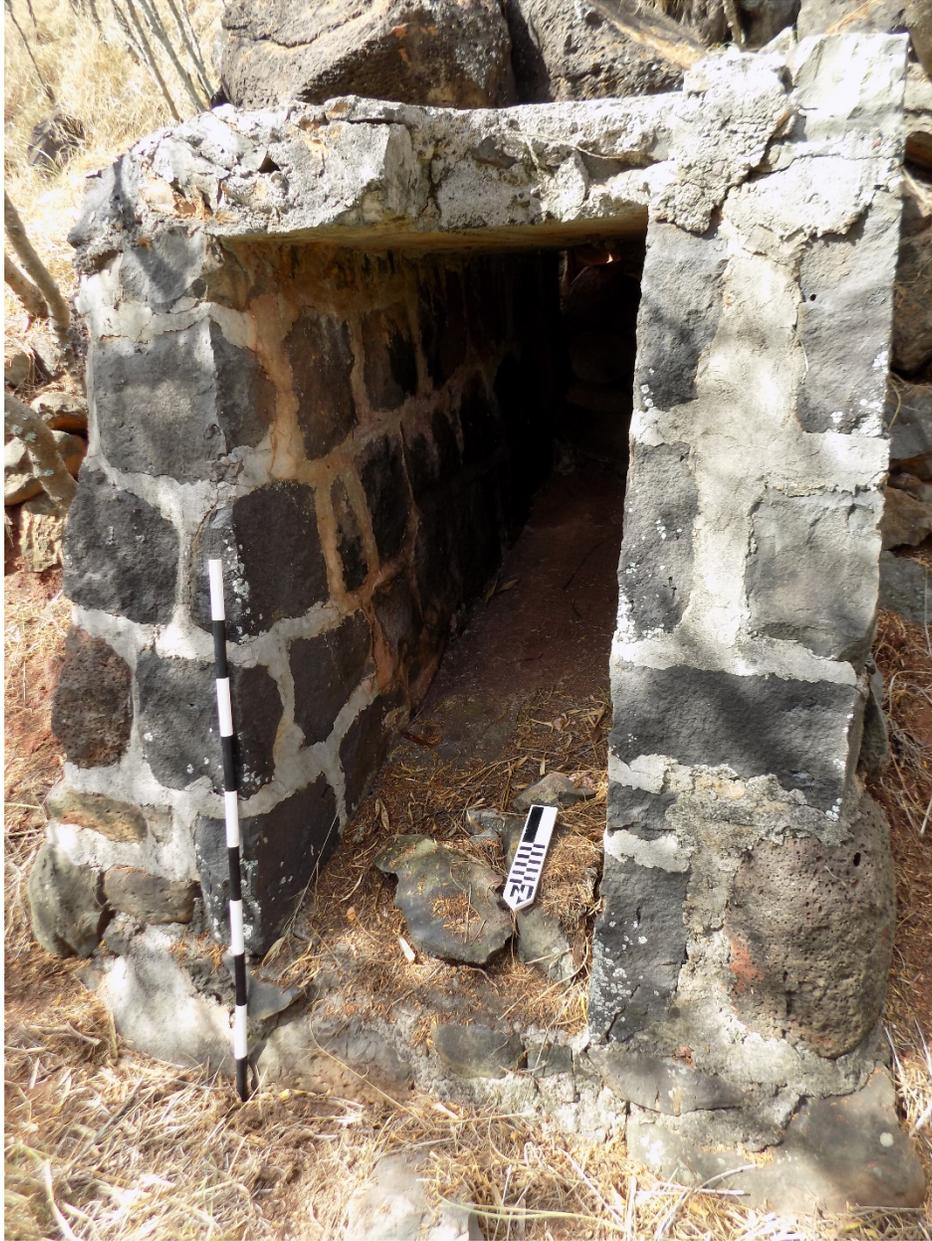
Feature L-1i Sealed Outlets (Figure 73). This is another sealed outlet on the western side of Compound V along the aqueduct. The gate has been (like others mentioned above) sealed permanently with concrete and basalt blocks. This feature sits about 200 feet north of guard tower and sealed gate (Features VI-50 and L-1d).

Figure 73. Feature L-1i, Sealed Outlet, facing south.

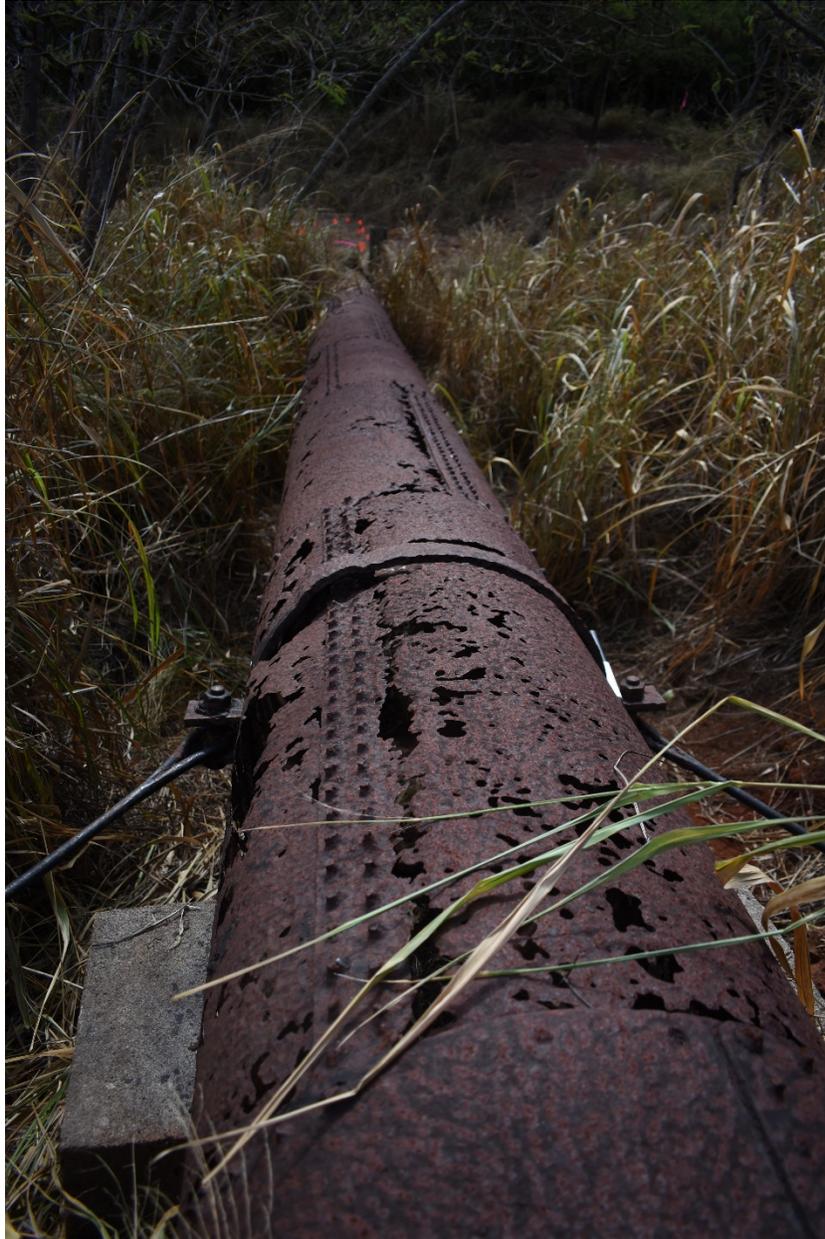
Feature L-2a Metal Siphon (Figures 74 and 75). This large metal pipe or siphon that carried water from a ditch on the west side of the Honouliuli Gulch to another ditch on the east side. The siphon is composed of 2-foot diameter sections of riveted steel pipe. It is supported at intervals by formed concrete piers that are approximately 48 inches high; the pipe sits in a half-cylinder formed depression on the top of the pier. A steel band girdles the siphon and connected with heavy gauge wire to eye-bolts that are fixed into clamps at small truncated pyramidal concrete anchors approximately 25 feet from the siphon on both the north and south ends. The siphon is in poor condition with numerous holes in the metal. The siphon is collapsing where it enters the road. This area was cordoned off to keep people from walking over it in order to minimize damage to the feature as well as injury.

Figure 74. Feature L-2a, Metal Siphon and Concrete Piers, facing downslope/east.

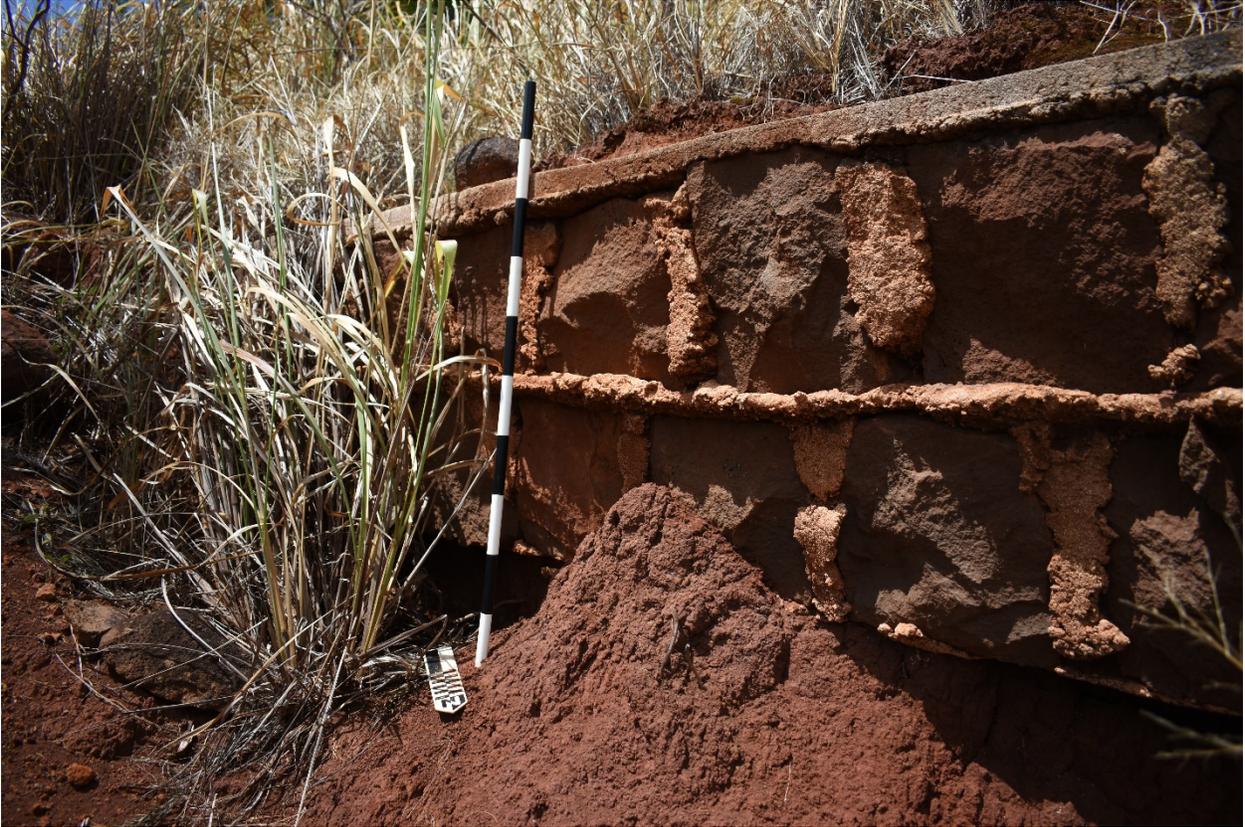
Feature L-2b Exposed Ditch (Figure 76). Along the western access road into the camp, an exposed portion of the concrete ditch is visible. The ditch appears to be formed of rectangular dressed basalt rock with concrete mortar. It is lined over the top and the interior surface with concrete. This area is prone to erosion, but this is an important portion of the ditch as this allows visitors to view how this ditch was constructed.

Figure 76. Feature L-2b, Exposed Irrigation Canal.
